SCHOOL DISTRICT 85
VANCOUVER ISLAND NORTH

ALERT BAY ELEMENTARY
ASBESTOS SURVEY AND ASSESSMENT

Date: July 2009
NWEST File: 10583

North West
Environmental Group Ltd.

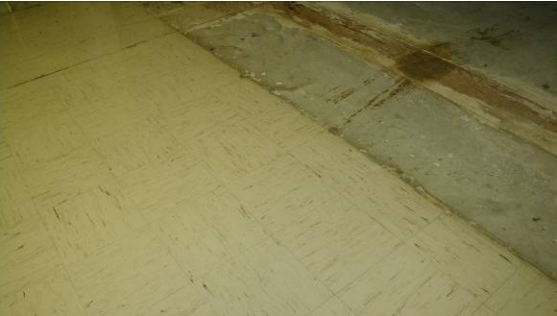
<p>Sample #1: Floor Tile Site: WC's and Janitor Room Asbestos: None Detected</p>	<p>Sample #2: Floor Tile Site: Entrance Asbestos: None Detected</p>

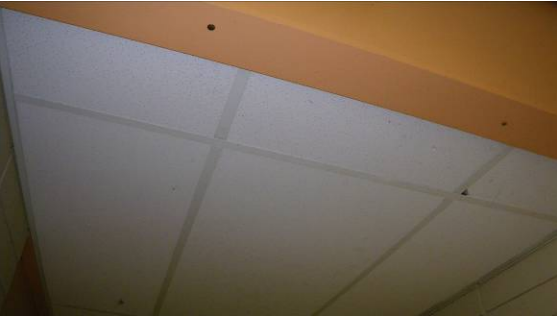
<p>Sample #3: Ceiling Tile Site: Throughout Building Asbestos: None Detected</p>	<p>Sample #4: Drywall Filler Site: Adjacent to new Construction Asbestos: None Detected</p>

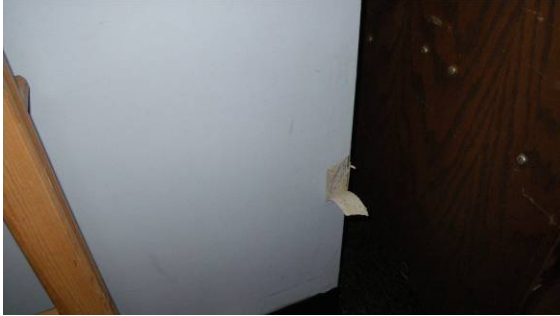
Sample #5:	Drywall Filler
Site:	Old Library
Asbestos:	None Detected

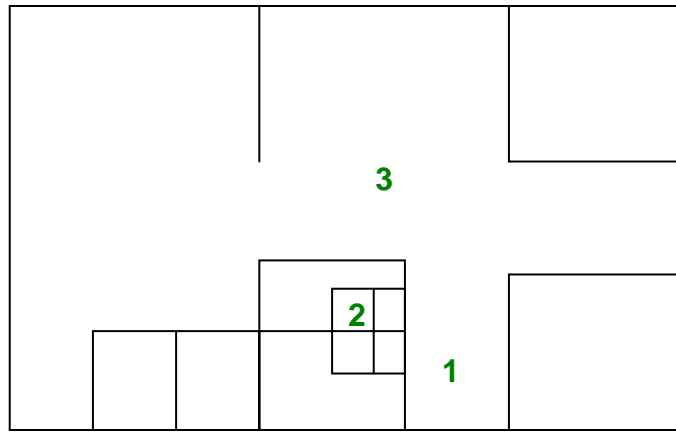
Alert Bay Elementary School

- 1** Non Asbestos containing sample location

Note that concrete blocks may be filled with asbestos-containing vermiculite.
