SCHOOL DISTRICT 85
VANCOUVER ISLAND NORTH

A.J. ELLIOTT ELEMENTARY
ASBESTOS SURVEY AND ASSESSMENT

Date: August 2009
NWEST File: 10562

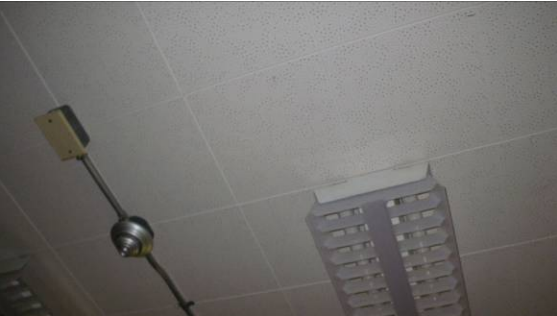
<p>Sample #: 3 Site: Gym Foyer Asbestos: None Identified</p>	<p>Sample #: 4 Site: Storage Classroom Asbestos: None Identified</p>

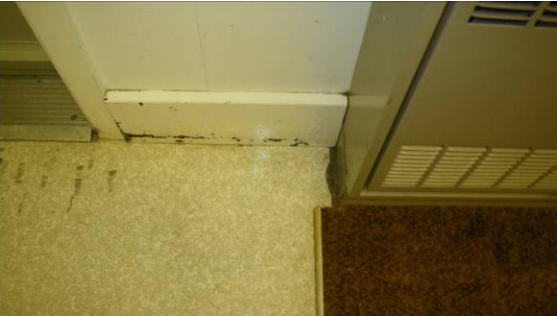
<p>Sample #: 5 Site: Electrical Room Asbestos: None Identified</p>	<p>Sample #: 6 Site: Gym Change Room Asbestos: None Identified</p>

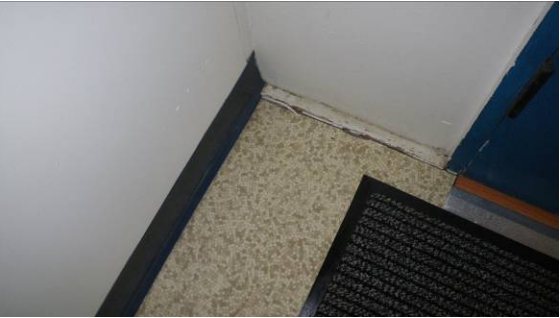
<p>Sample #: 7 Site: Pre-School Asbestos: None Identified</p>	<p>Sample #: 8 Site: Pre-School Asbestos: None Identified</p>

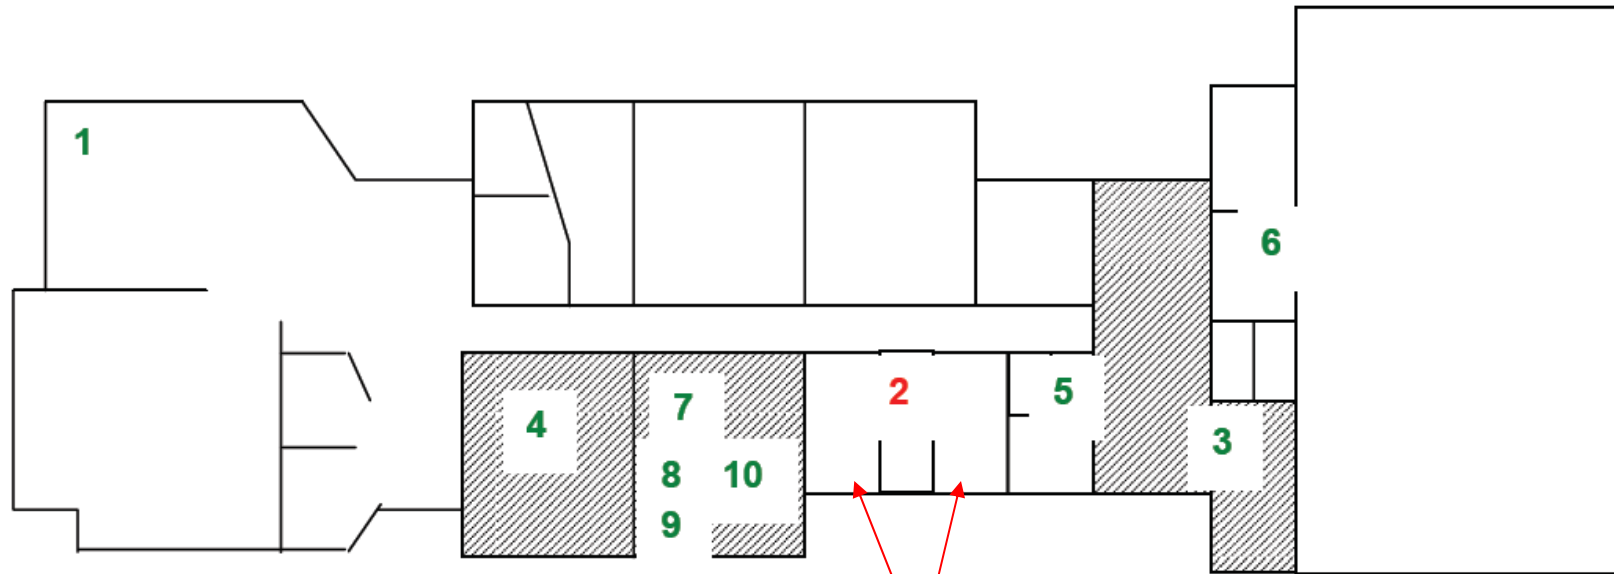
APPENDIX 6: SAMPLE LOCATION DRAWING

Asbestos Cement Board
(not sampled, known to contain)

Note that concrete blocks may be filled with asbestos-containing vermiculite.
