SCHOOL DISTRICT 85  
VANCOUVER ISLAND NORTH

**CHESLAKEES ELEMENTARY**  
ASBESTOS SURVEY AND ASSESSMENT

Date: July 2009  
NWEST File: 10560

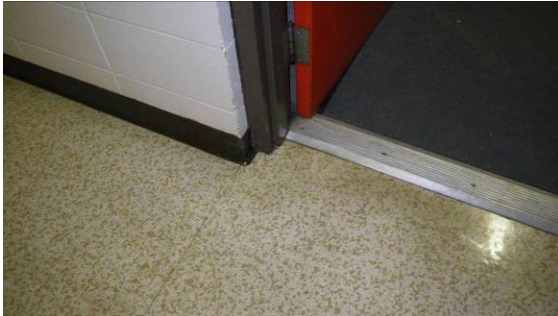
Asbestos containing sheet floor backing and glue contain asbestos. This product is protected by the vinyl layer of the sheet flooring and is unlikely to be disturbed during routine building activities.

Sample #1: Sheet Flooring  
Site: Throughout School  
Asbestos: Paper Backing and Glue

Asbestos backed sheet flooring and glue are unlikely to be disturbed during routine building activities. This product can be managed in place. Damage to the vinyl layer will require remedial actions.

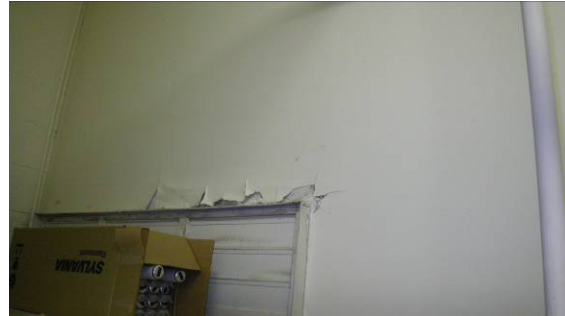
Sample #2: Drywall Filler  
Site: Mechanical Room  
Asbestos: None Detected
