SCHOOL DISTRICT 85
VANCOUVER ISLAND NORTH

COAL HARBOUR ELEMENTARY
ASBESTOS SURVEY AND ASSESSMENT

Date: July 2009
NWEST File: 10575

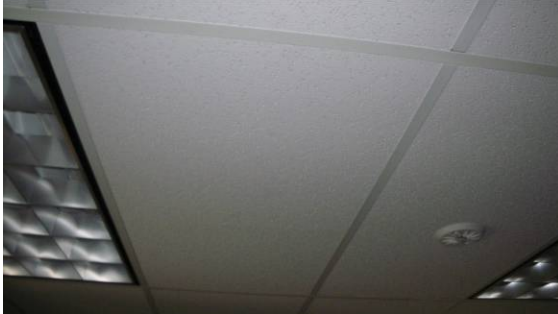
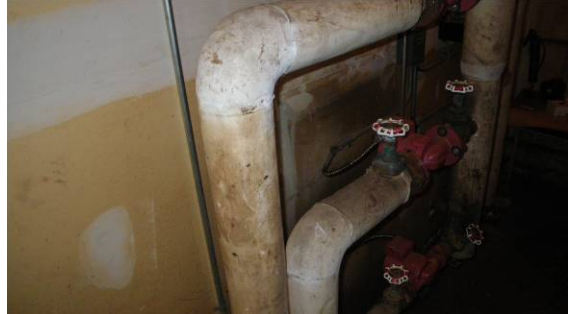
Sample #: 9 – Ceiling Tile
 Site: Room 10
 Asbestos: None Detected

Sample #: 10 – Pipe Elbow Insulation
 Site: Boiler Room
 Asbestos: 20% Chrysotile

Asbestos pipe insulation is unlikely to be damaged during routine building activities and can be managed in place.

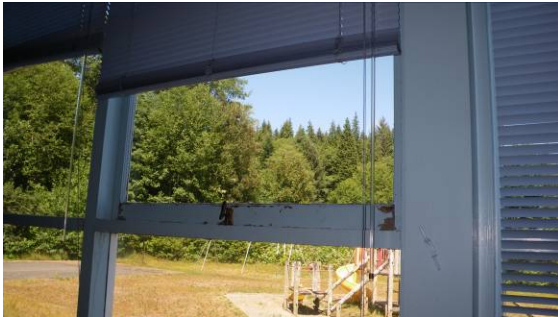
Window putty was found to contain asbestos. This product is considered non-friable and is unlikely to be disturbed during routine building activities. This product should be removed prior to the start of any renovation or demolition activities.

Sample #: 11 – Window Putty
 Site: Room 2
 Asbestos: <1% Chrysotile

Asbestos containing window putty is unlikely to be damaged during routine building activities and can be managed in place.
