SCHOOL DISTRICT 85  
VANCOUVER ISLAND NORTH

**EAGLE VIEW ELEMENTARY**  
ASBESTOS SURVEY AND ASSESSMENT

Date: July 2009

NWEST File: 10569

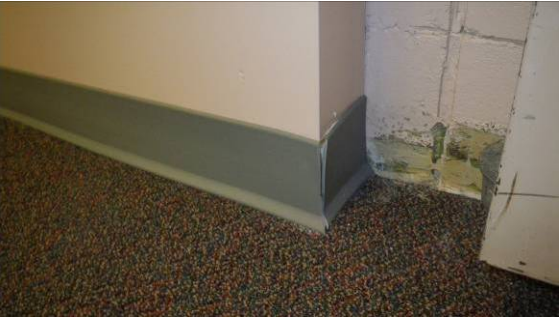
<p>Sample #: 1 – Drywall Filler            Site: Room 106            Asbestos: None Detected</p>	<p>Sample #: 2 – Drywall Filler            Site: Room 202            Asbestos: None Detected</p>

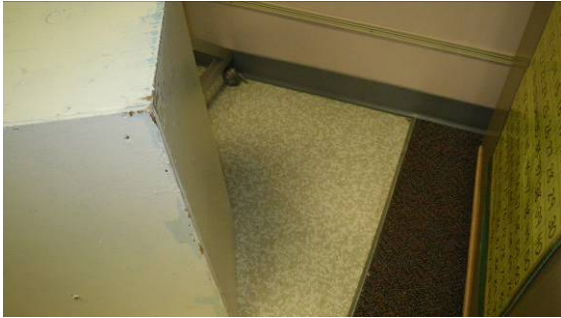
<p>Sample #: 3 – Drywall Filler            Site: Room 301            Asbestos: None Detected</p>	<p>Sample #: 4 – Drywall Filler            Site: Music Room            Asbestos: None Detected</p>

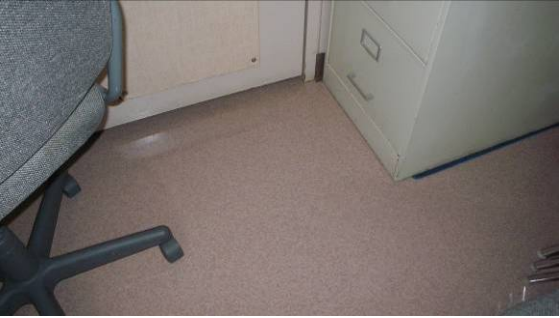
<p>Sample #: 5 – Drywall Filler                  Site: Room 403                  Asbestos: None Detected</p>	<p>Sample #: 6 – Layer 1 – Sheet Flooring                  Site: Room 206                  Asbestos: None Detected                  Sample # 6 – Layer 2 – Adhesive                  Asbestos: None Detected</p>

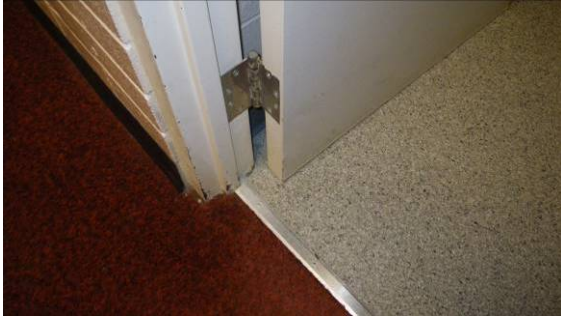
<p>Sample #: 7 – Layer 1 – Sheet Flooring                  Site: Room 302                  Asbestos: None Detected                  Sample #? 7 – Layer 2 – Adhesive                  Asbestos: None Detected</p>	<p>Sample #: 8 – Layer 1 – Sheet Flooring                  Site: Room 412                  Asbestos: None Detected                  Sample #: 8 – Layer 2 – Adhesive                  Asbestos: None Detected</p>

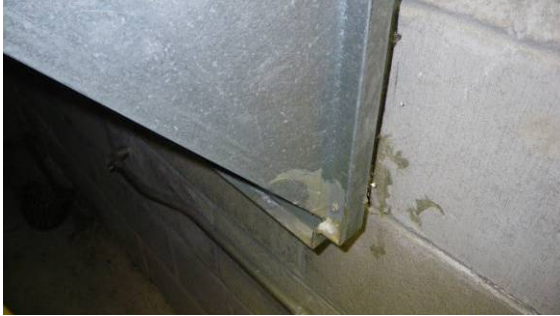
Material	Location	Assessment	Recommendation
Pipe Elbow Insulation	Room 207 and throughout the building	Good condition, not accessible, friable	Manage in Place

Asbestos containing mechanical insulation is present in Room 207 in the building. This product may be present in other locations. If materials do not need to be disturbed, they may be managed in place. Materials that will be disturbed by the renovation or demolition activities must be removed prior to the start of any work.

<p>Sample #: 11 – Ceiling Tile                  Site: Hallway Outside Gym                  Asbestos: None Detected</p>	<p>Sample #: 12 – Pipe Elbow Insulation                  Site: Room 207                  Asbestos: 20% Chrysotile</p>

This product should be removed prior to the start of any demolition or renovation work that will disturb them.

Asbestos containing pipe insulation (elbows and fittings) is unlikely to be disturbed during routine building activities. They can be managed in place as long as they remain undisturbed.
