SCHOOL DISTRICT 85  
VANCOUVER ISLAND NORTH

**FORT RUPERT ELEMENTARY**  
ASBESTOS SURVEY AND ASSESSMENT

Date: July 2009  
NWEST File: 10569

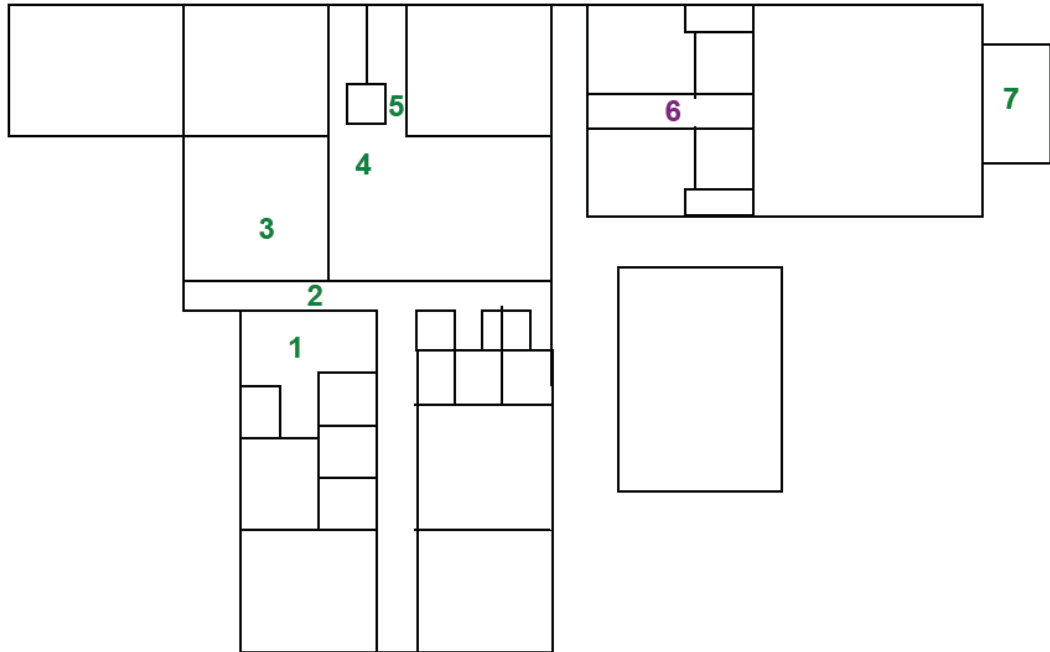
## APPENDIX 5: SAMPLE LOCATION DRAWING

- 1** Non Asbestos containing sample location
- 6** Asbestos containing sample location
