SCHOOL DISTRICT 85
VANCOUVER ISLAND NORTH

**NORTH ISLAND SECONDARY
SCHOOL**
ASBESTOS SURVEY AND ASSESSMENT

Date: July 2009
NWEST File: 10556

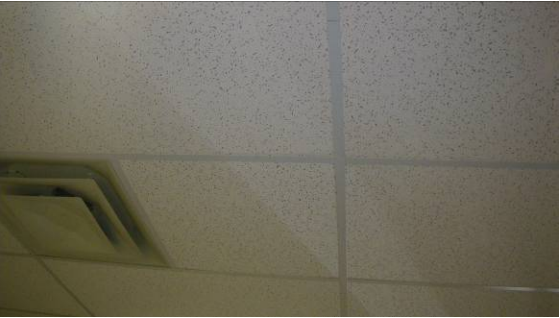
<p>Sample #1: Ceiling Tile Site: Office Asbestos: None Detected</p>	<p>Sample #2: Drywall Filler Site: Library Asbestos: None Detected</p>

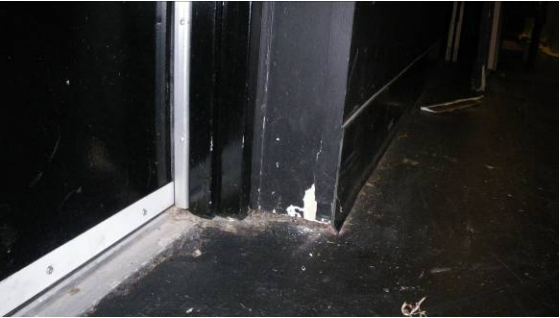
<p>Sample #3: Drywall Filler Site: Drama Room Asbestos: None Detected</p>	<p>Sample #4: Floor Tile Site: Band/Gym Hallway Asbestos: None Detected</p>

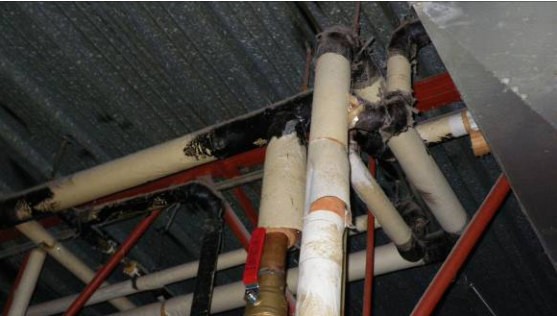
<p>Sample #5: Mastic on Pipe Insulation Site: Gym Janitor Room Asbestos: None Detected</p>	<p>Sample #6: Duct Caulking Site: Gym Janitor Room Asbestos: None Detected</p>

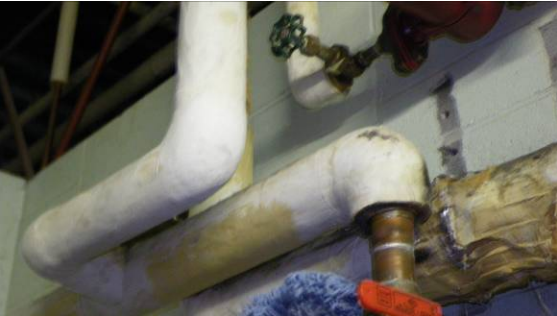
Asbestos pipe elbows and fittings are likely present throughout the building. These products are in good condition and can be managed in place.

Asbestos containing pipe elbows and fittings are likely to be present throughout the building. All observed materials are in good condition and unlikely to be disturbed during routine building activities.

<p>Sample #7: Pipe Elbow Site: Gym Janitor Room Asbestos: 60% Chrysotile</p>	<p>Sample #8: Drywall Filler Site: Room 203 Asbestos: None Detected</p>

Asbestos containing pipe insulation, cement board panels and sheet flooring are in good condition and unlikely to be disturbed during routine building activities. These products can be managed in place.

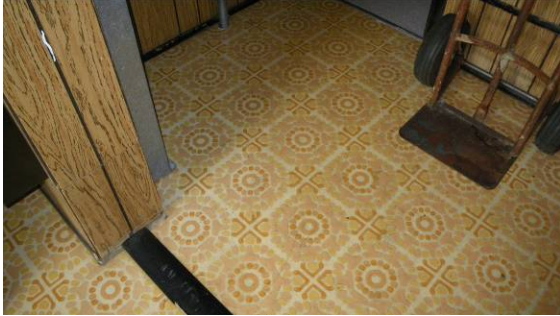
Asbestos backed sheet flooring is present in the Maintenance Building attached to the school. This material is in good condition and can be managed in place.

Asbestos backed sheet flooring is present in the Maintenance Building attached to the school. This material is in good condition and unlikely to be damaged during routine building activities.

Sample #17: Sheet Flooring
Site: Maintenance Trailer
Asbestos: 25% Chrysotile
