Asbestos Inventory and Condition Assessment

North Island Secondary School - Shop - 2071 McNeill Road, Port McNeil, B.C.

NWest Project Number: 30639 V.1.0

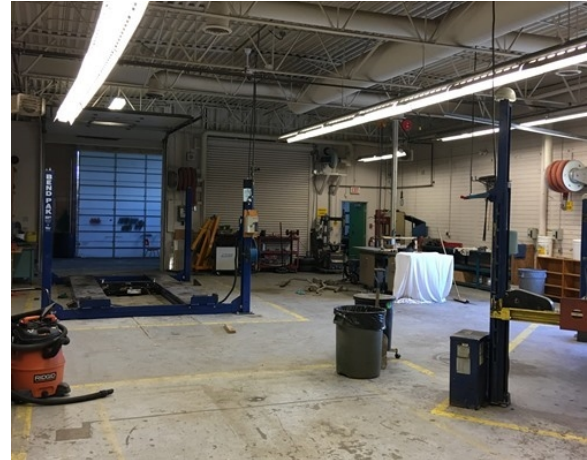
Autoshop Main

Ceiling: Q-Deck
 Wall: Concrete Blocks May Contain Vermiculite, Wood
 Floor: Concrete

No Photograph		Concrete Blocks May Contain Vermiculite	Suspect	Good	Proactive ACM Removal or Routine Surveillance

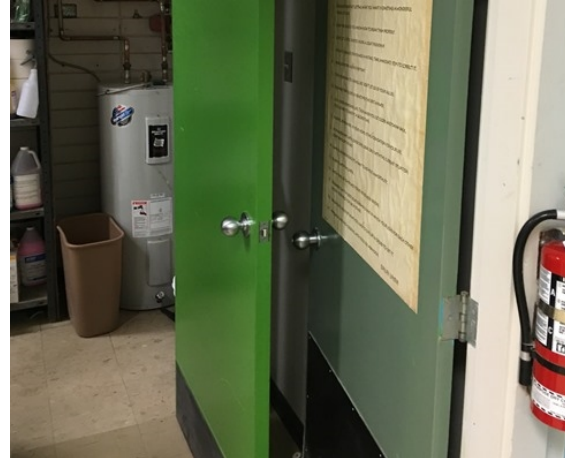
Autoshop Storage and Hot Water Tank

Ceiling: Wood
 Wall: Concrete Blocks May Contain Vermiculite, Wood
 Floor: Floor Tile Type1 - 12" x 12" Brown and Beige with White Streaks, Floor Tile Type2 - 12" x 12" Brown and Beige with Black Smears

No Photograph		Concrete Blocks May Contain Vermiculite	Suspect	Good	Proactive ACM Removal or Routine Surveillance

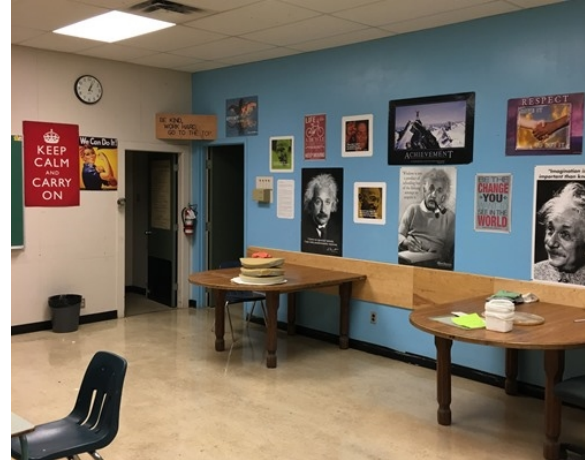
Classroom by Drafting

- Ceiling: Ceiling Tile (Acoustic) Type1 - Patterned Fissure, Ceiling Tile (Acoustic) Type2 - Random Fissure, Large Pinholes
- Wall: Concrete Blocks May Contain Vermiculite, Drywall Joint Compound Type1 - White, Cementitious
- Floor: Sheet Flooring Type7 - Beige with Dark and White Streak Pattern

Concrete Blocks May Contain Vermiculite	Suspect	Good	Proactive ACM Removal or Routine Surveillance

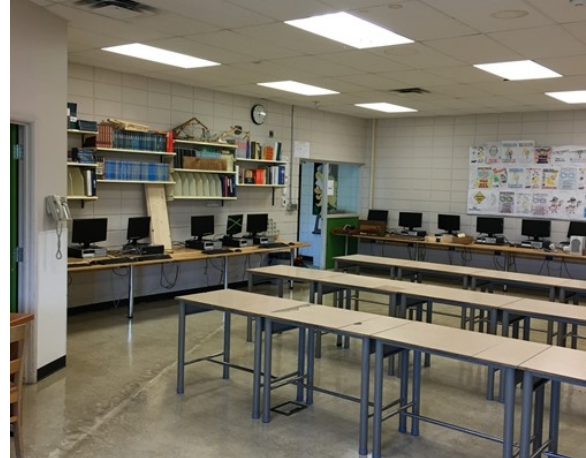
Drafting

Ceiling: Ceiling Tile (Acoustic) Type1 - Patterned Fissure, Ceiling Tile (Acoustic) Type2 - Random Fissure, Large Pinholes
 Wall: Concrete Blocks May Contain Vermiculite
 Floor: Sheet Flooring Type7 - Beige with Dark and White Streak Pattern

Sample 30639-1 - Sheet Flooring Type 7 (Layer 1) (no asbestos detected)
 Sample 30639-1 - Sheet Flooring Type 7 (Layer 2) (no asbestos detected)

Concrete Blocks May Contain Vermiculite	Suspect	Good	Proactive ACM Removal or Routine Surveillance

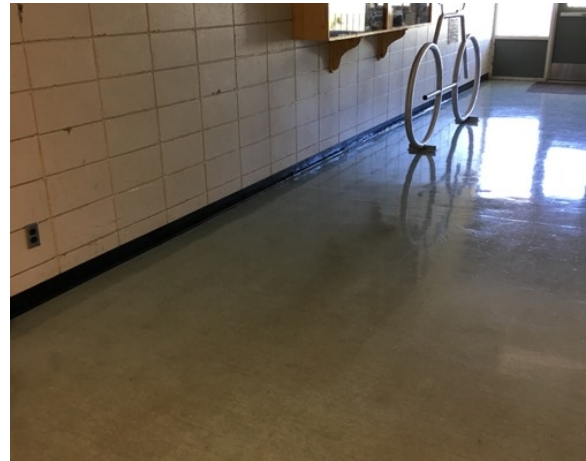
Hall Drafting

Ceiling: Ceiling Tile (Acoustic) Type1 - Patterned Fissure, Ceiling Tile (Acoustic) Type2 - Random Fissure, Large Pinholes
 Wall: Concrete Blocks May Contain Vermiculite
 Floor: Sheet Flooring Type8 - Green Streak Pattern

Sample 30639-2 - Sheet Flooring Type 8 (no asbestos detected)

Concrete Blocks May Contain Vermiculite	Suspect	Good	Proactive ACM Removal or Routine Surveillance

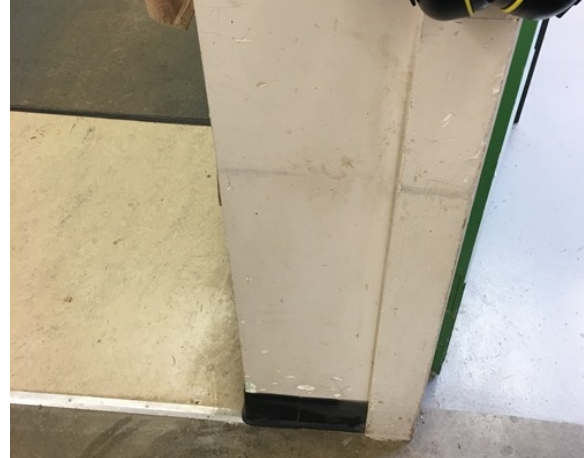
Wood Shop Office "D"

Floor: Sheet Flooring Type9 - Yellow with Brown Streak Pattern

Sample 30639-4 - Sheet Flooring Type 9 (Layer 1) (no asbestos detected)

Sample 30639-4 - Sheet Flooring Type 9 (Layer 2) (no asbestos detected)

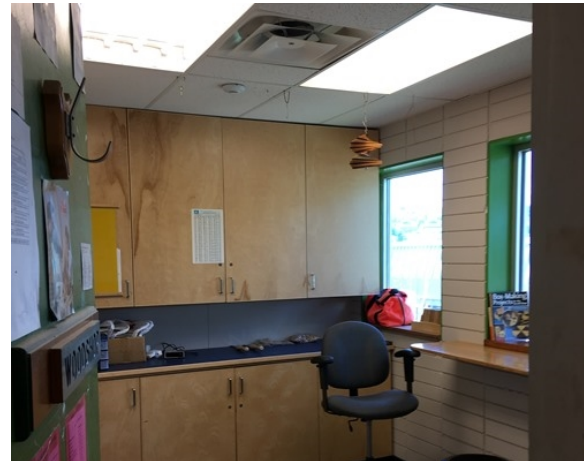
Woodshop

Ceiling: Drywall Joint Compound Type1 - White, Cementitious
 Wall: Drywall Joint Compound Type1 - White, Cementitious, Concrete Blocks May Contain Vermiculite
 Floor: Concrete

Sample 30639-3 - Drywall Joint Compound Type 1 (no asbestos detected)

No Photograph		Concrete Blocks May Contain Vermiculite	Suspect	Good	Proactive ACM Removal or Routine Surveillance

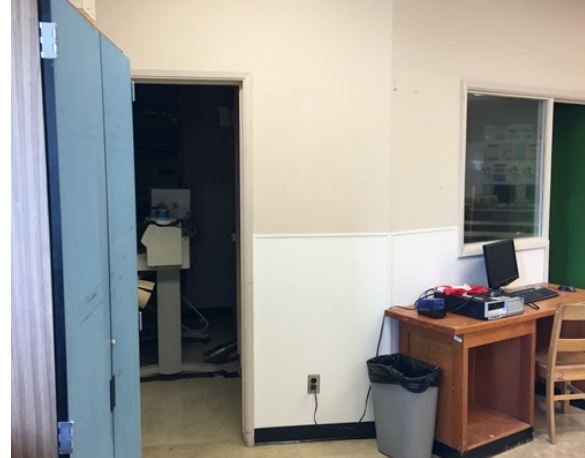
Woodshop Office "A"

Ceiling: Ceiling Tile (Acoustic) Type1 - Patterned Fissure, Ceiling Tile (Acoustic) Type2 - Random Fissure, Large Pinholes

Wall: Concrete Blocks May Contain Vermiculite, Drywall Joint Compound Type1 - White, Cementitious

No Photograph		Concrete Blocks May Contain Vermiculite	Suspect	Good	Proactive ACM Removal or Routine Surveillance
