School District 85 - Vancouver Island North

## Asbestos Inventory and Condition Assessment

**Seaview Carpentry Shop - Port Alice, B.C.**

**NWest Project Number: 30711 V.1.0**

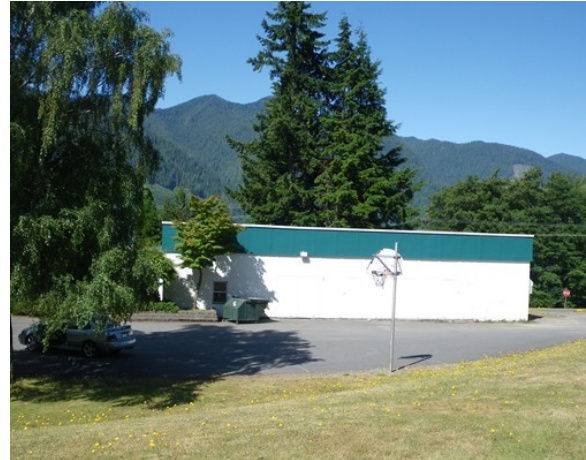
### Exterior

Window: Caulking Type1 - Gray, Caulking Type1 - Gray

Sample 30711-1 - Caulking Type 1 (no asbestos detected)  
Sample 30711-4 - Caulking Type 1 (no asbestos detected)

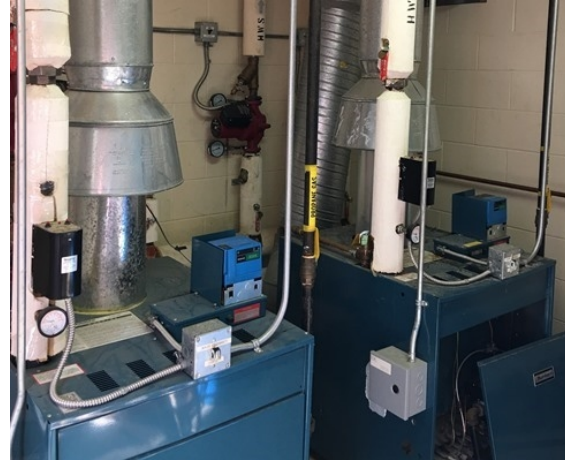
## Boiler Room

Ceiling: Drywall Joint Compound Type1 - White, cementitious  
 Wall: Concrete Block Walls May Contain Vermiculite  
 Floor: Concrete

Drywall Joint Compound Type 1 - White, cementitious	Suspect	Good	Proactive ACM Removal or Routine Surveillance

Concrete Block Walls May Contain Vermiculite	Suspect	Good	Proactive ACM Removal or Routine Surveillance

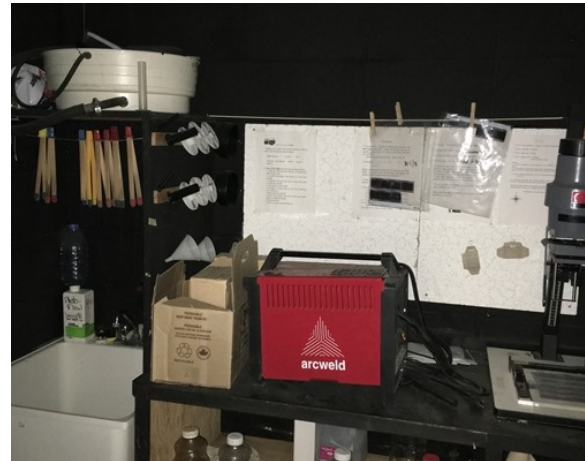
## Dark Room

Ceiling: Drywall Joint Compound Type1 - White, cementitious  
 Wall: Concrete Block Walls May Contain Vermiculite  
 Floor: Concrete  
 Other: Gasket Type1 - Light Gasket, Penetration Insulation Type1 - White, cementitious

Sample 30711-2 - Drywall Joint Compound Type 1 (no asbestos detected)  
 Sample 30711-3 - Penetration Insulation Type 1 (no asbestos detected)

Concrete Block Walls May Contain Vermiculite	Suspect	Good	Proactive ACM Removal or Routine Surveillance

Gasket Type 1 - Light Gasket	Suspect	Good	Proactive ACM Removal or Routine Surveillance

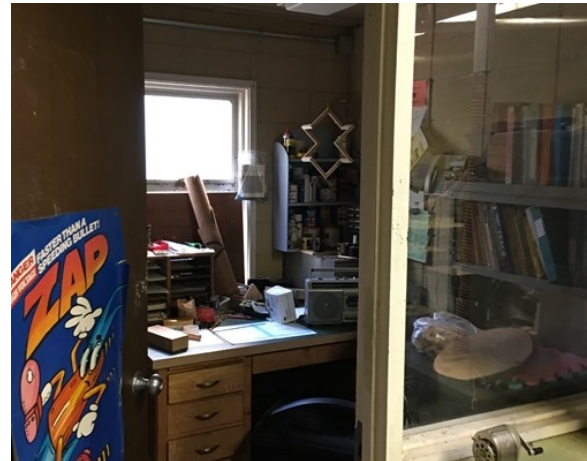
**Office**

Ceiling: Wood  
 Floor: Concrete  
 Other: Concrete Block Walls May Contain Vermiculite

Concrete Block Walls May Contain Vermiculite	Suspect	Good	Proactive ACM Removal or Routine Surveillance

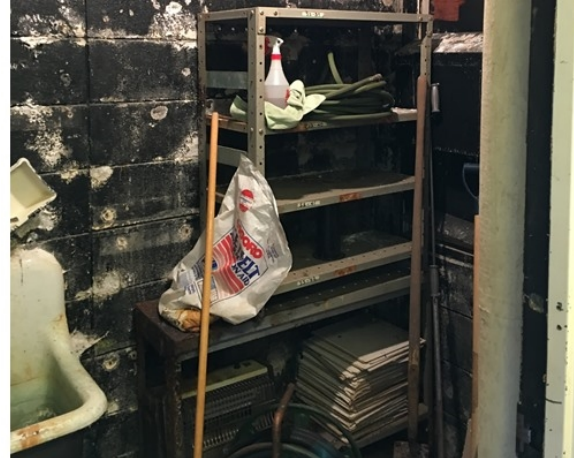
## Storage Room

Ceiling: Wood  
 Wall: Concrete Block Walls May Contain Vermiculite  
 Floor: Concrete  
 Other: Pipe Insulation Type1 - Fibreglass

Concrete Block Walls May Contain Vermiculite	Suspect	Good	Proactive ACM Removal or Routine Surveillance

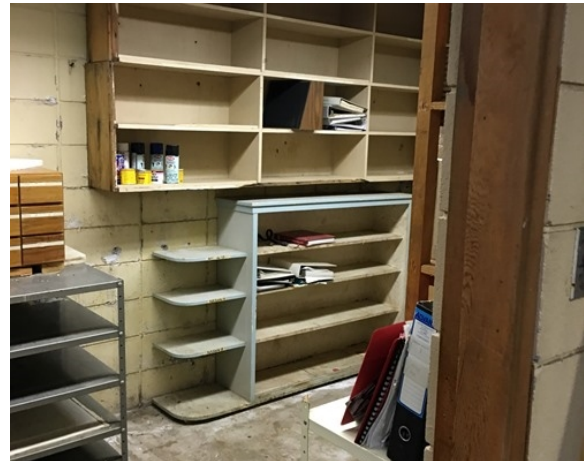
## Storage Room "B"

Ceiling: Wood  
 Wall: Concrete Block Walls May Contain Vermiculite  
 Floor: Concrete

Concrete Block Walls May Contain Vermiculite	Suspect	Good	Proactive ACM Removal or Routine Surveillance

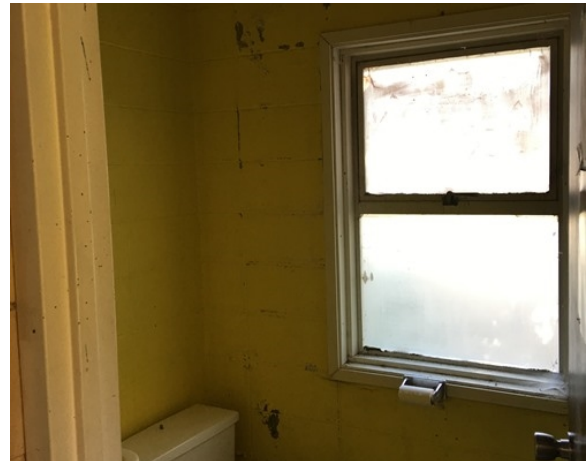
## Washroom

Ceiling: Wood  
 Wall: Concrete Block Walls May Contain Vermiculite  
 Floor: Concrete

Concrete Block Walls May Contain Vermiculite	Suspect	Good	Proactive ACM Removal or Routine Surveillance

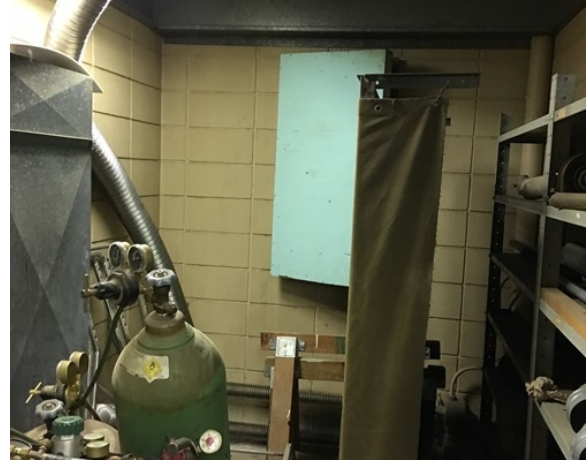
## Welding Room

Ceiling: Metal  
 Wall: Concrete Block Walls May Contain Vermiculite  
 Floor: Concrete

Concrete Block Walls May Contain Vermiculite	Suspect	Good	Proactive ACM Removal or Routine Surveillance

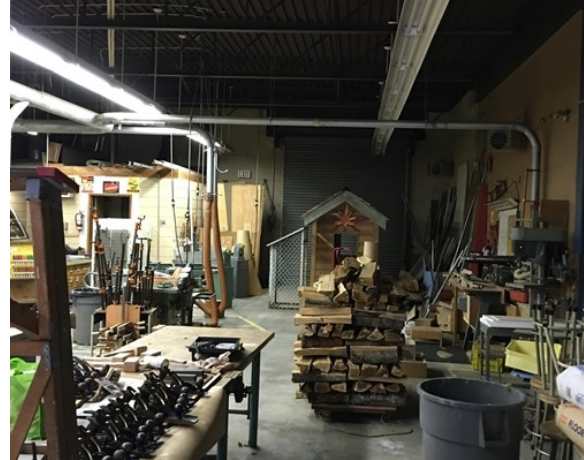
## Work Shop

Ceiling: Metal Q Deck  
 Wall: Concrete Block Walls May Contain Vermiculite  
 Floor: Concrete

Concrete Block Walls May Contain Vermiculite	Suspect	Good	Proactive ACM Removal or Routine Surveillance
