SCHOOL DISTRICT 85  
VANCOUVER ISLAND NORTH

DAYCARE

ASBESTOS SURVEY AND ASSESSMENT

Date: July 2009  
NWEST File: 10586

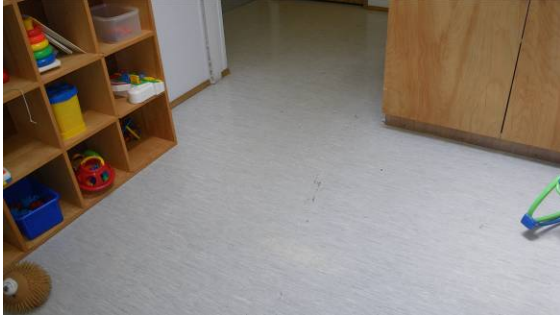
Sample #1: Sheet Flooring  
Site: Throughout Building  
Asbestos: None Detected
