**Prepared for:**  
School District No. 85  
Vancouver Island North

# Asbestos Inventory & Condition Assessment

## Port Hardy Secondary School Portable

Project No. 33310 HMA1 V1.0  
Date Issued: July 24<sup>th</sup>, 2017

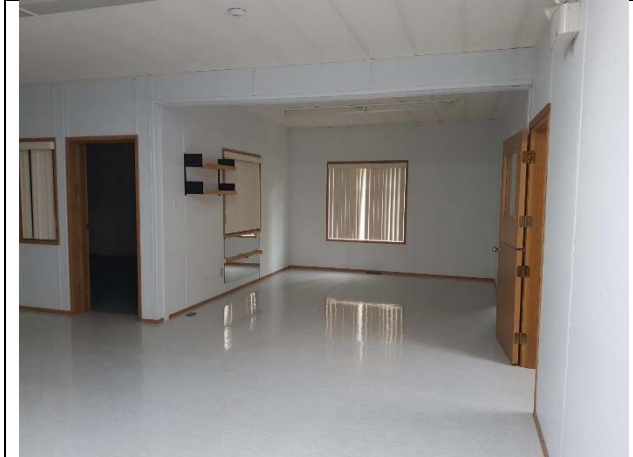
Photo: 33310-1  
Location: Classroom  
Description: Sheet Flooring  
Asbestos: No Asbestos Detected

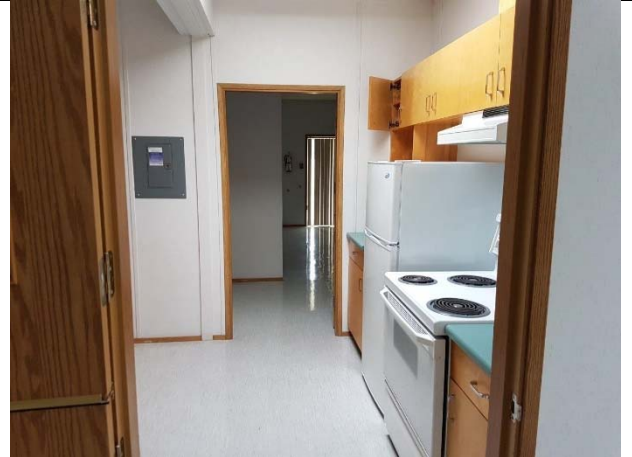
Photo: 33310-2  
Location: Kitchen  
Description: Sheet Flooring  
Asbestos: No Asbestos Detected

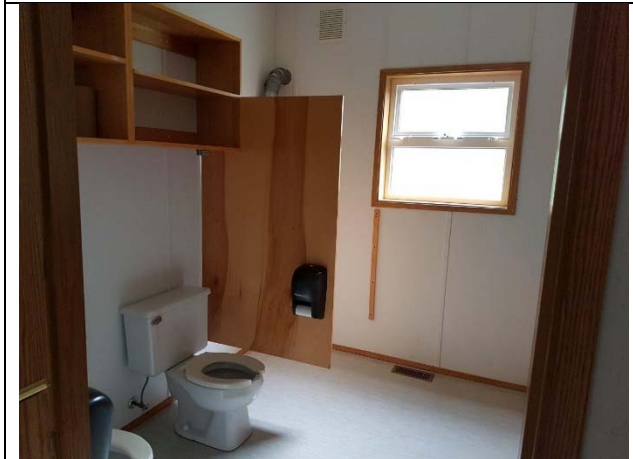
Photo: 33310-3  
Location: Washroom  
Description: Sheet Flooring  
Asbestos: No Asbestos Detected

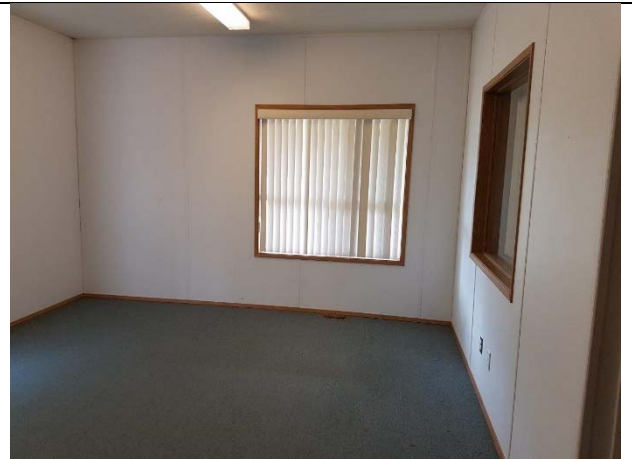
Photo: 33310-4  
Location: Office  
Description: Sheet Flooring may be present  
beneath carpeting  
Asbestos: No Asbestos Detected

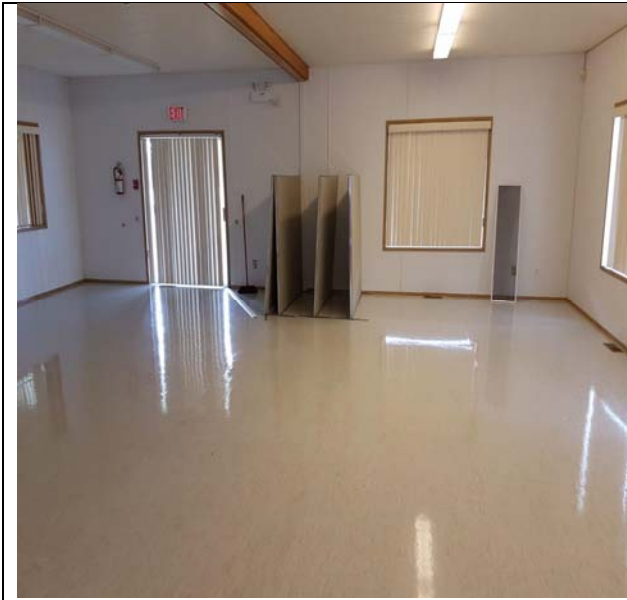
Photo: 33310-5  
Location: Classroom  
Description: Sheet Flooring  
Asbestos: No Asbestos Detected

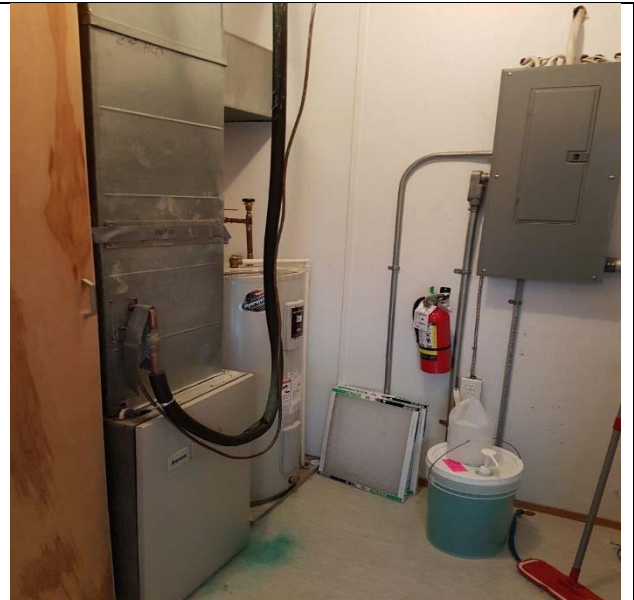
Photo: 33310-6  
Location: Furnace Room  
Description: Sheet Flooring  
Asbestos: No Asbestos Detected

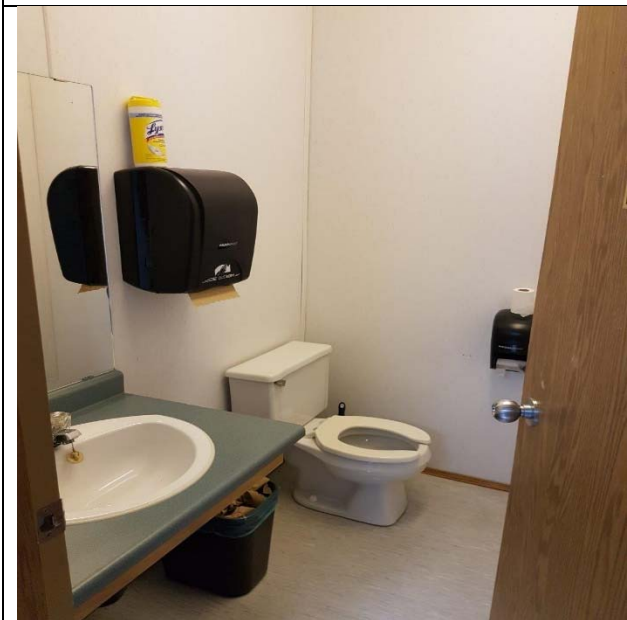
Photo: 33310-7  
Location: Washroom  
Description: Sheet Flooring  
Asbestos: No Asbestos Detected

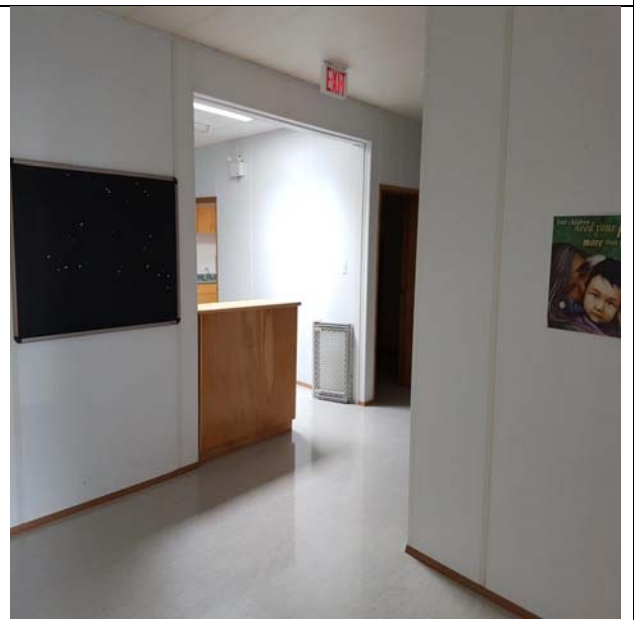
Photo: 33310-8  
Location: Reception  
Description: Sheet Flooring  
Asbestos: No Asbestos Detected
