SCHOOL DISTRICT 85
VANCOUVER ISLAND NORTH

PORT HARDY SECONDARY
SCHOOL

ASBESTOS SURVEY AND ASSESSMENT

Date: July 2009
NWEST File: 10174

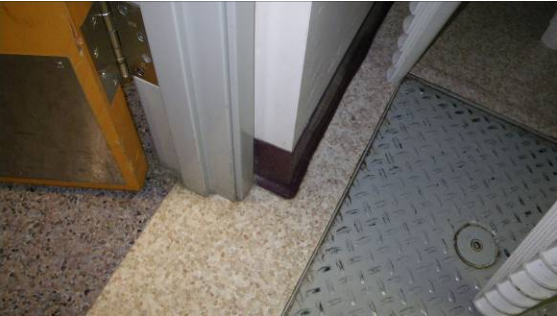
<p>Sample #3: Sheet Flooring Site: Music Room Asbestos: None Detected</p>	<p>Sample #4: Drywall Filler Site: Gym Mezzanine Asbestos: None Detected</p>

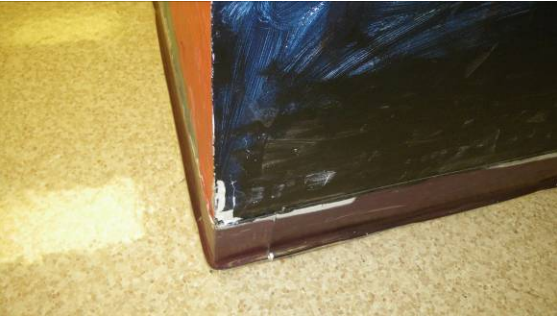
<p>Sample #9: Drywall Filler Site: Drafting Hallway Asbestos: None Detected</p>	<p>Sample #10: Drywall Filler Site: Resource 535 Asbestos: None Detected</p>

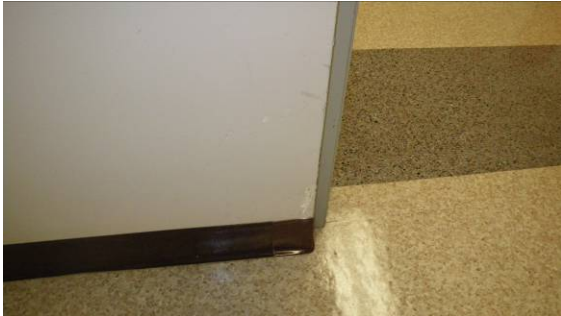
<p>Sample #11: Ceiling Tile Site: Foods 515 Asbestos: None Detected</p>	<p>Sample #12: Drywall Filler Site: Science 330 Asbestos: None Detected</p>

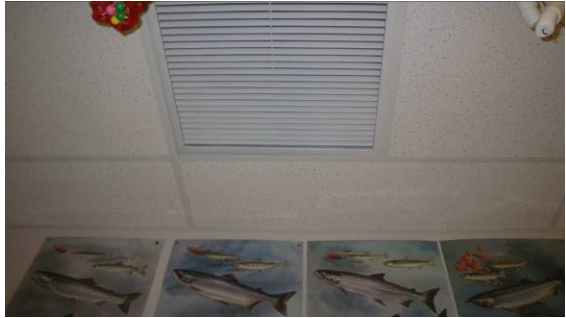
<p>Sample #13: Ceiling Tile Site: Science 330 Asbestos: None Detected</p>	<p>Sample #14: Fumehood Lining Site: Science 350 Asbestos: None Detected</p>

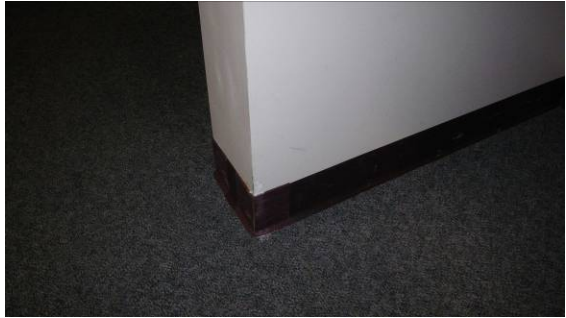
<p>Sample #15: Drywall Filler Site: Library Asbestos: None Detected</p>	<p>Sample #16: Ceiling Tile Site: Library Asbestos: None Detected</p>

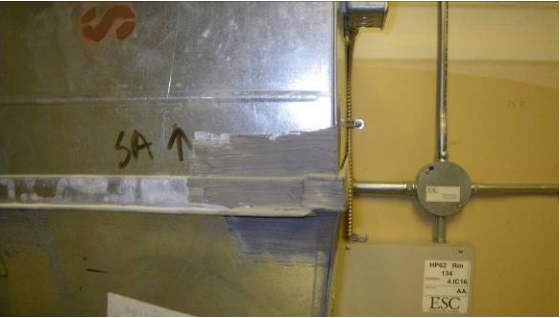
<p>No Photo</p>
<p>Sample #17: Duct Caulking Site: Gym Mezzanine Asbestos: None Detected</p>	<p>Sample #18: Duct Caulking Site: Hall Outside 405 Asbestos: None Detected</p>

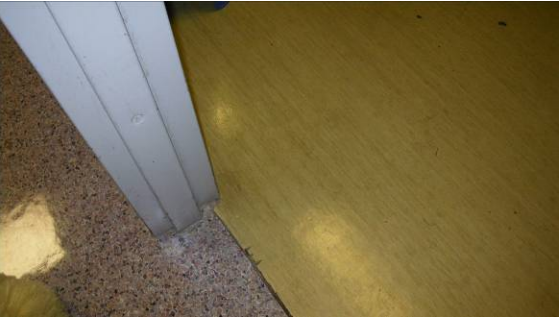
<p>Sample #19: Sheet Flooring Site: Janitor Room Asbestos: None Detected</p>	<p>Sample #20: Sheet Flooring Site: Hallway Outside 300 Asbestos: None Detected</p>

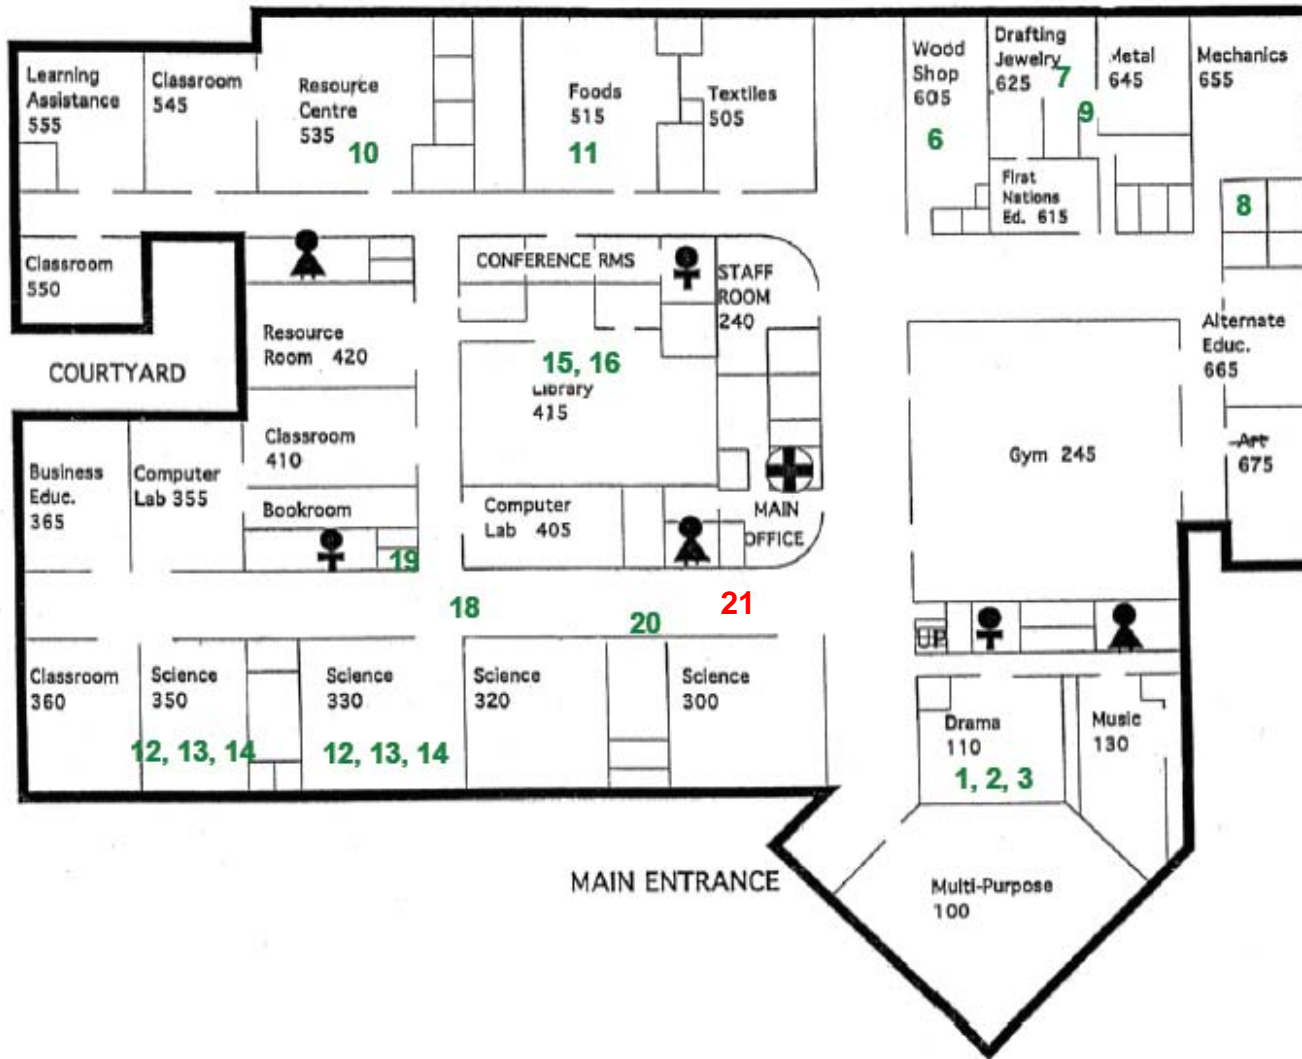
Port Hardy Senior Secondary School

Asbestos-containing cement piping has been identified in the building. This material is not accessible and is unlikely to be disturbed during routine building activities. If this material does not need to be disturbed as part of any renovation or demolition activities it may be managed in place. If the materials will be disturbed by such activities it must be removed prior to the start of any renovation or demolition activity.

Note that concrete blocks may be filled with Asbestos containing Vermiculite.

Asbestos cement piping is unlikely to be damaged during routine building activities. This product can be included in the Asbestos Management Plan and managed in place.
