SCHOOL DISTRICT 85  
VANCOUVER ISLAND NORTH

**ROBERT SCOTT ELEMENTARY**  
ASBESTOS SURVEY AND ASSESSMENT

Date: July 2009  
NWEST File: 10573

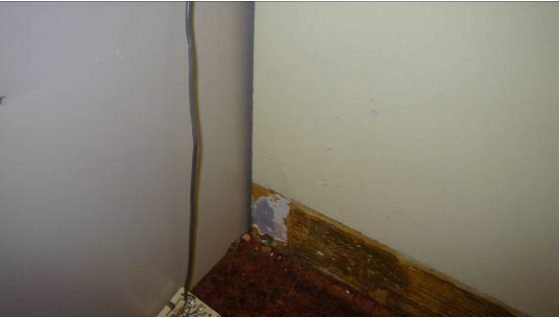
<p>Sample #3: Drywall Filler            Site: Staff Room            Asbestos: Chrysotile</p>	<p>Sample #4: Drywall Filler            Site: Library            Asbestos: Chrysotile</p>

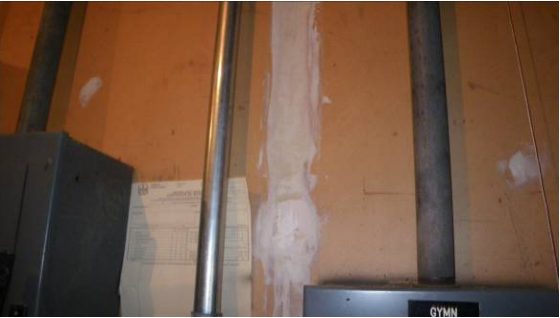
<p>Sample #5: Drywall Filler            Site: Room 8            Asbestos: Chrysotile</p>	<p>Sample #6: Drywall Filler            Site: Room 10            Asbestos: Chrysotile</p>
