SCHOOL DISTRICT 85  
VANCOUVER ISLAND NORTH

**DISTRICT BOARD OFFICE**  
ASBESTOS SURVEY AND ASSESSMENT

Date: July 2009  
NWEST File: 10576

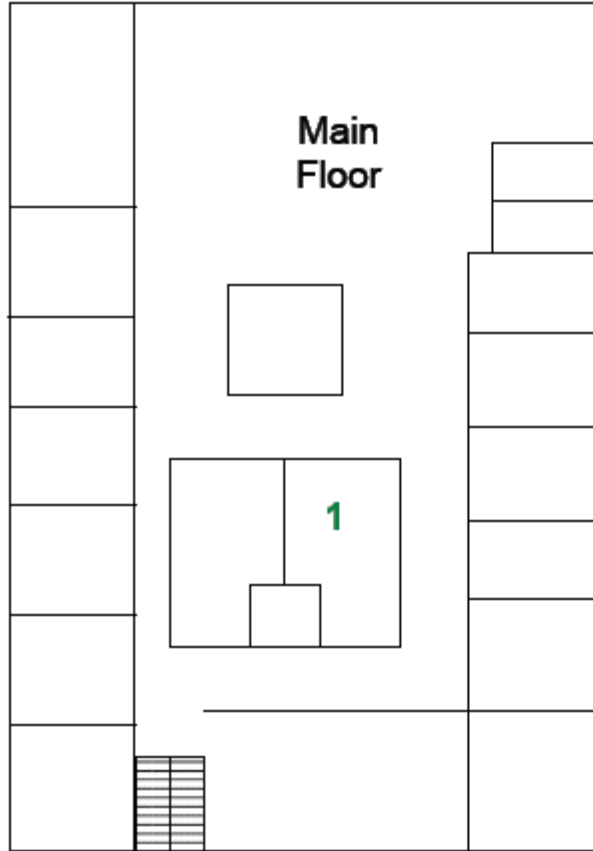
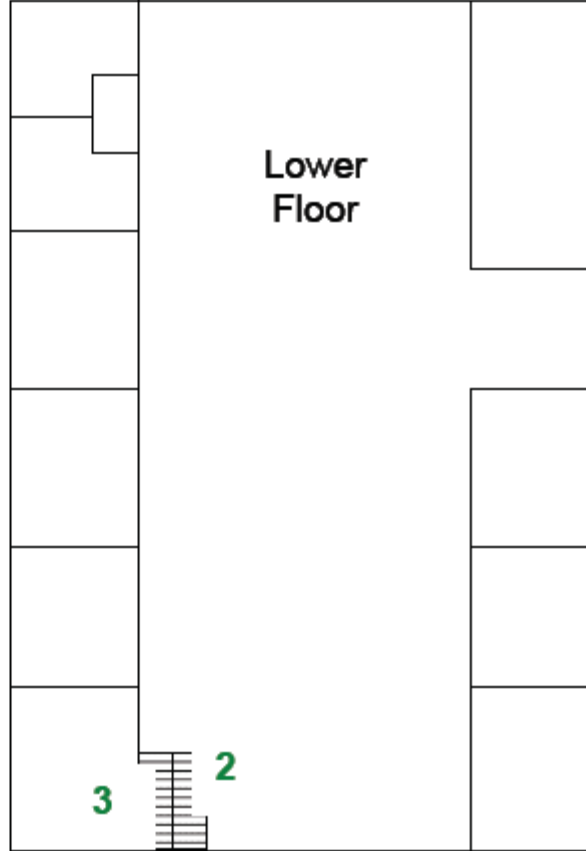
**School Board Offices**

1 Non Asbestos containing sample location

\*NOTE: Concrete block walls may be filled with Asbestos containing Vermiculite
