SCHOOL DISTRICT 85
VANCOUVER ISLAND NORTH

SUNSET ELEMENTARY
ASBESTOS SURVEY AND ASSESSMENT

Date: July 2009
NWEST File: 10561

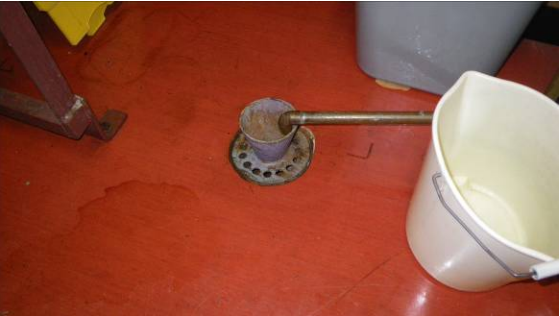
<p>Sample #1: Drywall Filler Site: Janitor Room Asbestos: None Detected</p>	<p>Sample #2: Pipe Elbow Site: Janitor Room Asbestos: None Detected</p>

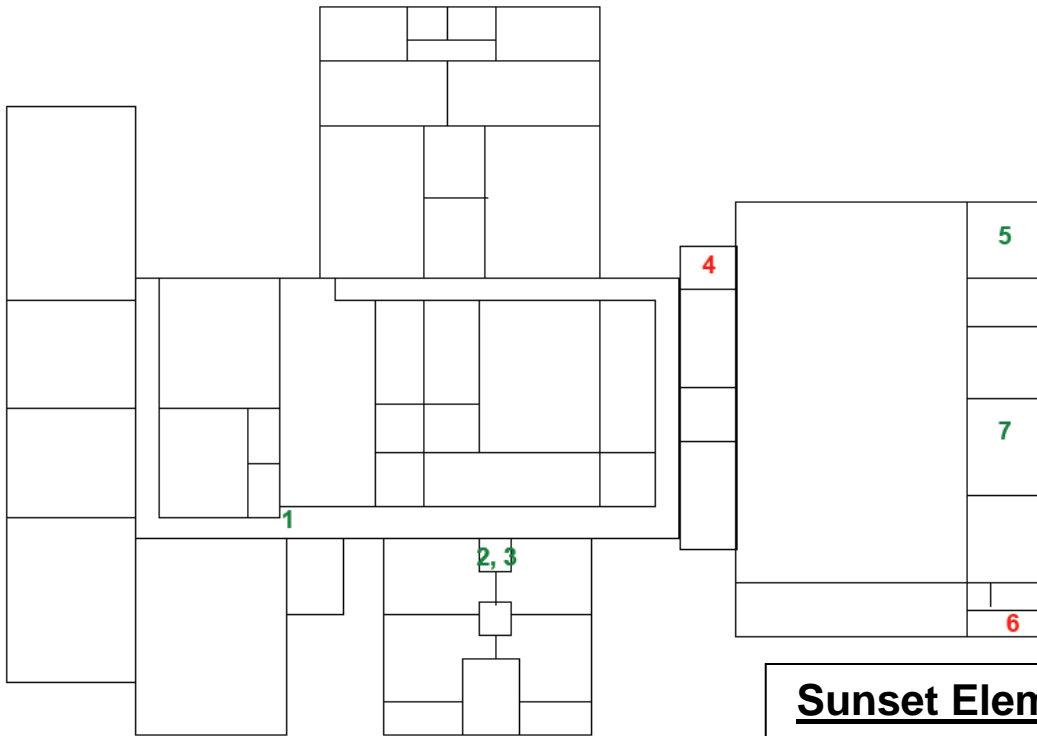
Sunset Elementary School

*NOTE: Concrete block walls may be filled with Asbestos containing Vermiculite
