SCHOOL DISTRICT 85  
VANCOUVER ISLAND NORTH

OLD PORT ALICE SECONDARY  
SCHOOL

ASBESTOS SURVEY AND ASSESSMENT

Date: July 2009  
NWEST File: 10567

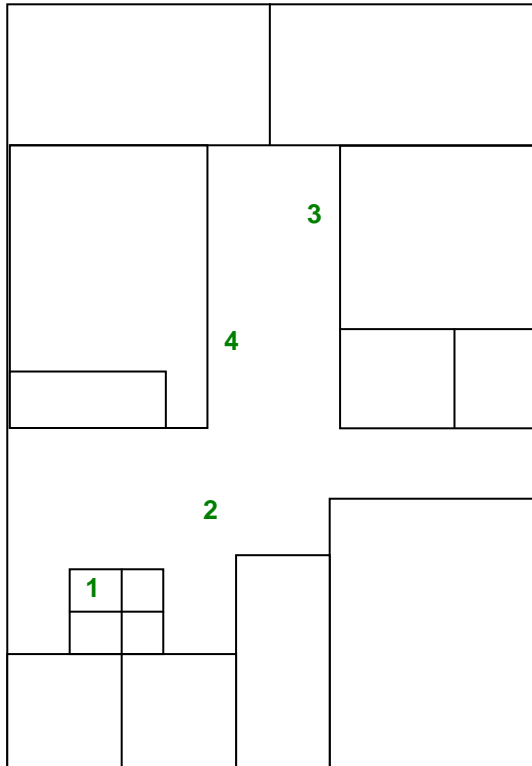
## **Old Port Alice Secondary School**

**1** Non Asbestos containing sample location

Note that concrete blocks may be filled with Asbestos containing Vermiculite
