SCHOOL DISTRICT 85
VANCOUVER ISLAND NORTH

SEA VIEW ELEMENTARY
ASBESTOS SURVEY AND ASSESSMENT

Date: July 2009
NWEST File: 10565

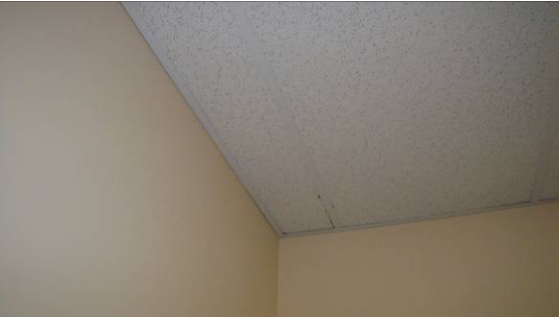
<p>Sample #5: Duct Caulking Site: Room 2 Asbestos: None Detected</p>	<p>Sample 6#: Ceiling Tile Site: Room 2 Asbestos: None Detected</p>

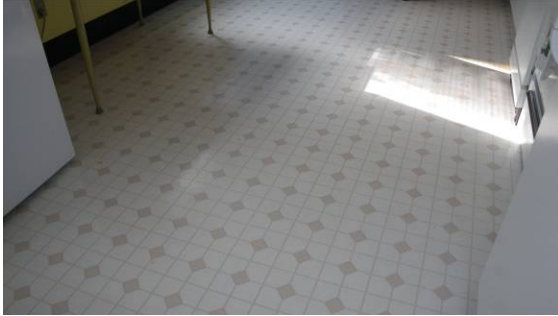
<p>Sample #7: Ceiling Tile Site: Office Asbestos: None Detected</p>	<p>Sample #: 8 Floor Tile Site: Janitor Room Asbestos: Chrysotile Asbestos</p>

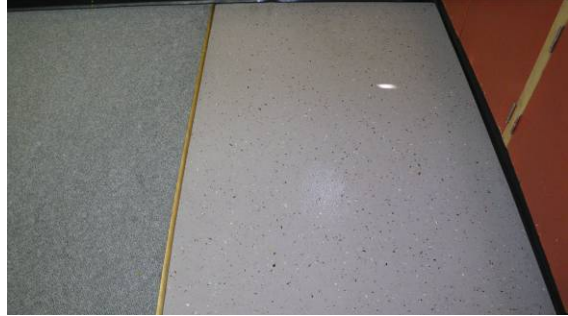
Asbestos containing floor tiles have been identified in the building. These are in the Janitor Room, but are likely present in other locations (under carpets or other flooring materials). Floor tiles are considered non-friable and are unlikely to be damaged during routine building activities.

Asbestos containing drywall filler compounds and floor tiles are in generally good condition and are unlikely to be damaged during routine building activities. These products can be included in the Asbestos Management Plan and managed in place.
