SCHOOL DISTRICT 85
VANCOUVER ISLAND NORTH

SEA VIEW SECONDARY
ASBESTOS SURVEY AND ASSESSMENT

Date: July 2009
NWEST File: 10566

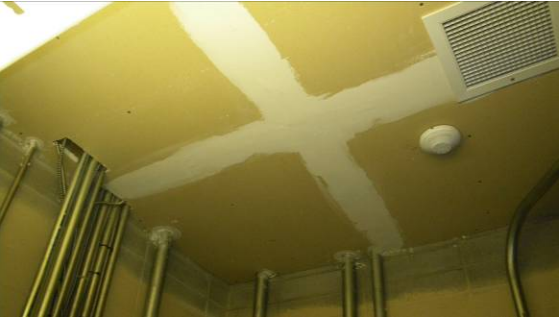
| <p>Sample #1: Drywall Filler Site: Electrical Room Asbestos: None Detected</p> | <p>Sample #2: Drywall Filler Site: Room 2 Asbestos: None Detected</p> |

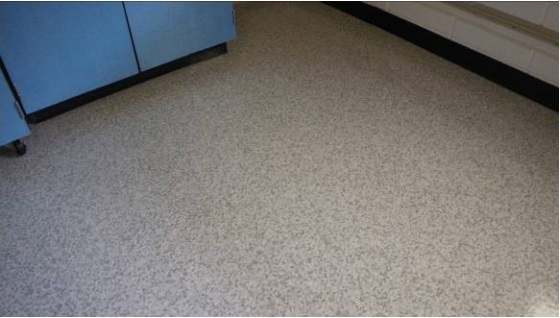
| <p>Sample #3: Sheet Flooring Site: Room 1 Asbestos: None Detected</p> | <p>Sample #4 & 5: Sheet Flooring Site: Room 2 Asbestos: Chrysotile – Bottom Layer Only</p> |

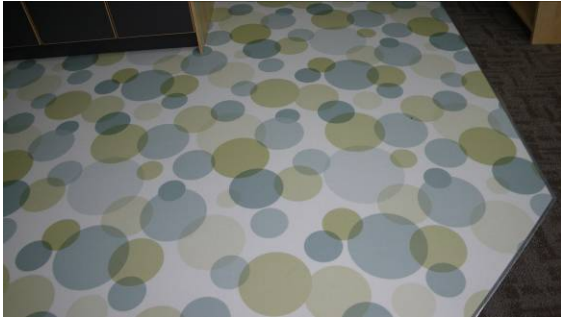
Asbestos backed sheet flooring is present in Room 2. This product is underneath another layer of non-asbestos sheet flooring. The paper backing is unlikely to be damaged during routine building activities.

Asbestos containing sheet floor backing and floor tiles are unlikely to be damaged during routine building activities. These products can be included in the Asbestos Management Plan and managed in place.

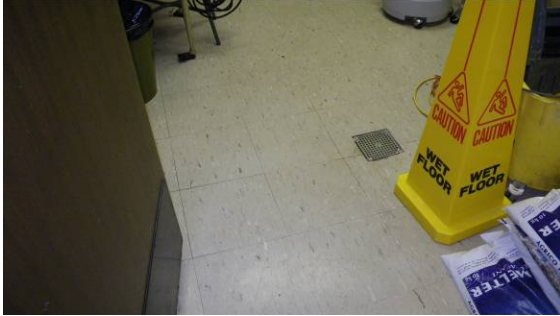
Asbestos containing floor tiles are present in the Band/Gym Hallway. They were not observed in other locations. Floor tiles are considered non-friable and are unlikely to be damaged during routine building activities.

Sample #6: Floor Tile
Site: Band/Gym Hallway
Asbestos: Chrysotile

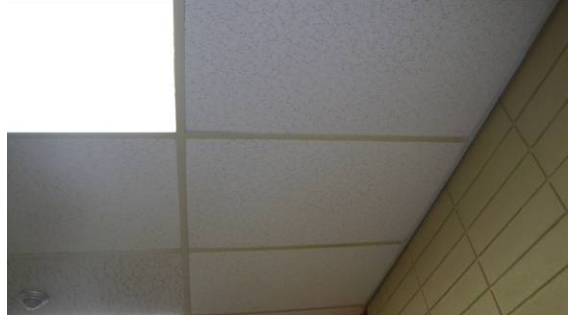
Sample #7: Ceiling Tile
Site: Corridor
Asbestos: None Detected
