School District 85 - Vancouver Island North

Asbestos Inventory and Condition Assessment

Seaview Secondary School - 1120 Nigei St, Port Alice, BC V0N 2N0

NWest Project Number: 30012 V.1.0

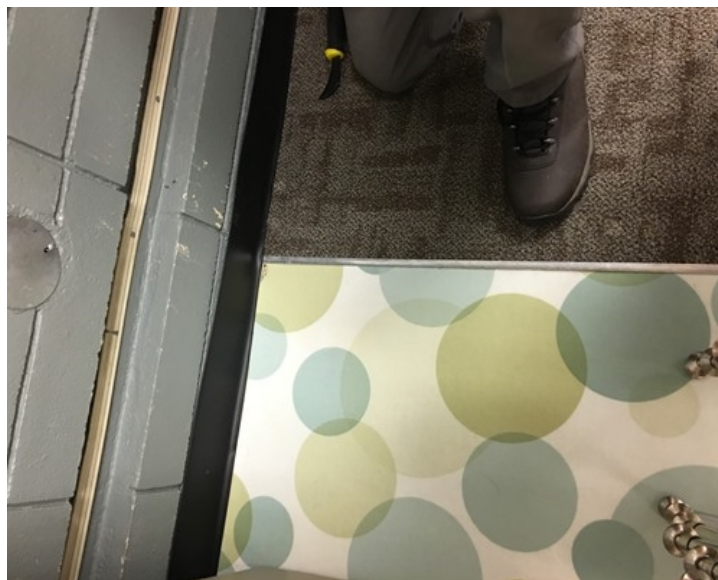
Sheet Flooring - Flooring below with Circles Pattern
(contains 15% Chrysotile asbestos)

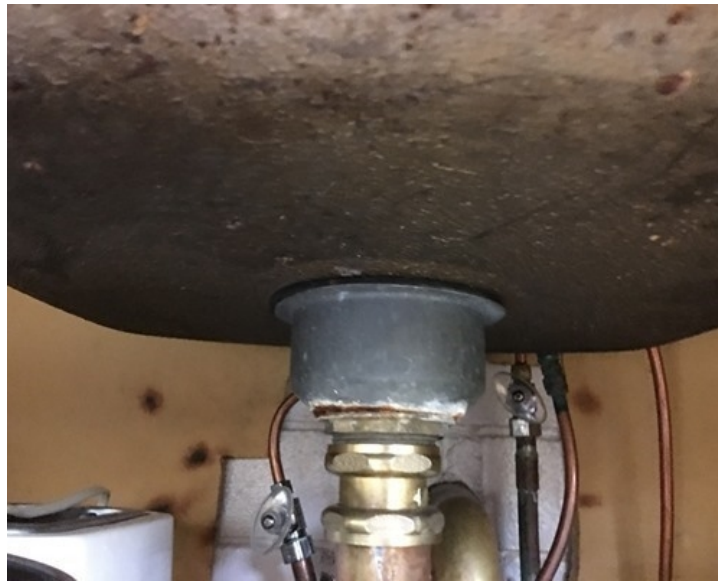
Mastic - Black/Brown on Sink
(contains 3.2% Chrysotile asbestos)

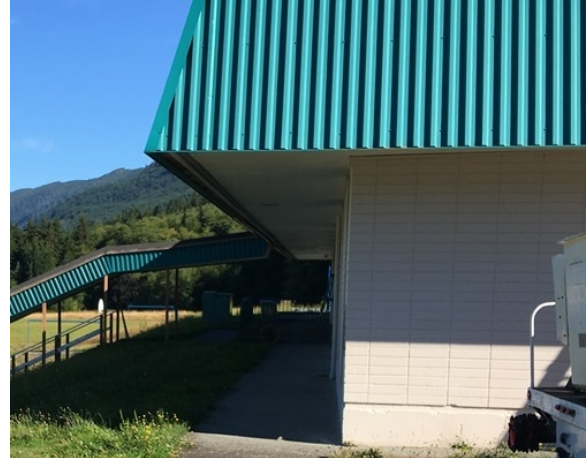
Exterior

Wall: Concrete Block Walls May Contain Vermiculite, Door Panels may contain asbestos
 Window: Caulking Type3 - Black/Gray
 Roof: Roofing Type1 - Torch On Membrane

Sample 30012-4 - Caulking Type 3 (no asbestos detected)

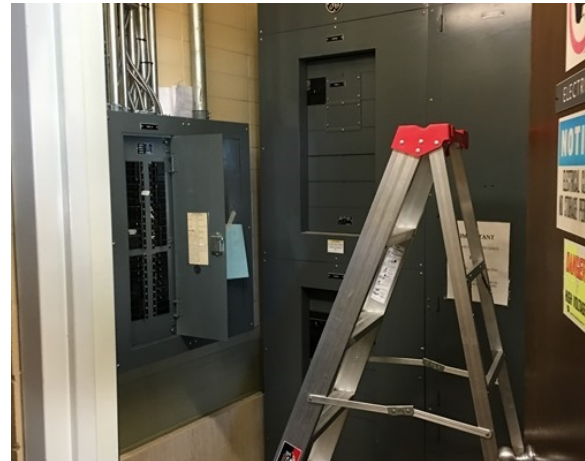
- Ceiling: Drywall Joint Compound Type1 - Cementitious, White
- Wall: Concrete Block Walls May Contain Vermiculite, Drywall Joint Compound Type1 - Cementitious, White
- Floor: Floor Tile Type1 - 12" x 12" Beige with White/Black Smears
- Other: Caulking Type1 - Electrical Penetration

- Sample 30012-11 - Caulking Type 1 (no asbestos detected)
- Sample 30012-12 - Drywall Joint Compound Type 1 (no asbestos detected)

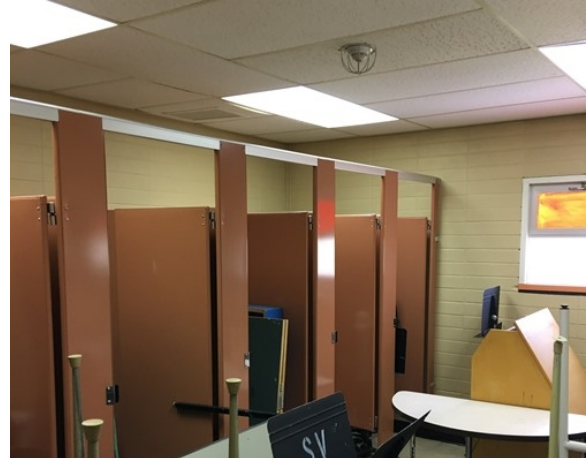
Ceiling: Ceiling Tile (Acoustic) Type1 - Patterned Fissure, Ceiling Tile (Acoustic) Type3 - Vertical Fissure Small and Large Pinholes

Wall: Concrete Block Walls May Contain Vermiculite

Floor: Floor Tile Type1 - 12" x 12" Beige with White/Black Smears

Sample 30012-10 - Floor Tile Type 1 (no asbestos detected)

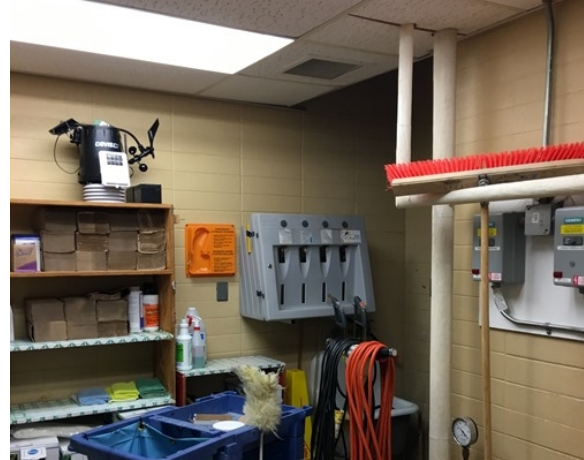
Ceiling: Ceiling Tile (Acoustic) Type1 - Patterned Fissure, Ceiling Tile (Acoustic) Type3 - Vertical Fissure Small and Large Pinholes
 Wall: Concrete Block Walls May Contain Vermiculite
 Floor: Floor Tile Type1 - 12" x 12" Beige with White/Black Smears
 Other: Pipe Insulation Type1 - Fibreglass

Floor Tile Type 1 - 12" x 12" Beige with White/Black Smears	Confirmed (Visually)	Fair	Proactive ACM Removal or ACM Repair

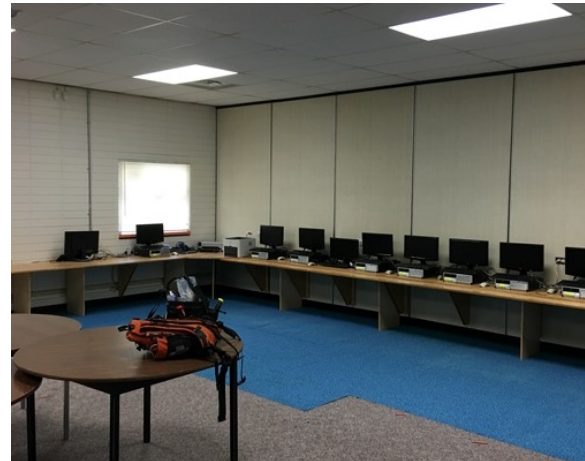
Ceiling:	Ceiling Tile (Acoustic) Type1 - Patterned Fissure, Ceiling Tile (Acoustic) Type3 - Vertical Fissure Small and Large Pinholes
Wall:	Concrete Block Walls May Contain Vermiculite, Drywall Type1 - No Drywall Joint Compound Observed
Floor:	Sheet Flooring Type1 - Mosaic Pattern - Gray, Carpet
Other:	Mastic Type1 - Black/Brown on Sink

Sample 30012-1 - Ceiling Tile (Acoustic) Type 1 (no asbestos detected)

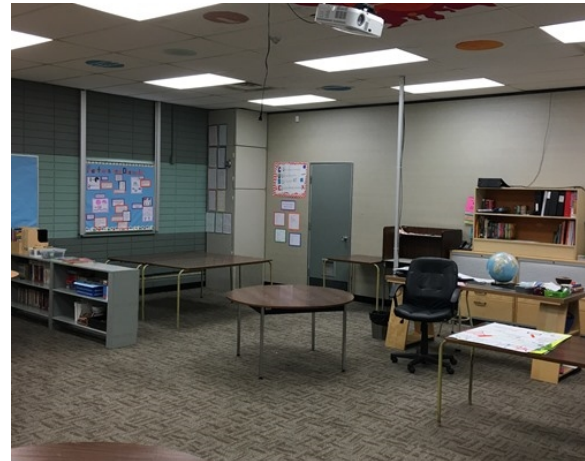
Ceiling: Ceiling Tile (Acoustic) Type1 - Patterned Fissure, Ceiling Tile (Acoustic) Type3 - Vertical Fissure Small and Large Pinholes

Wall: Concrete Block Walls May Contain Vermiculite, Drywall Type1 - No Drywall Joint Compound Observed

Floor: Sheet Flooring Type2 - Circles Pattern, Carpet, Sheet Flooring Type3 - Flooring below with Circles Pattern

Sample 30012-6 - Sheet Flooring Type 2 (no asbestos detected)

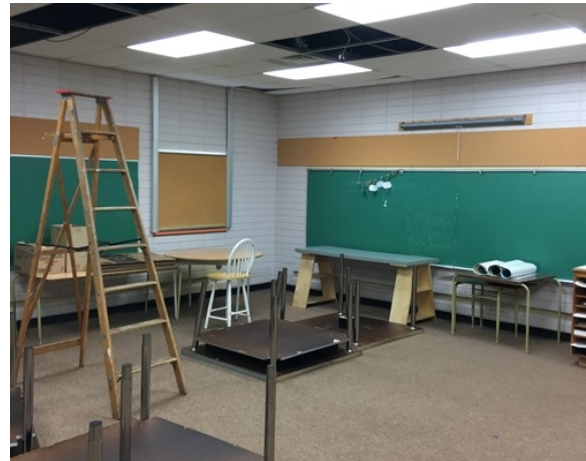
Ceiling: Ceiling Tile (Acoustic) Type1 - Patterned Fissure, Ceiling Tile (Acoustic) Type3 - Vertical Fissure Small and Large Pinholes, Q-Deck

Wall: Concrete Block Walls May Contain Vermiculite, Drywall Type1 - No Drywall Joint Compound Observed

Floor: Carpet, Adhesive Type1 - White Cementitious

Ducting: Caulking Type2 - Grey

Sample 30012-2 - Ceiling Tile (Acoustic) Type 3 (no asbestos detected)
