## Asbestos Inventory and Condition Assessment

**TACAN Maintenance Offices and Shop - 6150 Brass Rd, Port Hardy, B.C. V0N 2P0**

**NWest Project Number: 30014 V.1.0**

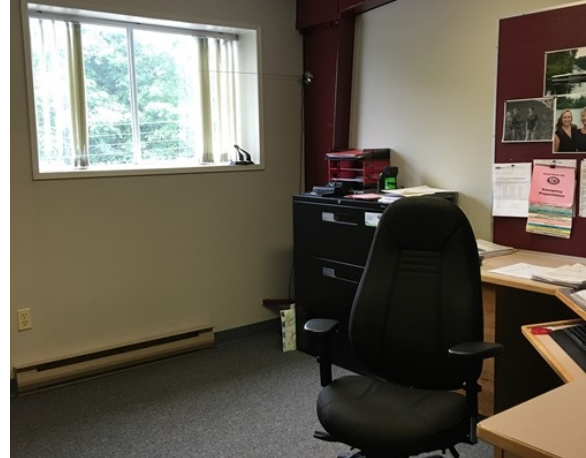
## 2nd Floor-Administrative Assistant

Ceiling: Ceiling Tile (Acoustic) Type1 - Vertical Fissure and Pinholes, Ceiling Tile (Acoustic) Type2 - Patterned Fissure  
Wall: Drywall Joint Compound Type1 - Drywall Joint Compound  
Floor: Carpet

Sample 30014-10 - Ceiling Tile (Acoustic) Type 2 (no asbestos detected)

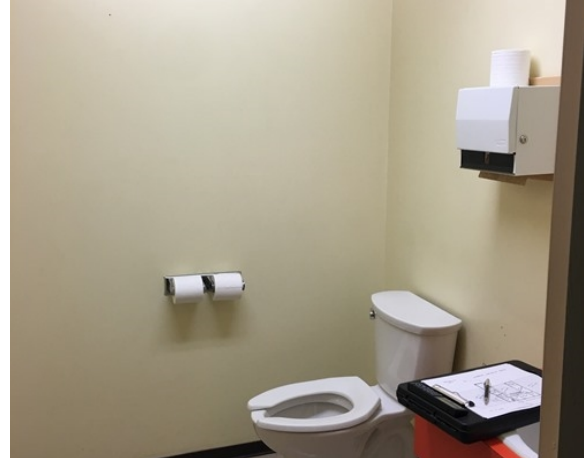
## 2nd Floor-Boys Washroom

Ceiling:	Ceiling Tile (Acoustic) Type1 - Vertical Fissure and Pinholes
Wall:	Drywall Joint Compound Type1 - Drywall Joint Compound
Floor:	Floor Tile Type1 - 12" x 12" Beige with White Streaks

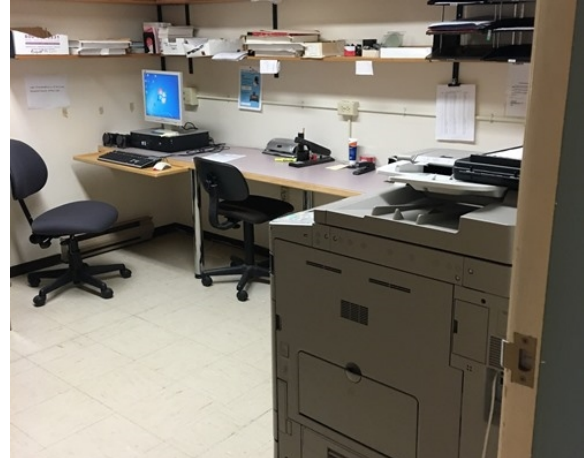
## 2nd Floor-Copier Room

Ceiling:	Ceiling Tile (Acoustic) Type1 - Vertical Fissure and Pinholes
Wall:	Drywall Joint Compound Type1 - Drywall Joint Compound
Floor:	Floor Tile Type1 - 12" x 12" Beige with White Streaks

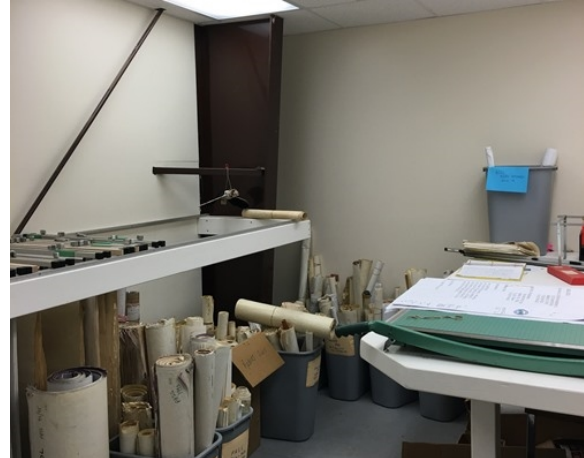
## 2nd Floor-Drafting Area

Ceiling:	Ceiling Tile (Acoustic) Type2 - Patterned Fissure
Wall:	Foil Face Fibreglass Insulation, Drywall Joint Compound Type1 - Drywall Joint Compound
Floor:	Floor Tile Type1 - 12" x 12" Beige with White Streaks

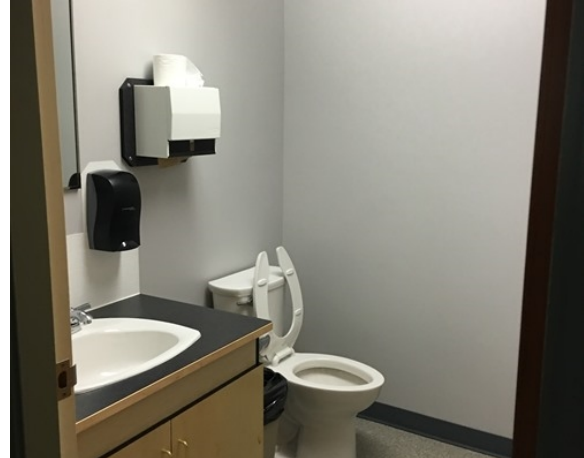
## 2nd Floor-Girls Washroom

Ceiling:	Ceiling Tile (Acoustic) Type1 - Vertical Fissure and Pinholes
Wall:	Drywall Joint Compound Type1 - Drywall Joint Compound
Floor:	Sheet Flooring Type1 - Grey with White and Black Specks

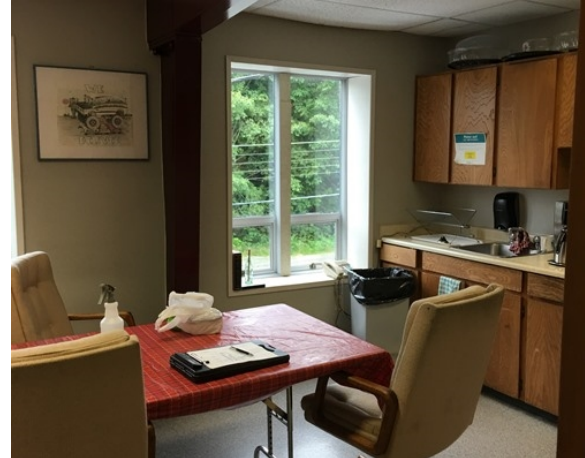
## 2nd Floor-Lunch Room

Ceiling: Ceiling Tile (Acoustic) Type1 - Vertical Fissure and Pinholes  
 Wall: Drywall Joint Compound Type1 - Drywall Joint Compound  
 Floor: Sheet Flooring Type1 - Grey with White and Black Specks  
 Other: Sink Acoustical Insulation

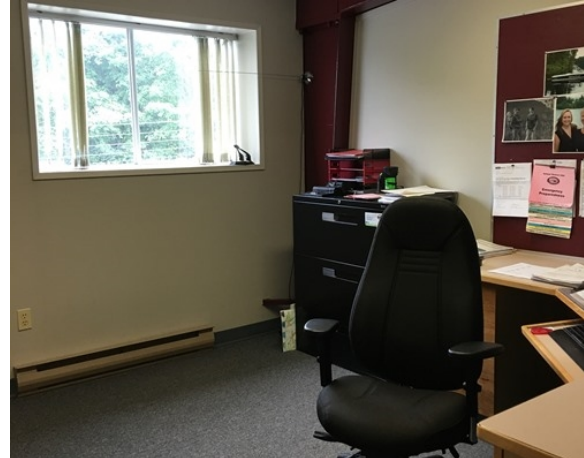
## 2nd Floor-Manager's Office

Ceiling:	Ceiling Tile (Acoustic) Type1 - Vertical Fissure and Pinholes
Wall:	Drywall Joint Compound Type1 - Drywall Joint Compound
Floor:	Carpet

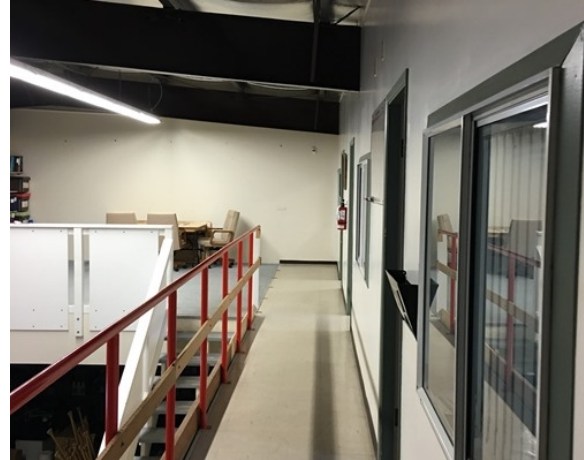
## 2nd Floor-Mezzanine Hallway

Ceiling:	Ceiling Tile (Acoustic) Type1 - Vertical Fissure and Pinholes
Wall:	Drywall Joint Compound Type1 - Drywall Joint Compound
Floor:	Floor Tile Type1 - 12" x 12" Beige with White Streaks , Material Under FT1

Sample 30014-3 - Material Under FT1 Type 1 (no asbestos detected)

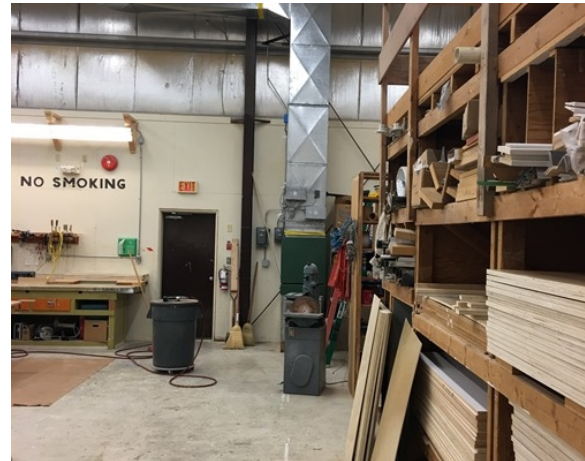
## Carpentry Shop

Ceiling:	Foil Face Fibreglass Insulation
Wall:	Wood, Drywall Joint Compound Type1 - Drywall Joint Compound
Floor:	Concrete
Ducting:	Vinyl Dampeners, no Duct Caulking observed

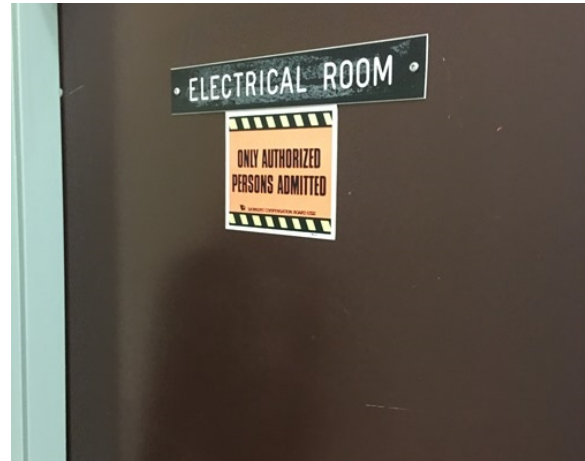
## Electrical Room

Ceiling: Ceiling Tile (Acoustic) Type1 - Vertical Fissure and Pinholes  
 Wall: Wood, Drywall Joint Compound Type1 - Drywall Joint Compound  
 Floor: Concrete  
 Other: Chair Present-Seat may contain asbestos

Sample 30014-4 - Ceiling Tile (Acoustic) Type 1 (no asbestos detected)  
 Sample 30014-9 - Drywall Joint Compound Type 1 (no asbestos detected)

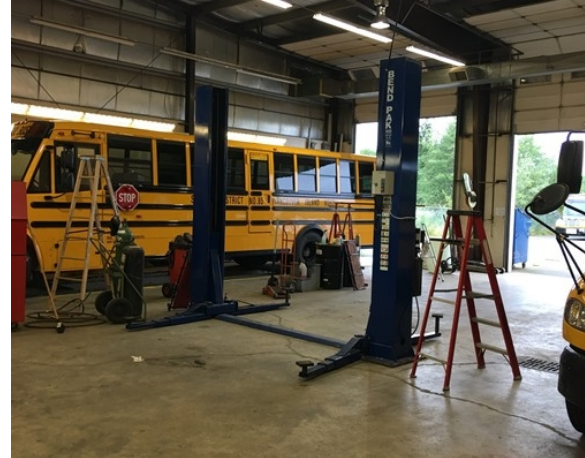
## Garage

Ceiling: Foil Face Fibreglass Insulation  
 Wall: Concrete Block Walls May Contain Asbestos, Drywall Joint Compound Type1 - Drywall Joint Compound  
 Floor: Concrete  
 Ducting: Vinyl Dampeners, no Duct Caulking observed

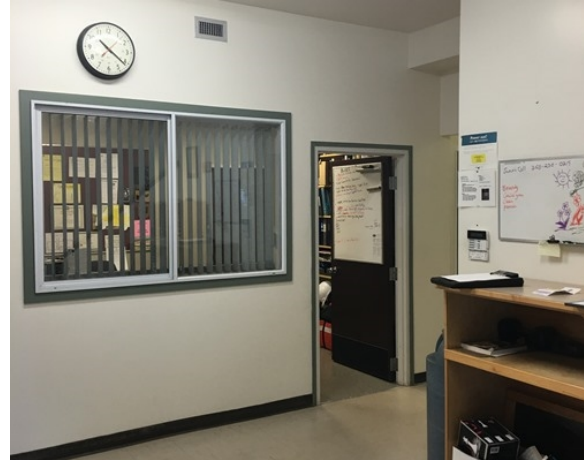
## Office A

Ceiling:	Ceiling Tile (Acoustic) Type1 - Vertical Fissure and Pinholes
Wall:	Drywall Joint Compound Type1 - Drywall Joint Compound
Floor:	Sheet Flooring Type1 - Grey with White and Black Specks

- Sample 30014-5 - Sheet Flooring Type 1 (Layer 1) (no asbestos detected)
- Sample 30014-5 - Sheet Flooring Type 1 (Layer 2) (no asbestos detected)

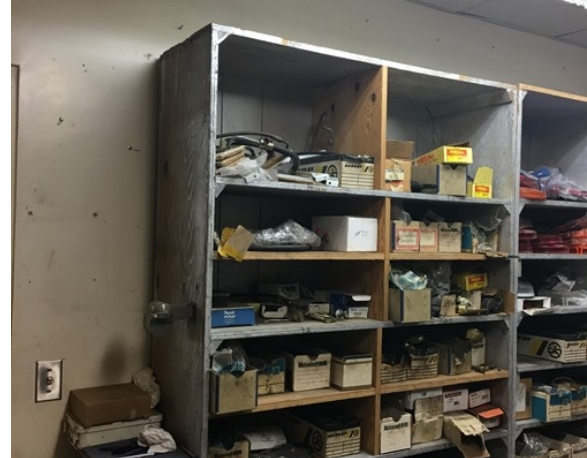
## Part Storage

Ceiling: Ceiling Tile (Acoustic) Type1 - Vertical Fissure and Pinholes  
 Wall: Concrete Block Walls May Contain Asbestos, Drywall Joint Compound Type1 - Drywall Joint Compound  
 Floor: Concrete  
 Other: Gasket Type1 - Stores

Sample 30014-1 - Gasket Type 1 (no asbestos detected)
