School District 85 - Vancouver Island North

Asbestos Inventory and Condition Assessment

ATCO Double Wide Trailer - 6150 Brass Rd, Port Hardy, B.C. V0N 2P0

NWest Project Number: 30014 V.1.0

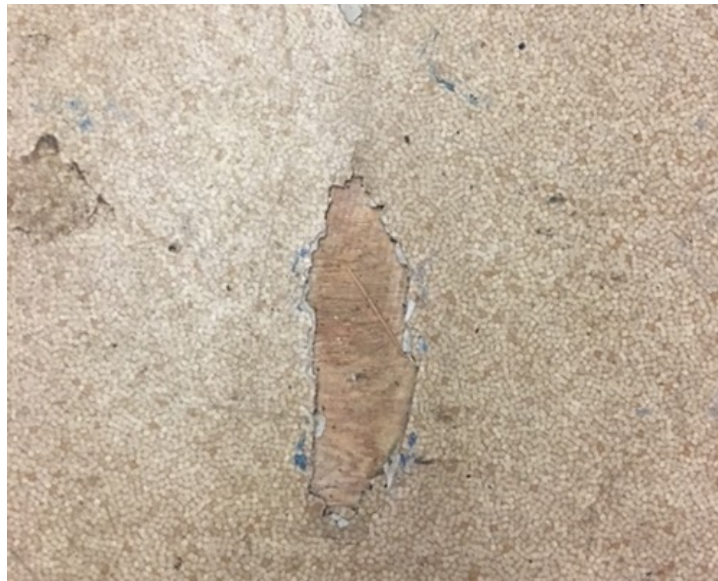
Sheet Flooring - SF2-Small Beige Mosaic
(contains 30% Chrysotile asbestos)

Damaged floor sheeting can be either enclosed or removed following work procedures satisfactory to WorkSafeBC.

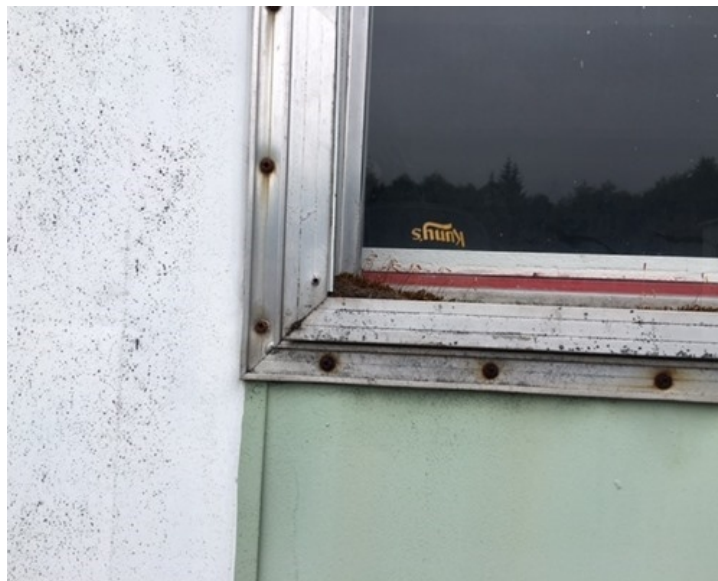
Caulking - Off White
(contains 15% Chrysotile asbestos)

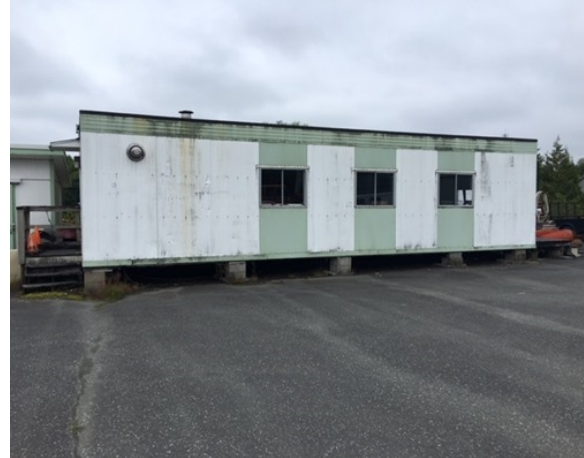
Exterior

Window: Caulking Type2 - Off White
 Roof: Roofing Type1 - Asphalt

Visually Similar to 30014-15	Caulking Type 2 - Off White	Confirmed (Visually)	Fair	Proactive ACM Removal or ACM Repair

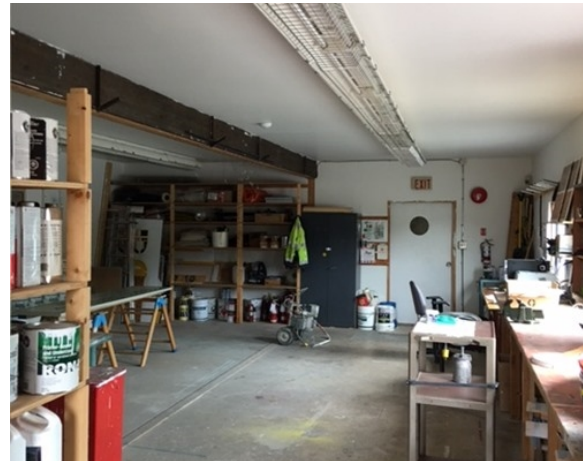
Main Room

30014-14	Sheet Flooring Type 1 - SF2-Small Beige Mosaic	Confirmed	Poor	ACM Removal Required for Compliance

30014-15	Caulking Type 2 - Off White	Confirmed	Fair	Proactive ACM Removal or ACM Repair

Damaged floor sheeting can be either enclosed or removed following work procedures satisfactory to WorkSafeBC.

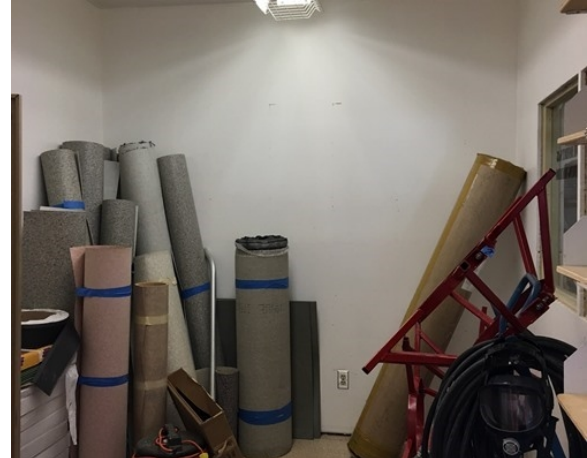
Storage Room

Visually Similar to 30014-14	Sheet Flooring Type 1 - SF2-Small Beige Mosaic	Confirmed (Visually)	Poor	ACM Removal Required for Compliance

Caulking Type 1 - Grey	Suspect	Fair	Proactive ACM Removal or ACM Repair
