SCHOOL DISTRICT 85
VANCOUVER ISLAND NORTH

WOSS ELEMENTARY
ASBESTOS SURVEY AND ASSESSMENT

Date: July 2009
NWEST File: 10584

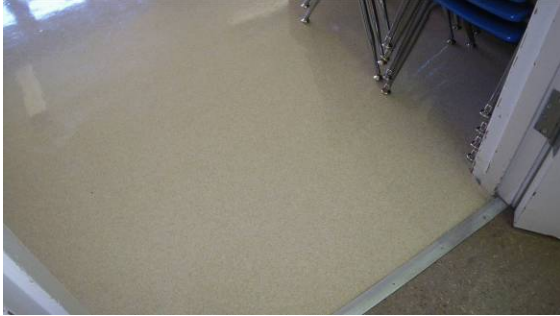
<p>Sample #3: Sheet Flooring Site: WC and Janitor Room Asbestos: None Detected</p>	<p>Sample #4: Sheet Flooring Site: Classroom Asbestos: None Detected</p>

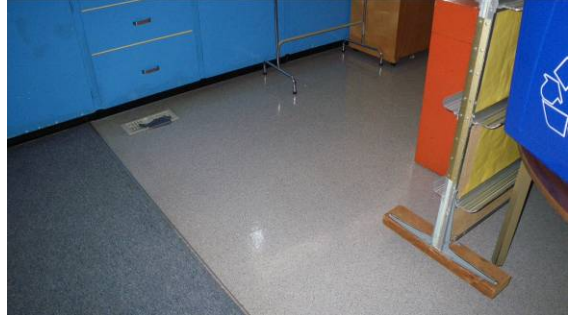
Sample #5: Sheet Flooring
 Site: Classroom
 Asbestos: None Detected

Sample #6: Sheet Flooring
 Site: Classroom
 Asbestos: None Detected

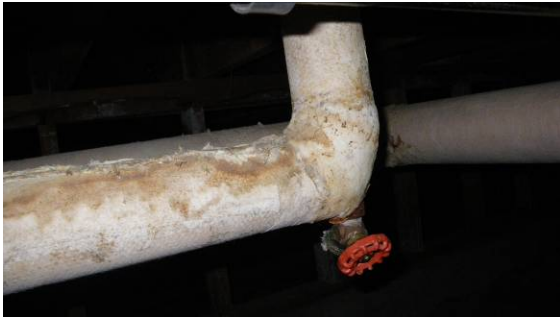
Asbestos pipe insulation is present on elbows and fittings in the Crawlspace. This material may be present in other locations. The product is not accessible and is unlikely to be damaged during routine building activities.

Sample #7: Pipe Elbow
 Site: Crawlspace
 Asbestos: Chrysotile

Asbestos containing pipe insulation in crawlspaces and possible other locations is not accessible and is unlikely to be damaged during routine building activities. This product can be included in the Asbestos Management Plan and managed in place.
