**Limited Hazardous Materials Assessment – Coal
Harbour School Gymnasium
District 85**

**Coal Harbour Elementary School
372 Albert Hole Road, Coal Harbour, BC**

NWest File: 39955 DHMA1 V1.0Rev1
Date Issued: May 25, 2022

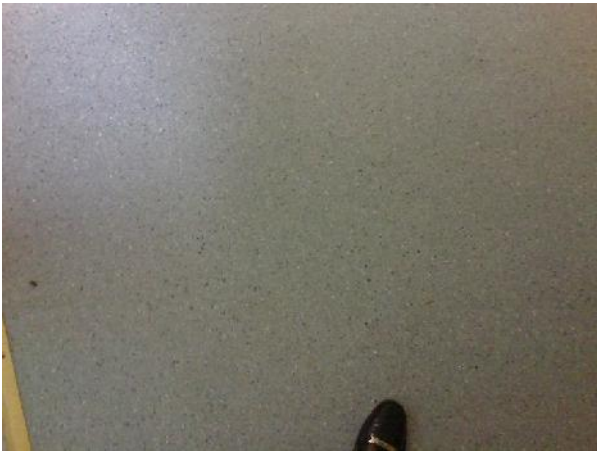
Photo 1
Description: Sheet flooring – SF7
Light Grey Mosaic
Location: Gymnasium
Asbestos: None detected
Sample(s): 30002-17

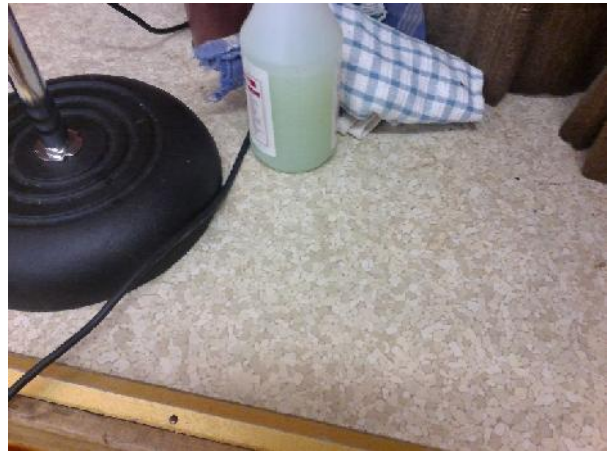
Photo 2
Description: Sheet flooring – SF8
Medium Beige Mosaic
Location: Gymnasium
Asbestos: None detected
Sample(s): 30002-16

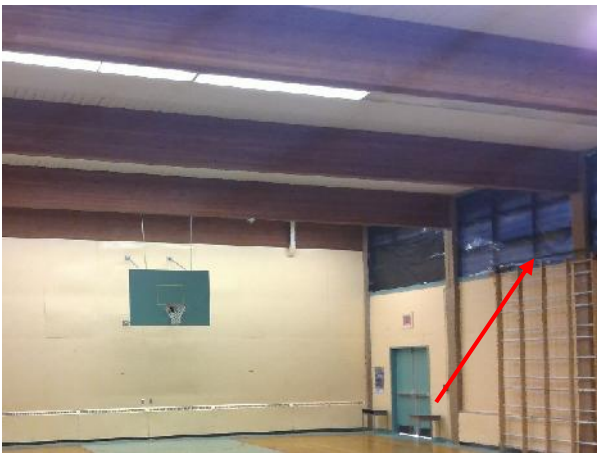
Photo 3
Description: Window putty
Location: Gymnasium
Asbestos: Suspect
Sample(s): None

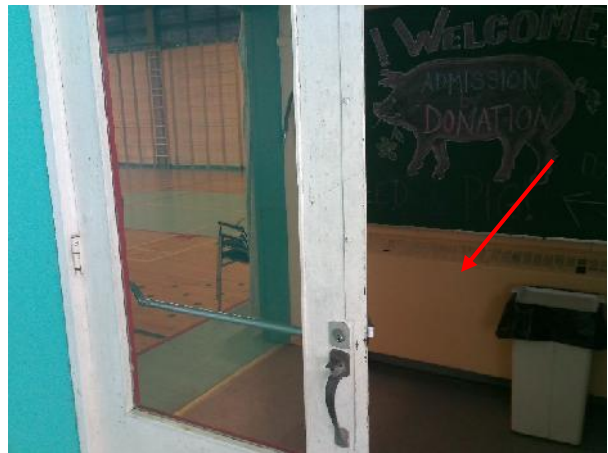
Photo 4
Description: Radiator pipe insulation
Location: Gymnasium
Asbestos: Suspect
Sample(s): None

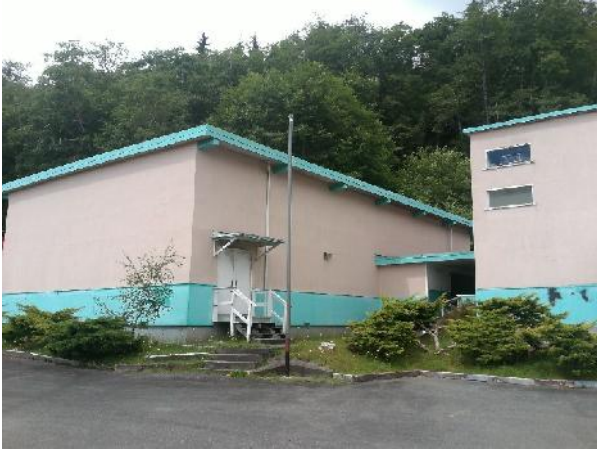
Photo 5
Description: Stucco
Location: Exterior
Hazmat: Contains crystalline silica and suspected to contain asbestos
Sample(s): None

7. **Crystalline Silica:** Workers must use caution to avoid creating airborne silica dust while working on or otherwise disturbing materials containing silica. Use WorkSafeBC-approved procedures in order to decrease dust levels.

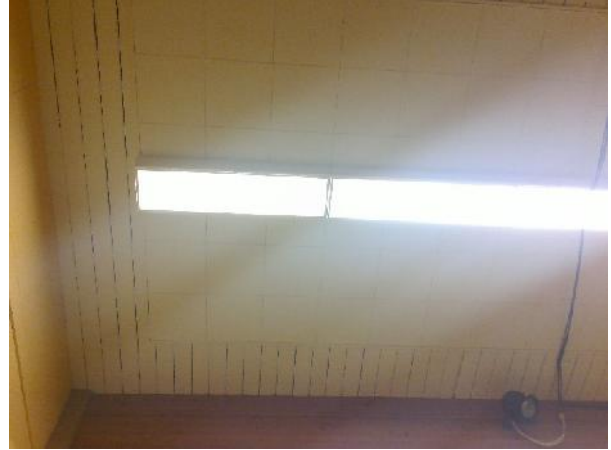
Photo 6
Description: Fluorescent light tubes
Location: Gymnasium
Lead: Tubes contain mercury, ballasts may contain PCBs
Sample(s): None

5. **Mercury Light Bulbs:** Care should be taken to avoid breaking fluorescent light tubes and compact fluorescent light (CFL) bulbs and releasing mercury vapour. Fluorescent light tubes and CFL bulbs should be recycled at a licensed recycling facility or disposed of at a household hazardous waste recipient.

6. **Polychlorinated Biphenyls:** Prior to disposal each suspect PCB-containing unit must be checked to determine if it contains PCB. Systems containing PCB must be removed, sorted and transported to a licensed facility. PCBs must be handled in accordance with regulations found in the Canadian Environmental Protection Act, SOR/2008-273, including amendments up to SOR/210-57, March 11, 2010.

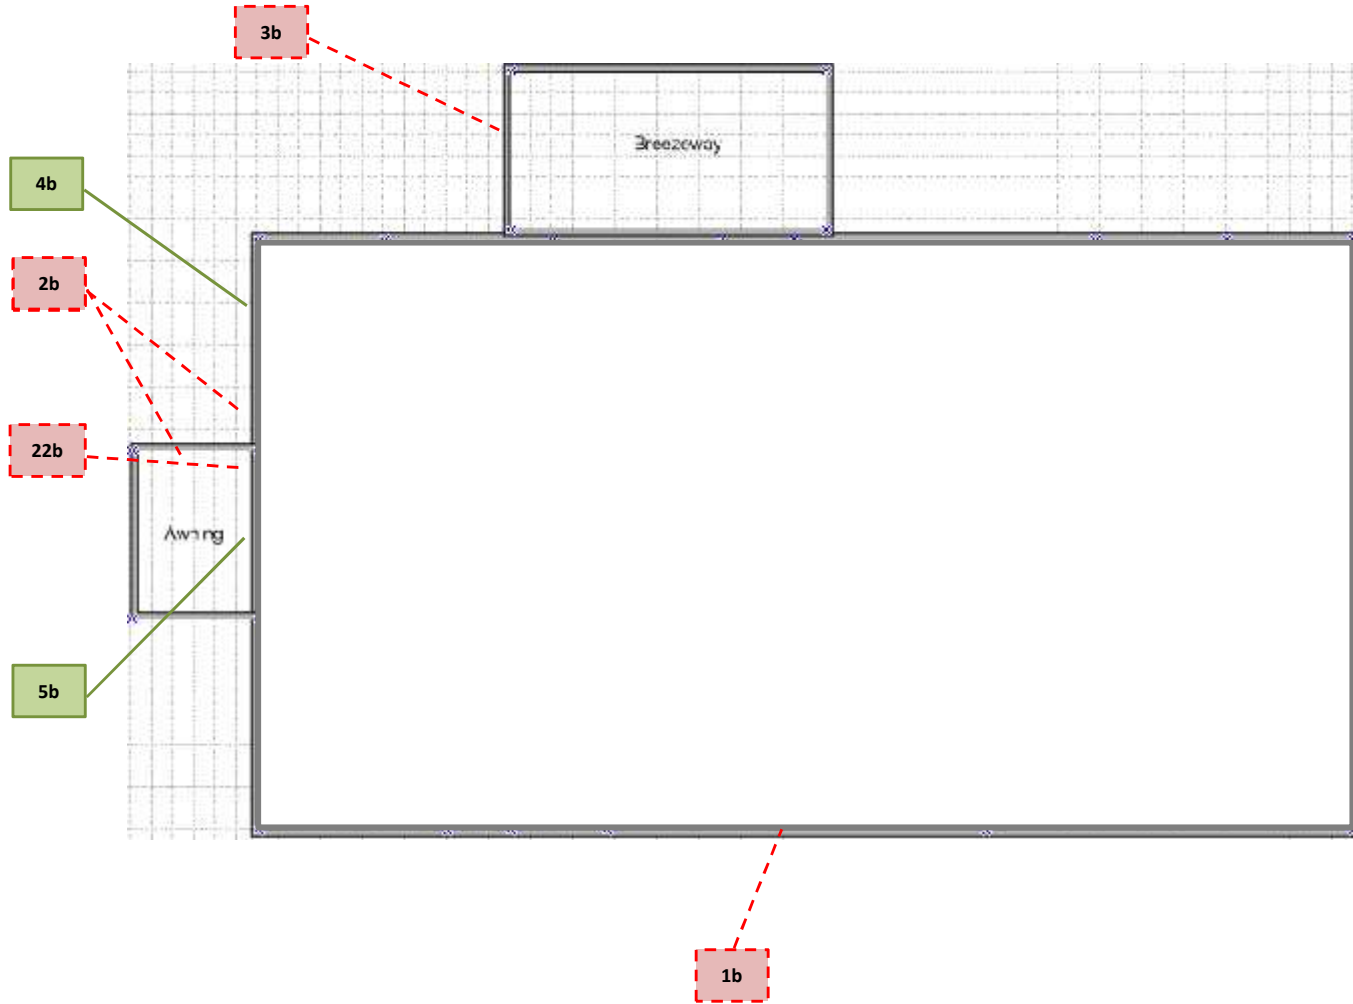
Location: 372 Albert Hole Road,
Coal Harbour, BC
Drawing Title: Historical Sample
Locations
Project No: 39955
Drawing No: 001
Surveyed By: PG & LK
Survey Date: August 10, 2020

1b	White paint on wood
2b	Grey paint on wood
3b	Aquamarine paint on wood
4b	Peach paint on stucco
5b	Green paint on metal
22b	White paint over red and grey on wood door

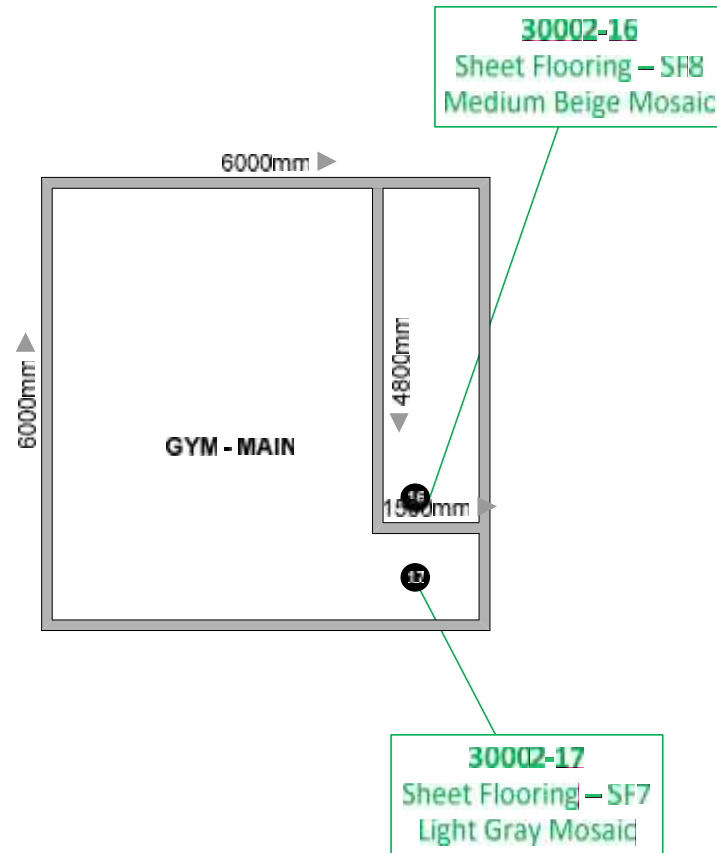
Location: 372 Albert Hole Road,
Coal Harbour, BC
Drawing Title: Historical Sample
Locations
Project No: 30002
Drawing No: 002
Surveyed By: JSM & BS
Survey Date: July 5, 2016

16	Sheet Flooring – SF8
17	Sheet Flooring – SF7
