A.J. Elliott Elementary
120 4th Street, Sointula, BC
Asbestos Management Inventory

North West
Environmental Group Ltd.

NWest File: 39957 AMI1 V1.0
Date Issued: November 10, 2020

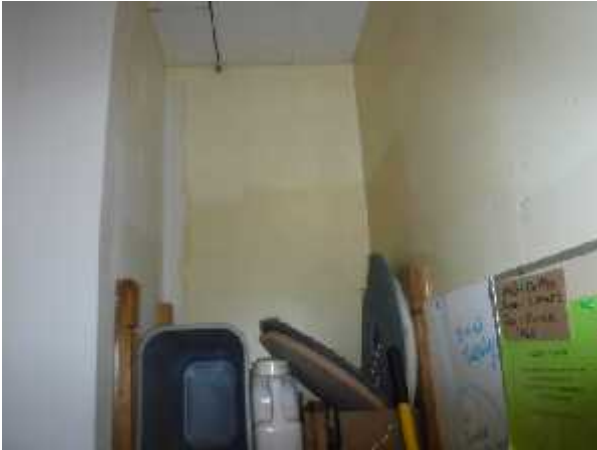
Photo 1
Description: Drywall joint compound
Location: Janitors Room
Asbestos: 1.8% Chrysotile
Sample(s): 30000-18

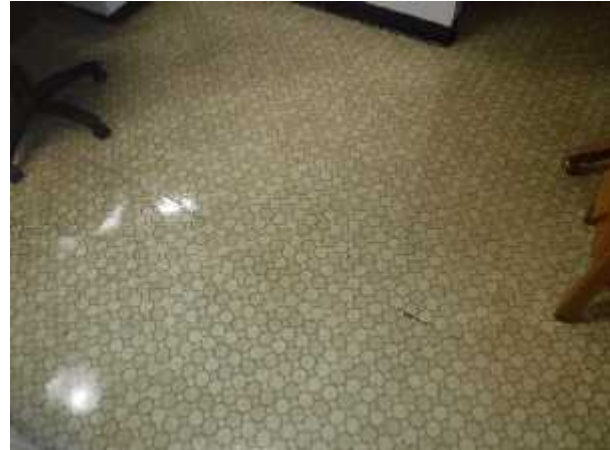
Sheet flooring 8 – Circle pattern	Floor	Classroom: 1, 9(Library)	Confirmed	210 ft ²	Access A – Accessible to all building users	Friable	Good	Action 5 – Proactive ACM removal / Action 7 – Routinely monitor condition Test prior to impact
Mastic type 1 – Black on pipe insulation	Insulation	Janitor Room	Suspect	Patches on fibreglass insulation in rooms listed	Access B – Accessible to maintenance worker	Non friable	Good	Action 5 – Proactive ACM removal / Action 7 – Routinely monitor condition Test prior to impact
Mastic type 2 – Black on sink	Sink	Classroom: 5, 6 Staff Kitchen	Confirmed	3 sinks	Access A – Accessible to all building users	Non friable	Good	Action 5 – Proactive ACM removal / Action 7 – Routinely monitor condition Test prior to impact
Mastic type 3 – Gold on sink	Sink	Classroom: 1, 2, 3 Gym Kitchen	Confirmed	4 sinks	Access A – Accessible to all building users	Non friable	Good	Action 5 – Proactive ACM removal / Action 7 – Routinely monitor condition Test prior to impact

Photo 2
Description: Sheet flooring 8 – Circle pattern
Location: Classroom 9 (Library)
Asbestos: 10% Chrysotile
Sample(s): 30000-21

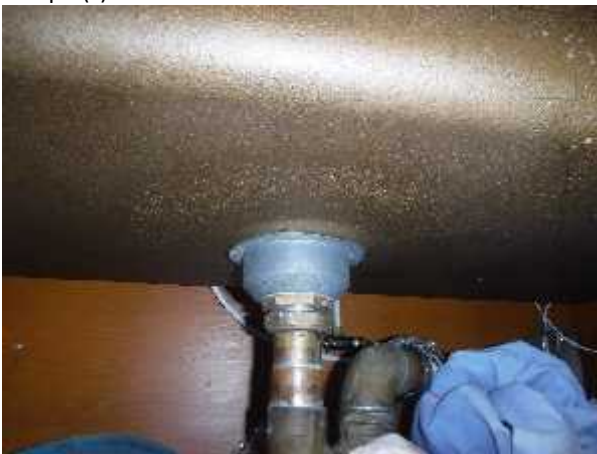
Photo 3
Description: Mastic – Gold
Location: Classroom 2
Asbestos: 1.5% Chrysotile
Sample(s): 30000-22

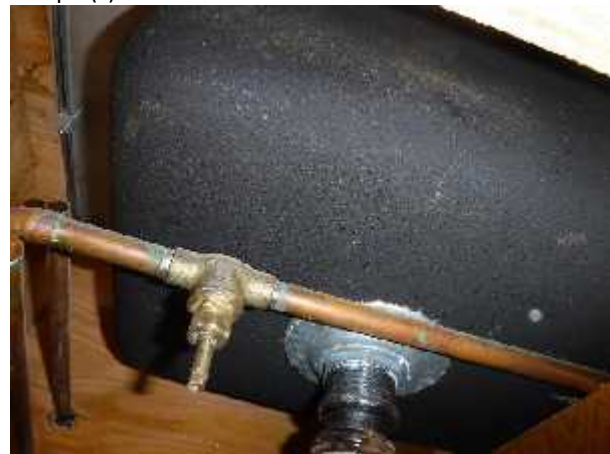
Photo 4
Description: Mastic – Black
Location: Classroom 5
Asbestos: 2.5% Chrysotile
Sample(s): 30000-25

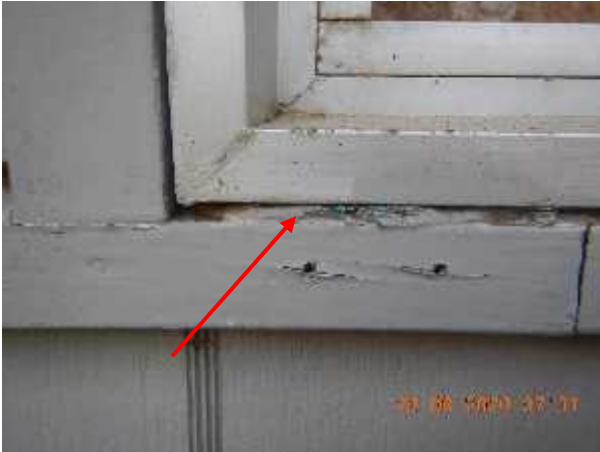
Description	System	Locations	Status	Quantity	Accessibility	Friability	Condition	Mgmt Recommendation
Caulking – Grey	Window	Exterior	Suspect	All exterior windows	Access A – Accessible to all building users	Non friable	Good	Action 5 – Proactive ACM removal / Action 7 – Routinely monitor condition Test prior to impact
Stucco	Siding	Exterior	Suspect	750 ft ²	Access A – Accessible to all building users	Non friable	Good	Action 5 – Proactive ACM removal / Action 7 – Routinely monitor condition Test prior to impact
Window mastic – Black	Window	Classroom: 2, 3, 5, 6, 7 Boys Washroom Off Hallway, Electrical Room, Girls Washroom Off Hallway, Boys Gym Changeround, Gym Entry, Staff Kitchen, Office Principal	Suspect	All windows in locations listed	Access A – Accessible to all building users	Non friable	Good	Action 5 – Proactive ACM removal / Action 7 – Routinely monitor condition Test prior to impact
Red 6”x6” ceramic tile grout and thinset	Wall	Boys Washroom Off Foyer, Girls Washroom Off Foyer	Suspect	900 ft ²	Access A – Accessible to all building users	Non friable	Good	Action 5 – Proactive ACM removal / Action 7 – Routinely monitor condition Test prior to impact

Photo 5
Description: Caulking – Grey
Location: Exterior
Asbestos: Suspect

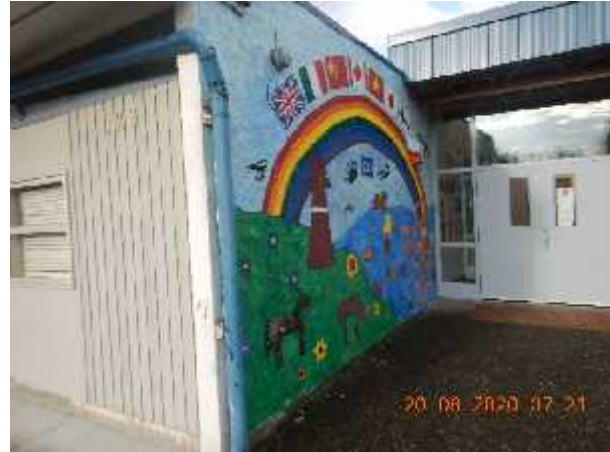
Photo 6
Description: Stucco
Location: Exterior
Asbestos: Suspect

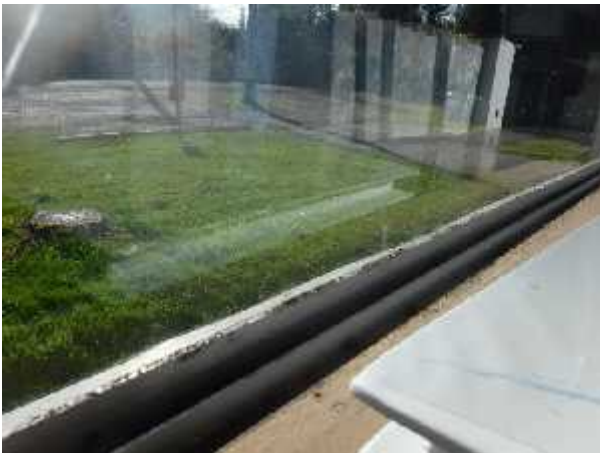
Photo 7
Description: Window Mastic – Black
Location: Classroom 5
Asbestos: Suspect

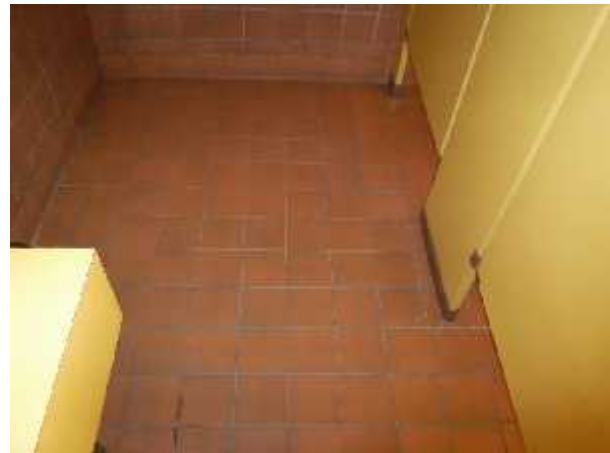
Red 6”x6” ceramic tile grout and thinset	Floor	Boys Washroom Off Foyer, Girls Washroom Off Foyer	Suspect	300 ft ²	Access A – Accessible to all building users	Non friable	Good	Action 5 – Proactive ACM removal / Action 7 – Routinely monitor condition Test prior to impact

Photo 8
Description: Red 6"x6" ceramic tile grout and thinset
Location: Boys Washroom Off Foyer
Asbestos: Suspect concealed asbestos leveling compound(s)

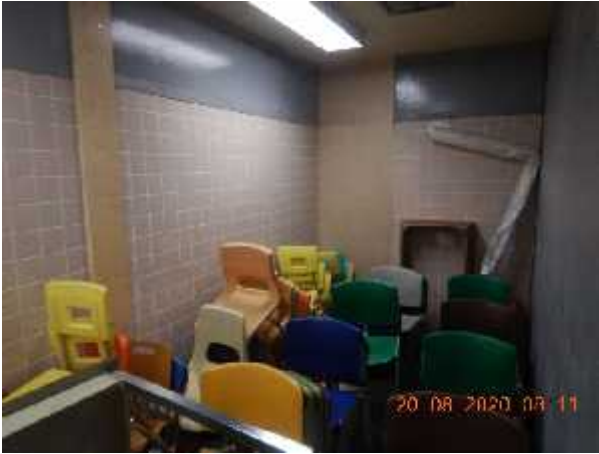
Description	System	Locations	Status	Quantity	Accessibility	Friability	Condition	Mgmt Recommendation
Tan 5"x5" ceramic tile grout and thinset	Wall	Gym Storage	Suspect	500 ft ²	Access A – Accessible to all building users	Non friable	Good	Action 5 – Proactive ACM removal / Action 7 – Routinely monitor condition Test prior to impact
Grey 2"x2" ceramic tile grout and thinset	Floor	Gym Storage	Suspect	125 ft ²	Access A – Accessible to all building users	Non friable	Good	Action 5 – Proactive ACM removal / Action 7 – Routinely monitor condition Test prior to impact
Drywall with joint compound	Wall	Janitor Room	Confirmed	350 ft ²	Access B – Accessible to maintenance worker	Non friable	Poor	Action 3 – ACM removal required for compliance
Drywall with joint compound	Wall	Mechanical Room, Electrical Room	Confirmed	975 ft ²	Access B – Accessible to maintenance worker	Non friable	Good	Action 5 – Proactive ACM removal / Action 7 – Routinely monitor condition Test prior to impact

Photo 9
Description: Tan 5"x5" ceramic tile grout and thinset
Location: Gym Storage
Asbestos: Suspect concealed asbestos leveling compound(s)

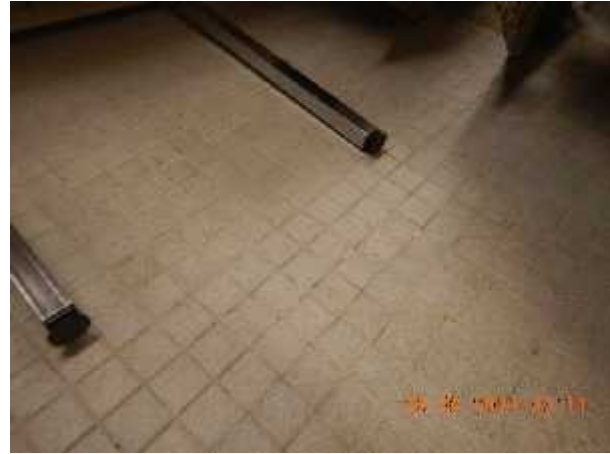
Photo 10
Description: Grey 2"x2" ceramic tile grout and thinset
Location: Gym Storage
Asbestos: Suspect concealed asbestos leveling compound(s)

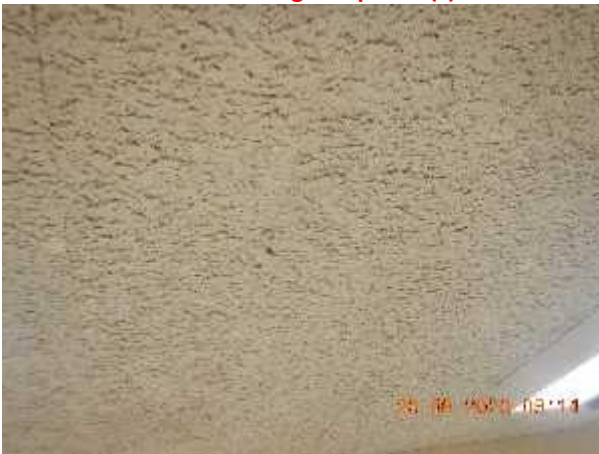
Description	System	Locations	Status	Quantity	Accessibility	Friability	Condition	Mgmt Recommendation
Acoustic ceiling tile type 3 – 12"x12" donnacona textured with pinholes and fissures	Ceiling	Gym, Boys Gym Changeround, Girls Gym Washroom	Suspect	5,100 ft ²	Access A – Accessible to all building users	Friable	Good	Action 5 – Proactive ACM removal / Action 7 – Routinely monitor condition Test prior to impact
Acoustic ceiling tile type 4 – Lateral fissure small and large pinhole	Ceiling	Classroom: 1, 7 Office Main, Office Medical Room, Office Principal	Suspect	1,725 ft ²	Access A – Accessible to all building users	Friable	Good	Action 5 – Proactive ACM removal / Action 7 – Routinely monitor condition Test prior to impact

Photo 11
Description: Acoustic ceiling tile type 3 – 12"x12" donnacona textured with pinholes and fissures
Location: Boys Gym Changeroom
Asbestos: Suspect

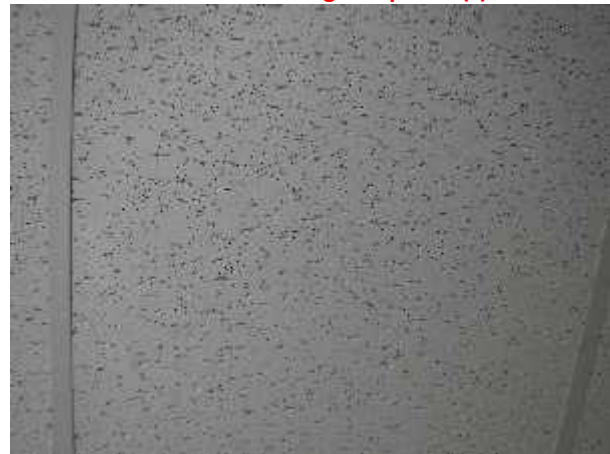
Photo 6
Description: 12 Acoustic ceiling tile type 4 – Lateral fissure small and large pinhole
Location: Main Office
Asbestos: Suspect

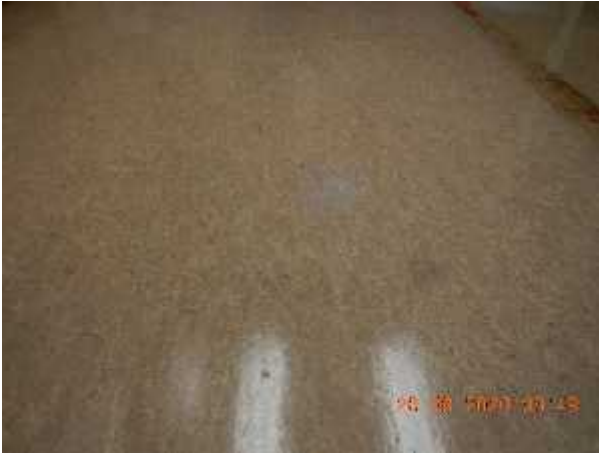
Sheet flooring 4 – Beige-peach marble	Floor	Electrical Room, Electrical Room Handicapped Washroom,	Suspect	120 ft ²	Access B – Accessible to maintenance worker	Friable	Good	Action 5 – Proactive ACM removal / Action 7 – Routinely monitor condition Test prior to impact

Photo 13
Description: Sheet flooring 4 – Beige-peach marble
Location: Electrical Room
Asbestos: Suspect

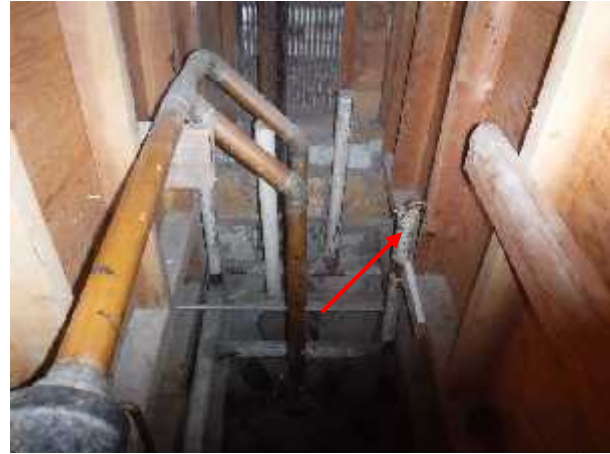
Photo 14
Description: Mastic type 1 – Black on pipe insulation
Location: Janitor Room Pipe Chase
Asbestos: Suspect

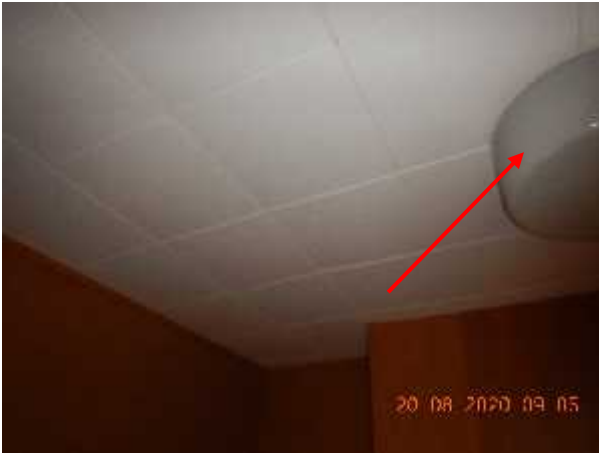
Incandescent light gasket	Lighting	Electrical Room Washroom	Suspect	1 light gasket	Access B – Accessible to maintenance worker	Friable	Good	Action 5 – Proactive ACM removal / Action 7 – Routinely monitor condition Test prior to impact

Photo 15
Description: Incandescent light gasket
Location: Electrical Room Washroom
Asbestos: Suspect

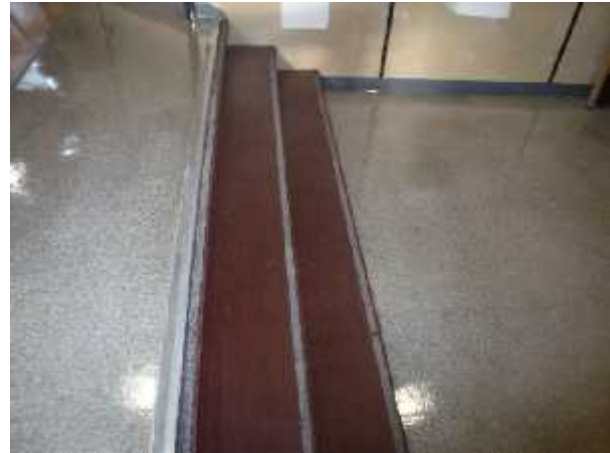
Description	System	Locations	Status	Quantity	Accessibility	Friability	Condition	Mgmt Recommendation
Red brown stair tread	Floor	Foyer by Main Door	Suspect	30 ft ²	Access A – Accessible to all building users	Non friable	Good	Action 5 – Proactive ACM removal / Action 7 – Routinely monitor condition Test prior to impact
Bell and Spigot Pipe Gaskets	Plumbing	Janitor Room Pipe Chase	Suspect	20 pipe gaskets	Access B – Accessible to maintenance worker	Non friable	Good	Action 5 – Proactive ACM removal / Action 7 – Routinely monitor condition Test prior to impact
Baseboard Adhesive	Wall	Throughout building	Suspect	Throughout building	Access A – Accessible to all building users	Non friable	Good	Action 5 – Proactive ACM removal / Action 7 – Routinely monitor condition Test prior to impact

Photo 16
Description: Red brown stair tread
Location: Foyer by Main Door
Asbestos: Suspect

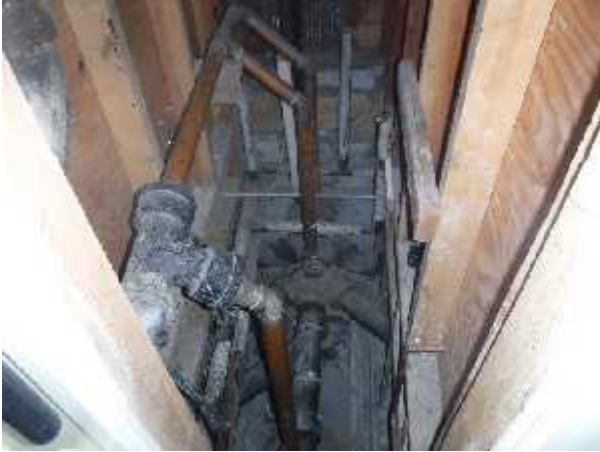
Photo 17
Description: Bell and spigot pipe gaskets
Location: Janitor Room Pipe Chase
Asbestos: Suspect

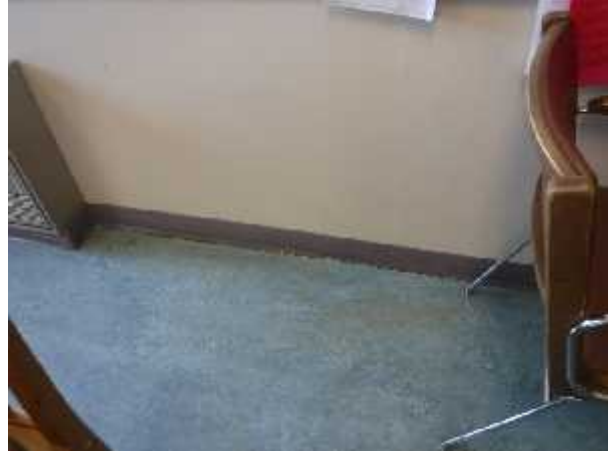
Photo 18
Description: Baseboard adhesive
Location: Staff Kitchen
Asbestos: Suspect

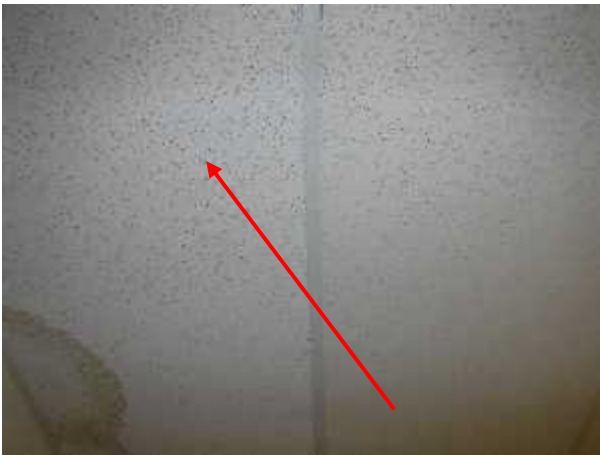
Acoustic ceiling tile type 1 – Patterned fissure with small and large pinholes	Ceiling	Classroom: 1, Boys Washroom Off Hallway, Girls Washroom Off Hallway, Office Main	Suspect	1,215 ft ²	Access A – Accessible to all building users	Friable	Good	Action 5 – Proactive ACM removal / Action 7 – Routinely monitor condition Test prior to impact

Photo 19
Description: Acoustic ceiling tile type 1 –
Patterned fissure with small and
large pinholes
Location: Main Office
Asbestos: Suspect
