## School District 85

**Alert Bay Elementary School  
381 Larch Street, Alert Bay, BC  
Asbestos Management Inventory**

NWest File: 39957 AMI1 V1.0  
Date Issued: November 10, 2020

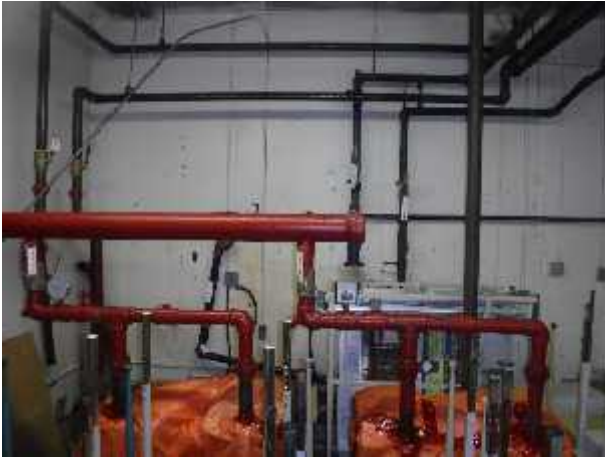
Photo 1  
Description: Drywall Joint Compound  
Location: Boiler Room  
**Asbestos: 1.7% Chrysotile**  
Sample(s): 39999-5

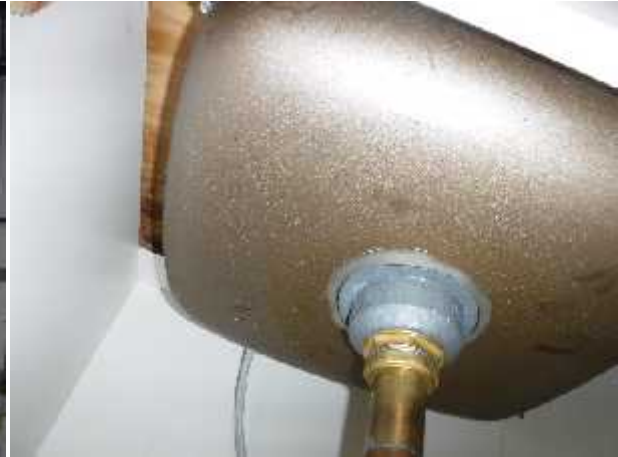
Photo 2  
Description: Mastic Type 1 – Silver on Sink  
Location: Medical Room  
**Asbestos: 1.5% Chrysotile**  
Sample(s): 39957-16

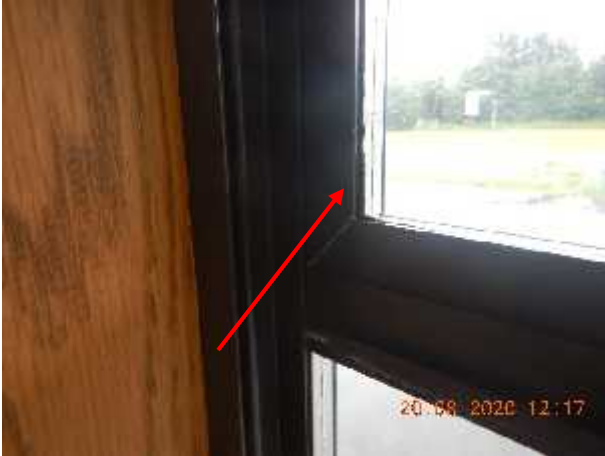
Photo 3  
Description: Window Putty – Black  
Location: Classroom 4  
**Asbestos: Suspect**

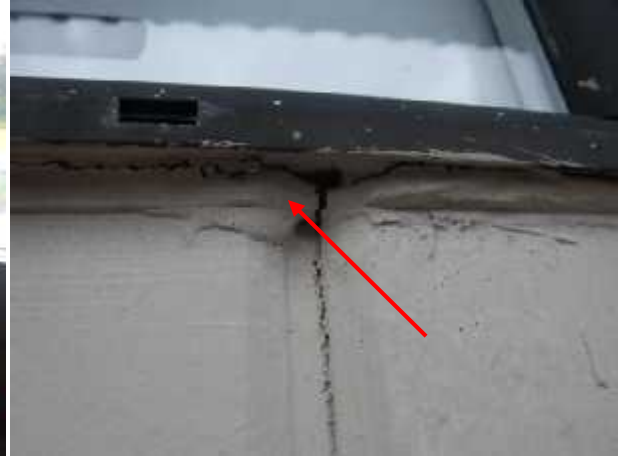
Photo 4  
Description: Mastic Type 2 – Black Around Windows and Doors  
Location: Exterior  
**Asbestos: Suspect**

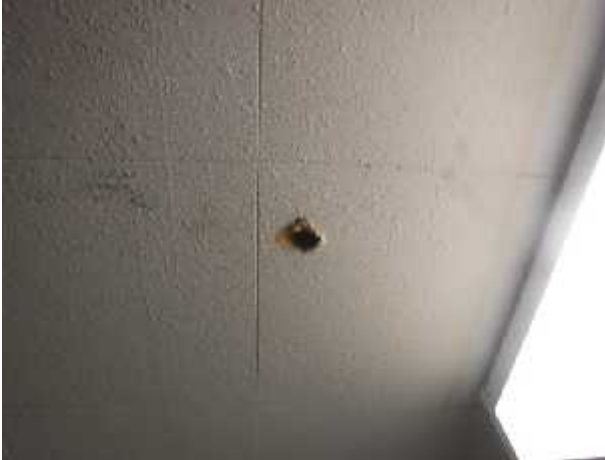
Photo 5  
Description: Acoustic Ceiling Tile Type 3 - 12" x 12" Donnacona (Textured)  
Location: Storage Room  
**Asbestos: Suspect**

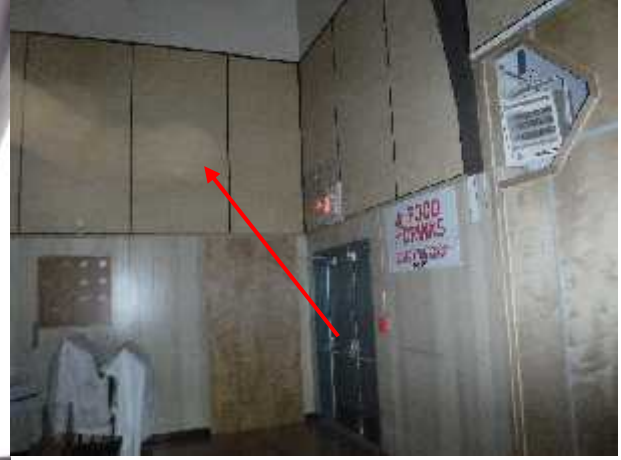
Photo 6  
Description: Acoustic Panels (Gym Upper Wall)  
Location: Gym  
**Asbestos: Suspect**

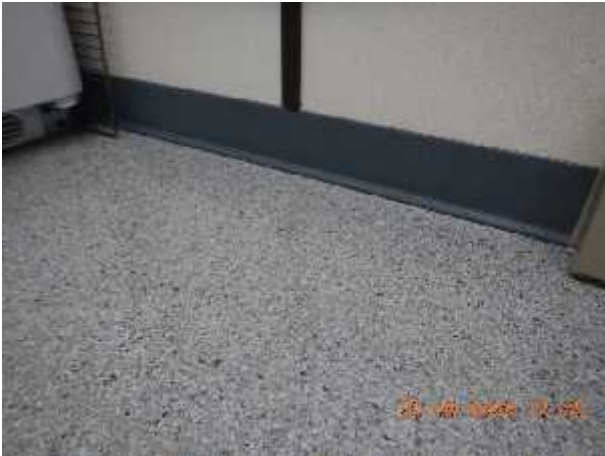
Description	System	Locations	Status	Quantity	Accessibility	Friability	Condition	Mgmt Recommendation
Adhesive type 1 – Baseboard adhesive	Baseboard	Throughout Building	Suspect	Throughout building	Access A	Non-friable	Good	Action 5 – Proactive ACM removal / Action 7 – Routinely monitor condition Test prior to impact

Photo 7  
Description: Adhesive Type 1 - Baseboard Adhesive  
Location: Staff Lunch Room  
**Asbestos: Suspect**

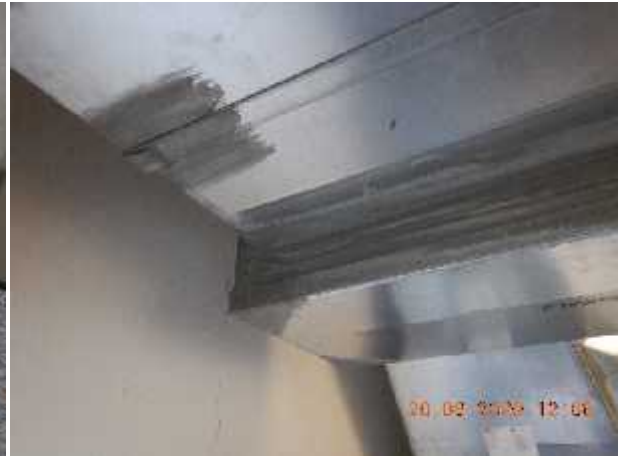
Photo 8  
Description: Caulking Type 1 - Grey (On Ducting)  
Location: Classroom 3  
**Asbestos: Suspect**

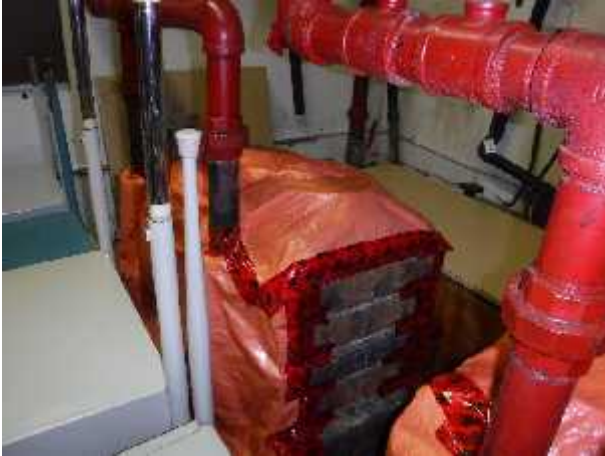
Photo 9  
Description: Boiler Refractory  
Location: Boiler Room  
**Asbestos: Suspect**

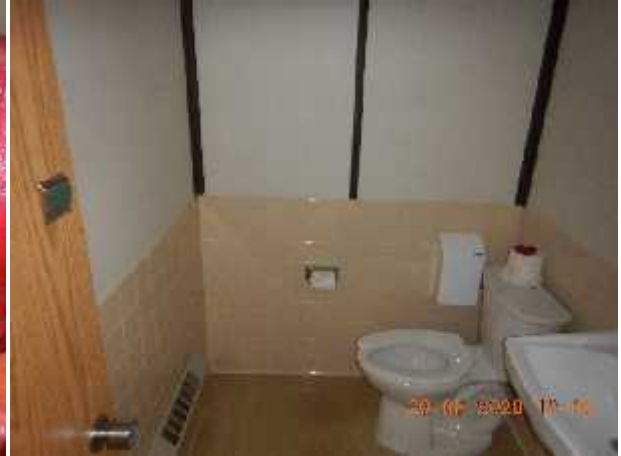
Beige ceramic with white tile grout and thinset	Wall	Washrooms: Boy’s and Girl’s Staff Washrooms: Male and Female	Suspect	900 ft <sup>2</sup>	Access A	Non-friable	Good	Action 5 – Proactive ACM removal / Action 7 – Routinely monitor condition Test prior to impact

Photo 10  
Description: Beige Ceramic Tile with White Grout and Thinset  
Location: Male Staff Washroom  
**Asbestos: Suspect concealed asbestos leveling compound(s)**

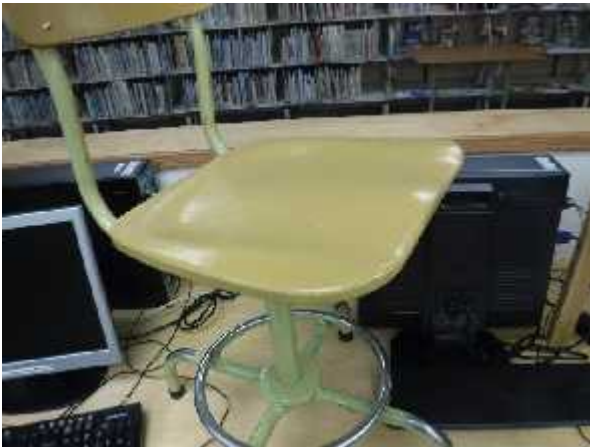
Photo 5  
Description: Chair  
Location: Library  
**Asbestos: Suspect**

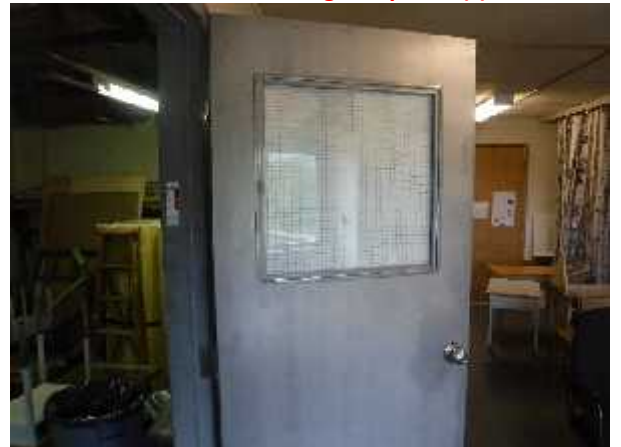
Fire door	Door	Boiler Room	Suspect	1 Door	Access A	Non-friable	Good	Action 5 – Proactive ACM removal / Action 7 – Routinely monitor condition Test prior to impact
Acoustic ceiling tile type 1 - Patterned fissures small and large pinhole	Ceiling	Library, Entry to Library, Gym Kitchen, Gym Storage	Suspect	570, 160, 160, 1800	Access A	Friable	Good	Action 5 – Proactive ACM removal / Action 7 – Routinely monitor condition Test prior to impact
Acoustic Ceiling Tile Type 3 - 12" x 12" Donnacona (Textured)	Ceiling	Gym Storage by Bleachers, Storage Room	Suspect	775 ft <sup>2</sup>	Access A	Friable	Good	Action 5 – Proactive ACM removal / Action 7 – Routinely monitor condition Test prior to impact
Acoustic panels	Wall	Gym	Suspect	2000 ft <sup>2</sup>	Access A	Friable	Good	Action 5 – Proactive ACM removal / Action 7 – Routinely monitor condition Test prior to impact
Torch-on roofing	Roof	Building Roof	Suspect	17,653 ft <sup>2</sup>	Access B	Non-friable	Good	Action 5 – Proactive ACM removal / Action 7 – Routinely monitor condition Test prior to impact

Photo 6  
Description: Fire Door  
Location: Boiler Room  
**Asbestos: Suspect**

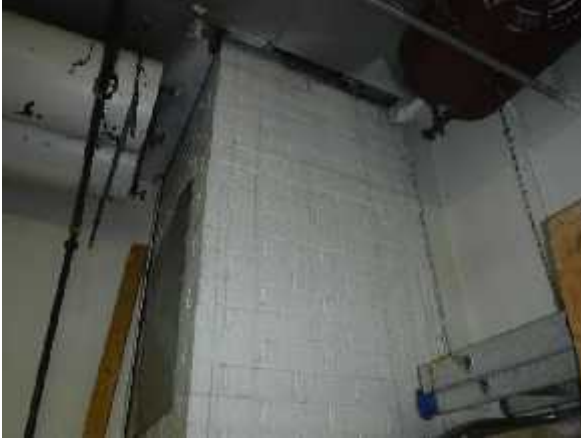
Photo 5

Brick and mortar	Chimney	Boiler Room	Suspect	100 ft <sup>2</sup>	Access B	Non friable	Fair	Action 5 – Proactive ACM removal / Action 7 – Routinely monitor condition Test prior to impact
Caulking type 1 – Grey	Ducting	Classrooms: 1, 2, 3, 4, 5, 6. Staff Lunch Room	Suspect	Concealed. Assumed on ducting throughout building	Access C(c)	Non-friable	Good	Action 5 – Proactive ACM removal / Action 7 – Routinely monitor condition Test prior to impact
Mastic type 1 – Silver on sink	Sink	Classroom 2, Medical Room, Staff Kitchen, Staff Lunch Room.	Confirmed	5 Sinks	Access A	Non-friable	Good	Action 5 – Proactive ACM removal / Action 7 – Routinely monitor condition Test prior to impact

Description: Brick and Mortar

Location: Boiler Room

**Asbestos:** **Suspect**
