School District 85

**North Island Secondary School Shop
2071 McNeill Road, Port McNeill, BC
Asbestos Management Inventory**

NWest File: 39957 AMI1 V1.0
Date Issued: November 10, 2020

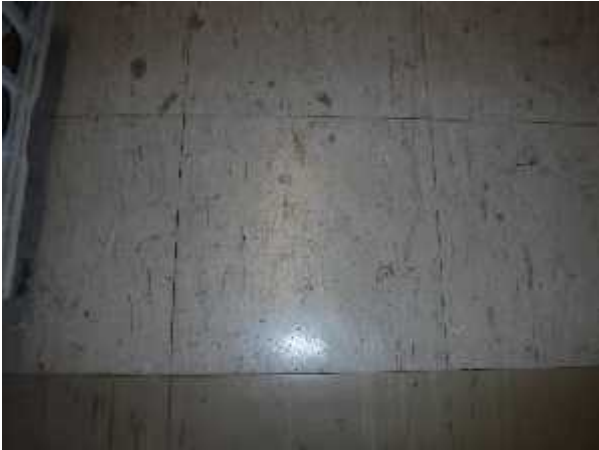
Photo 1
Description: Floor tile 1 – 12"x12" brown and beige with white streaks
Location: Autoshop Storage and Hot Water Tank
Asbestos: Suspect

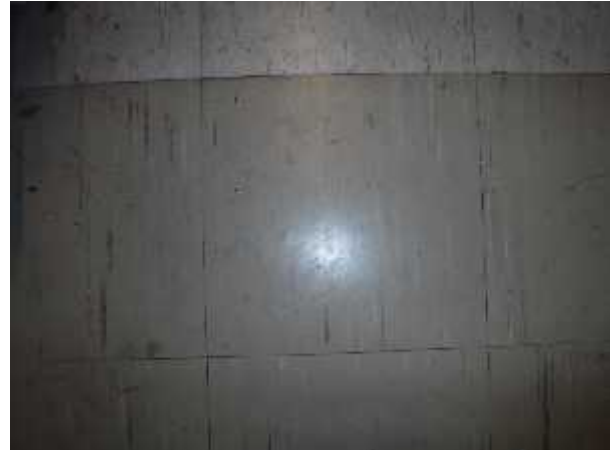
Photo 2
Description: Floor tile 2 – 12"x12" brown and beige with black smears
Location: Autoshop Storage and Hot Water Tank
Asbestos: Suspect

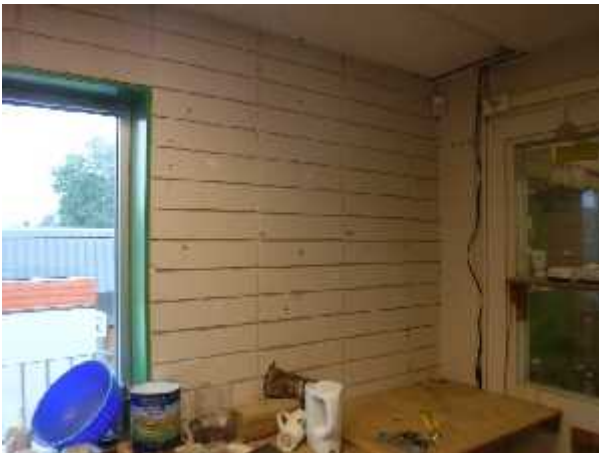
Photo 3
Description: Concrete block (may contain vermiculite)
Location: Woodshop Office
Asbestos: Suspect

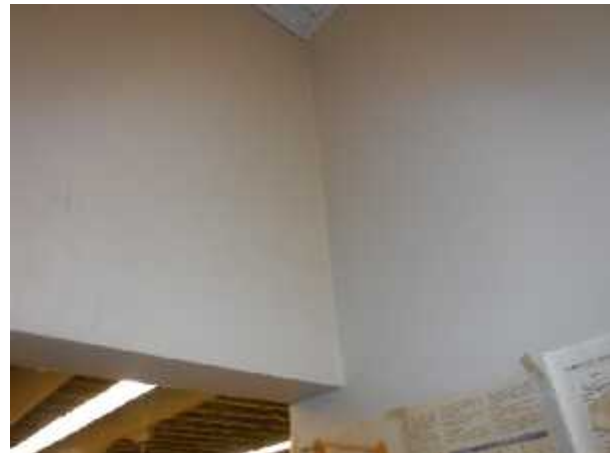
Photo 4
Description: Drywall with joint compound
Location: Entrance to Woodshop
Asbestos: Suspect

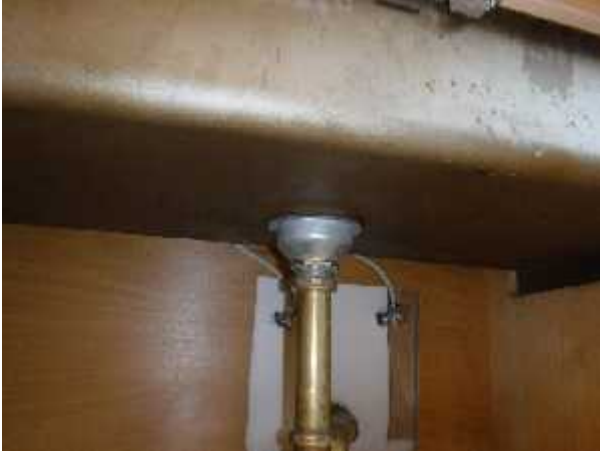
Photo 5
Description: Mastic 1 – Gold/silver
Location: Drafting Classroom
Asbestos: Suspect

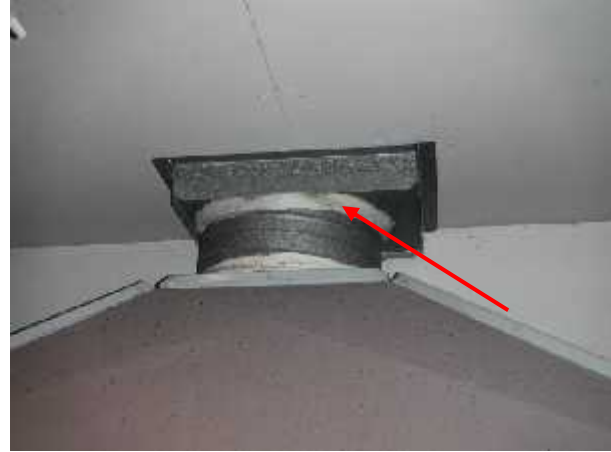
Photo 6
Description: Mastic 2 – Off white
Location: Metal Shop Fume Hood Room
Asbestos: Suspect

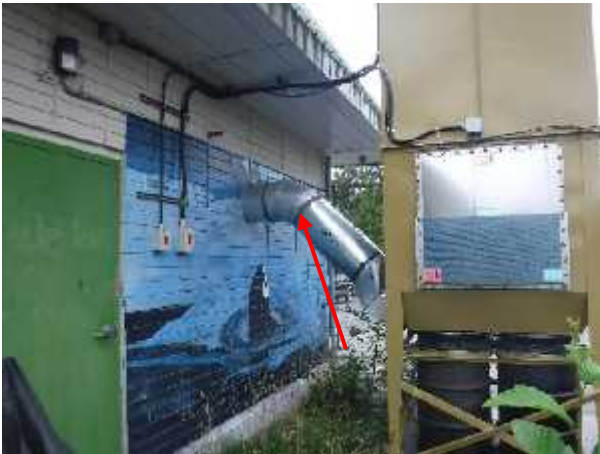
Photo 5
Description: Mastic 3 – Grey
Location: Exterior
Asbestos: Suspect

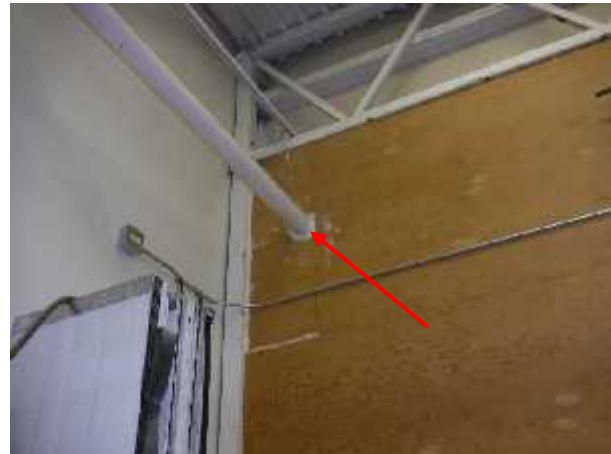
Photo 6
Description: Penetration caulking – White
Location: Autoshop Loading Bay
Asbestos: Suspect

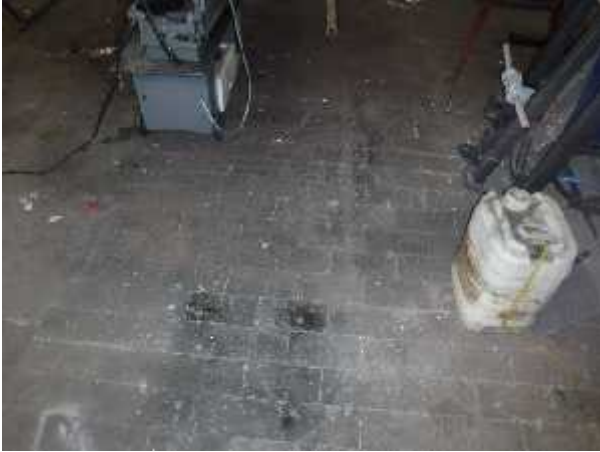
Photo 5
Description: Brick and mortar
Location: Area Outside Metal Stock Rooms
Asbestos: **Suspect**

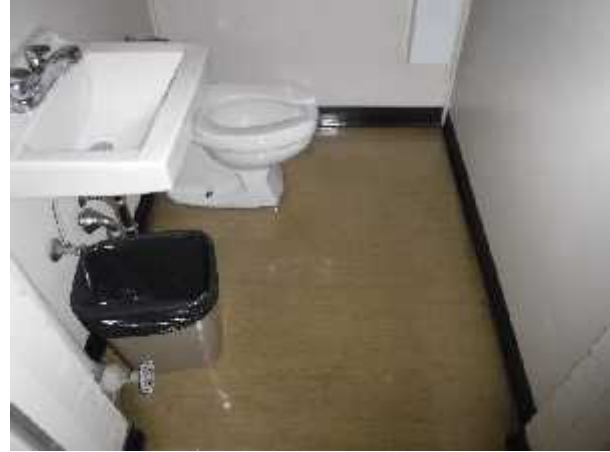
Photo 6
Description: Baseboard adhesive
Location: Ladies Washroom
Asbestos: **Suspect**

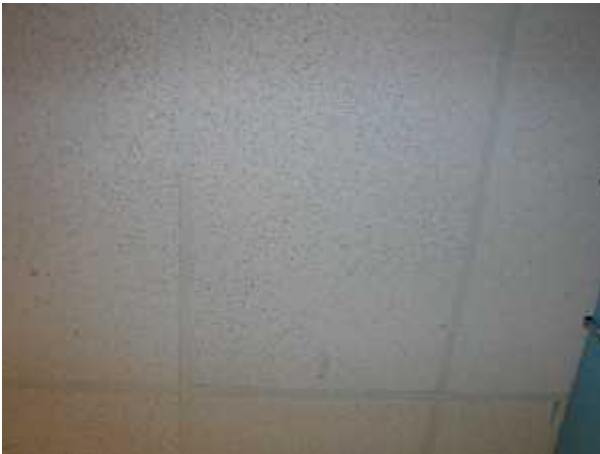
Photo 5
Description: Acoustic ceiling tile 1 – Patterned
fissure small and large pinhole
Location: Woodshop Classroom
Asbestos: **Suspect**

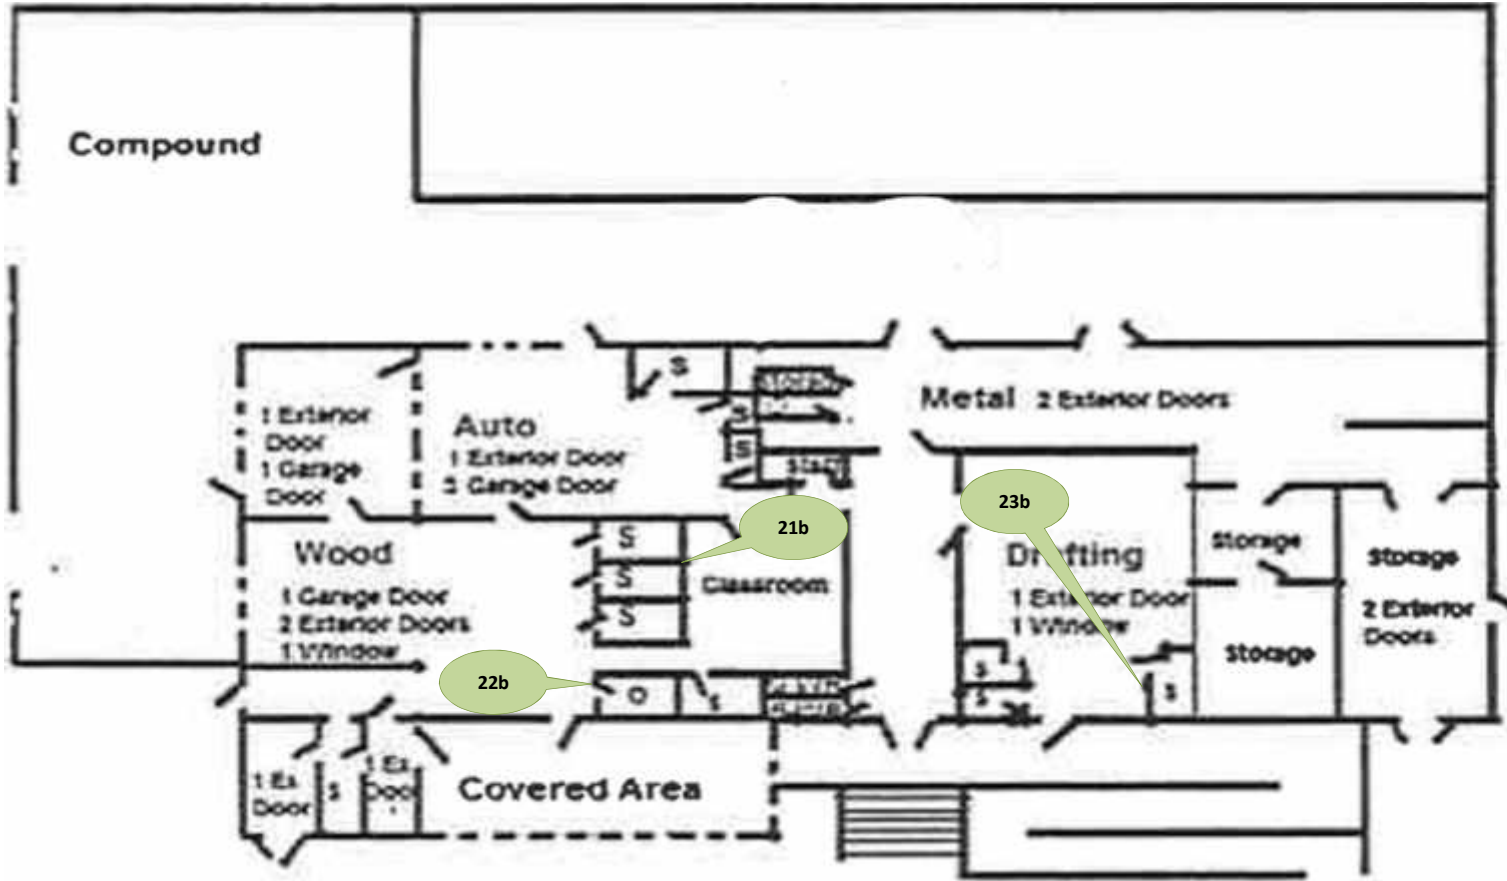
Location: NISS Maintenance Shop,
2071 McNeill Road, Port McNeill,
BC
Drawing Title: Sample Locations
Project No: 39957
Drawing No: 001
Surveyed By: PG & LK
Survey Date: August 18, 2020

21b	Drywall Joint Compound
22b	Drywall Joint Compound
23b	Drywall Joint Compound
