School District 85

Robert Scott Elementary
6855 Market Street, Port Hardy, BC
Asbestos Management Inventory

NWest File: 39957 AMI1 V1.0
Date Issued: November 16, 2020

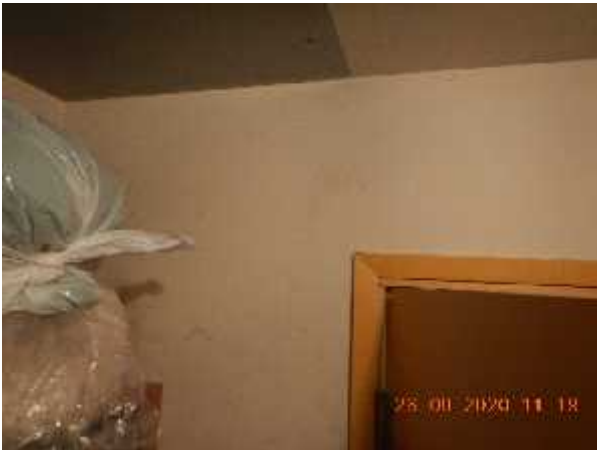
Photo 1
Description: Drywall with joint compound
Location: Store Room
Asbestos: 1.4%-3.9% Chrysotile
Sample(s): 30010-7, 9, 10, 11, 13

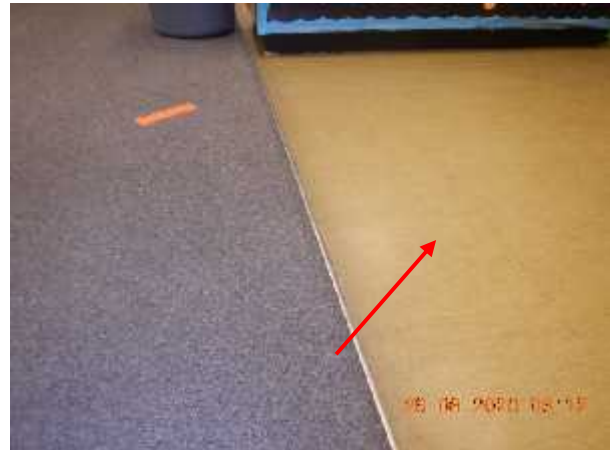
Sheet flooring 2 – Beige and grey streaks	Floor	Classroom: 2, 3, 7, D, E, F, K Boys Washroom, Corridor Adjacent Basement Washrooms, Washroom Adjacent Classroom E, First Aid Room (7B), Janitor Room, 9-12 Wing Janitor Room, Basement Janitor Room, Men's Washroom, Office C, Basement Entry Adjacent Stairs, Store Room, Woman's Washroom	Confirmed	3,200 ft ²	Access A – Accessible to all building users	Friable	Good	Action 5 – Proactive ACM removal / Action 7 – Routinely monitor condition Test prior to impact

Photo 2
Description: Sheet flooring 2 – Beige and grey streaks
Location: Classroom 3
Asbestos: 2.9% Chrysotile
Sample(s): 30010-1

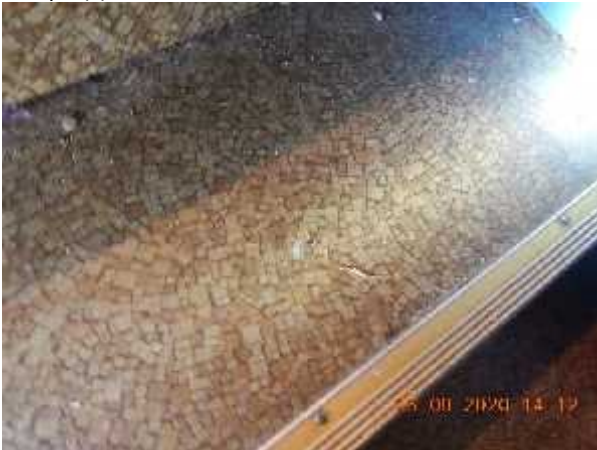
Sheet flooring 5 – Beige red mosaic	Floor	Gym Stage Stairs	Confirmed	25 ft ²	Access A – Accessible to all building users	Friable	Good	Action 5 – Proactive ACM removal / Action 7 – Routinely monitor condition Test prior to impact
Floor tile 2 – 9"x 9" Beige	Floor	Classroom: D Gym Mechanical Room	Confirmed	180 ft ²	Access A – Accessible to all building users	Non-Friable	Good	Action 5 – Proactive ACM removal / Action 7 – Routinely monitor condition Test prior to impact
Floor tile 3 – Beige with red streaks	Floor	Gym Storage	Suspect	145	Access A – Accessible to all building users	Non-Friable	Good	Action 5 – Proactive ACM removal / Action 7 – Routinely monitor condition Test prior to impact

Photo 3
Description: Sheet flooring 5 – Beige red mosaic
Location: Gym Stage Stairs
Asbestos: 7.1% Chrysotile
Sample(s): 30010-25

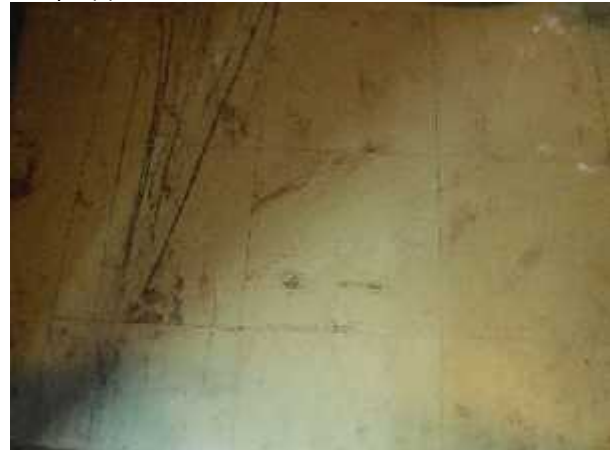
Photo 4
Description: Floor tile 2 – 9”x9” Beige
Location: Gym Mechanical Room
Asbestos: 3.1% Chrysotile
Sample(s): 30010-24

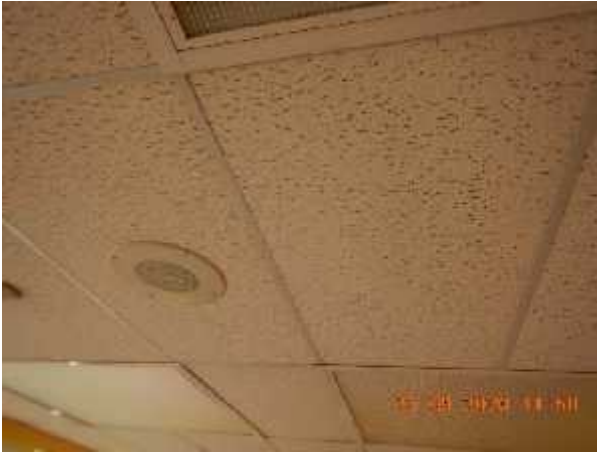
Description	System	Locations	Status	Quantity	Accessibility	Friability	Condition	Mgmt Recommendation
Acoustic ceiling tile 1 – Vertical fissure and pinholes	Ceiling	Classroom: 1, 2, 3, 4, 4A, 5, 5A, 6, 7, 8, 9, 10, 11, 12, D, E, F, K 9-12 Wing Boys Washroom, Basement Boys Washroom, Washroom Adjacent Classroom E, First Aid Room (7B), 9-12 Wing Girls Washroom, Basement Girls Washroom, 9-12 Wing Hallway, 2-6 Wing Hallway, Entry Corridor Adjacent Library, Library, Staff Room, Staff Room Corridor, 9-12 Wing Stairway to Basement, Basement Classroom Corridor, Basement Entry Adjacent Stairs	Confirmed	23,070 ft ²	Access A – Accessible to all building users	Friable	Stained and slightly damaged tiles throughout listed areas	Action 3 - ACM removal required for compliance
Acoustic ceiling tile 3 – 12"x12" vertical fissure small and large pinhole	Ceiling	Main Office, First Aid Room Adjacent Main Office, Office A, Office B, Office C	Suspect	845 ft ²	Access A – Accessible to all building users	Friable	Stained and slightly damaged tiles throughout listed areas	Action 3 - ACM removal required for compliance Test prior to impact

Photo 5
Description: Acoustic ceiling tile 1 – Vertical fissure and pinholes
Location: Staff Room
Asbestos: 3% Amosite
Sample(s): 39957-Xb

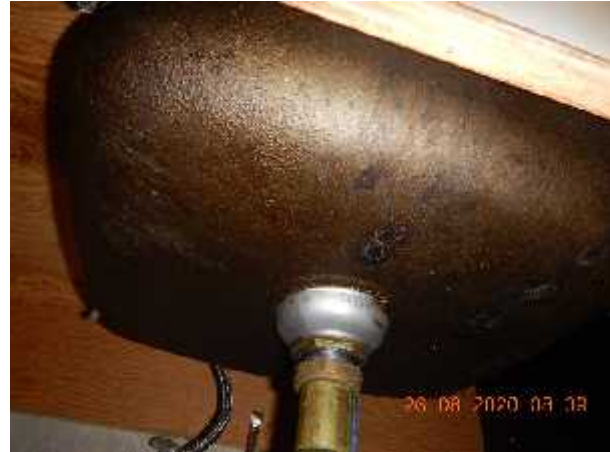
Photo 6
Description: Caulking – Acoustical sink insulation (Black)
Location: Classroom 2 Sink
Asbestos: 2.5% Chrysotile
Sample(s): 30010-6

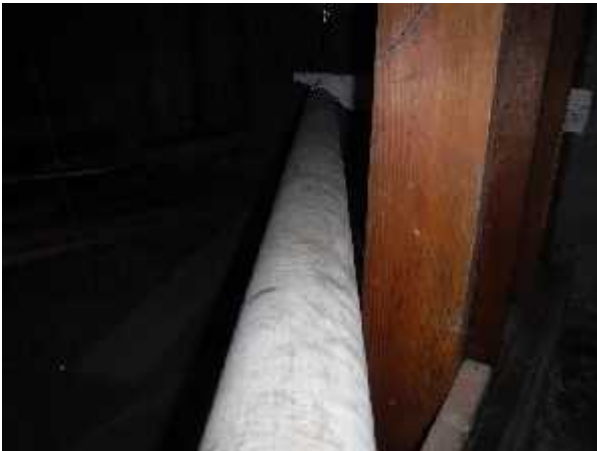
Photo 7
Description: Cement pipe
Location: Crawl Space
Asbestos: 15% Chrysotile
Sample(s): 30010-17

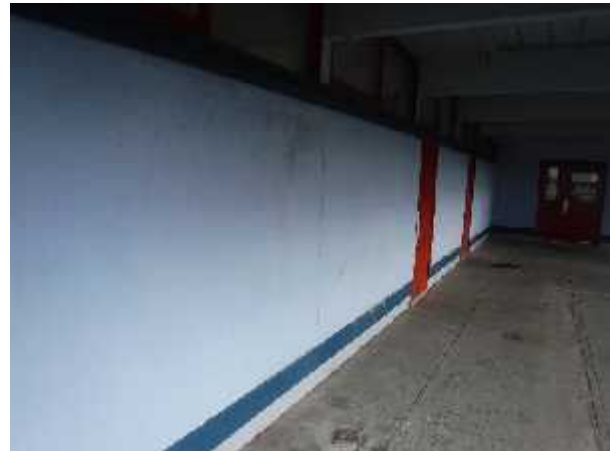
Photo 8
Description: Stucco
Location: Exterior
Asbestos: Suspect

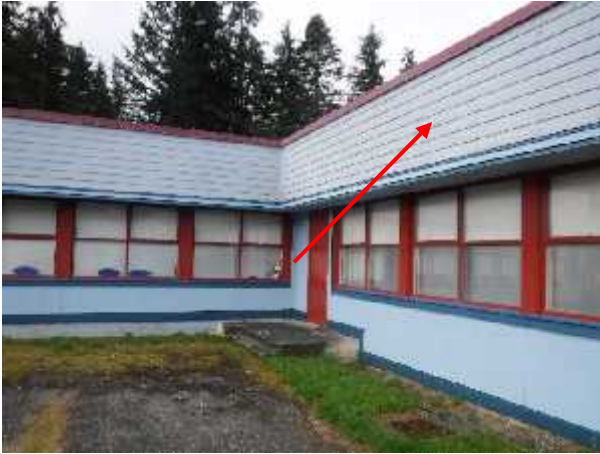
Photo 9
Description: Cement board
Location: Exterior
Asbestos: Suspect

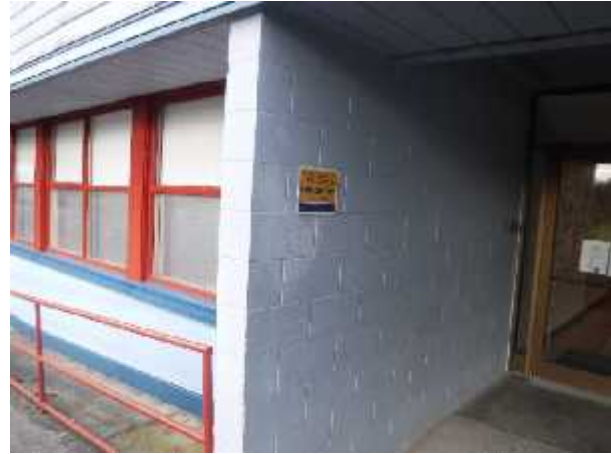
Photo 10
Description: Concrete block wall
Location: Exterior
Asbestos: Suspect

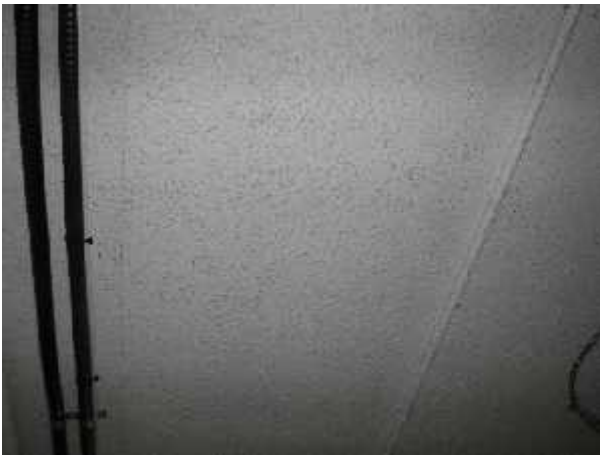
Photo 11
Description: Texture coat
Location: Electrical Room
Asbestos: Suspect

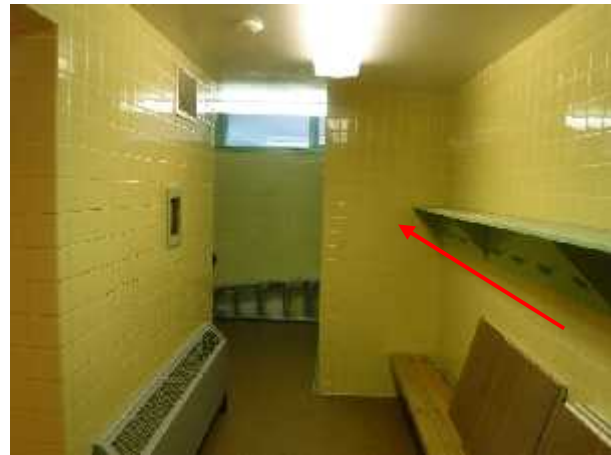
Photo 12
Description: Ceramic tile 1 – 4"x4" beige
Location: Men's Washroom
Asbestos: Suspect concealed asbestos leveling compound(s)

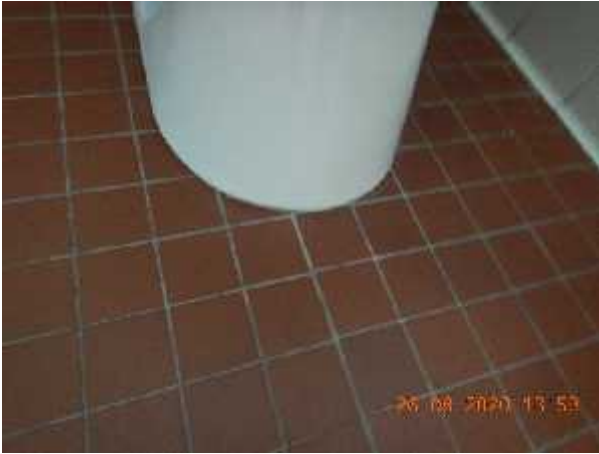
Description	System	Locations	Status	Quantity	Accessibility	Friability	Condition	Mgmt Recommendation
Ceramic tile 2 – 2"x2" brown	Floor	Boys Washroom, 9-12 Wing Boys Washroom, Basement Boys Washroom, Washroom Adjacent Classroom E, 9-12 Wing Girls Washroom, Basement Girls Washroom, Girls Washroom, Janitor Room	Suspect	1,260 ft ²	Access A – Accessible to all building users	Non-Friable	Good	Action 5 – Proactive ACM removal / Action 7 – Routinely monitor condition Test prior to impact

Photo 13
Description: Ceramic tile 2 – 2"x2" brown
Location: Men's Washroom
Asbestos: **Suspect concealed asbestos leveling compound(s)**

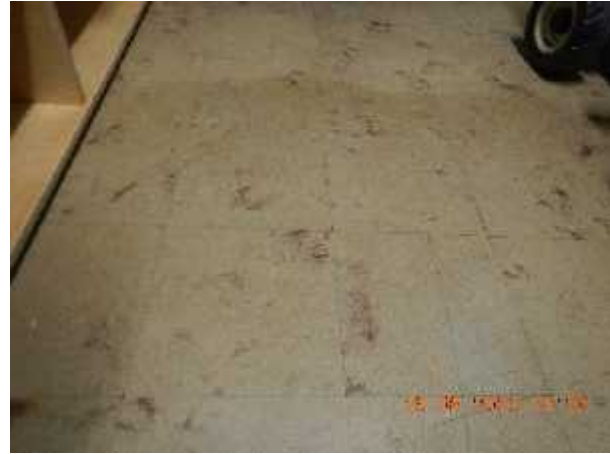
Photo 14
Description: Floor tile 3 – Beige with red streaks
Location: Gym Storage
Asbestos: **Suspect**

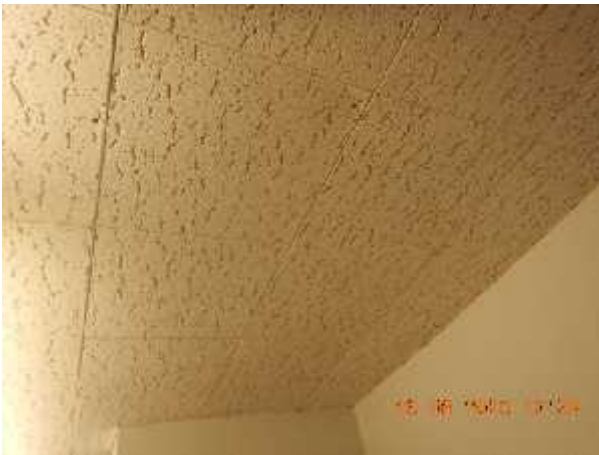
Photo 15
Description: Acoustic ceiling tile 3 – 12"x12" vertical fissure small and large pinhole
Location: Main Office
Asbestos: **Suspect**

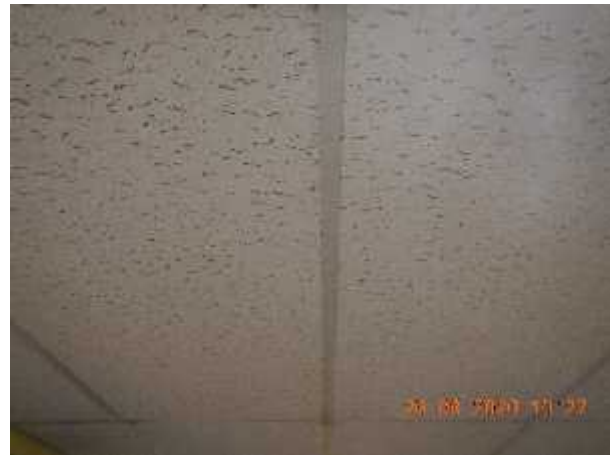
Acoustic ceiling tile 5 – 2'x4' lateral fissure small and large pinhole	Ceiling	Basement Classroom Corridor, Basement Entry Adjacent Stairs	Suspect	25 ft ²	Access A – Accessible to all building users	Friable	Stained and slightly damaged tiles throughout listed areas	Action 3 - ACM removal required for compliance Test prior to impact
Acoustic ceiling tile 6 – 2'x4' small and large pinhole	Ceiling	Basement Classroom Corridor	Suspect	10 ft ²	Access A – Accessible to all building users	Friable	Stained and slightly damaged tiles throughout listed areas	Action 3 - ACM removal required for compliance Test prior to impact
Caulking – Acoustical sink insulation (Black)	Sink	Classroom: 2, 6 Staff Room	Confirmed	3 sinks	Access A – Accessible to all building users	Non-Friable	Good	Action 5 – Proactive ACM removal / Action 7 – Routinely monitor condition Test prior to impact

Photo 16
Description: Acoustic ceiling tile 5 – 2'x4' lateral fissure small and large pinhole
Location: Basement Classroom Corridor
Asbestos: **Suspect**

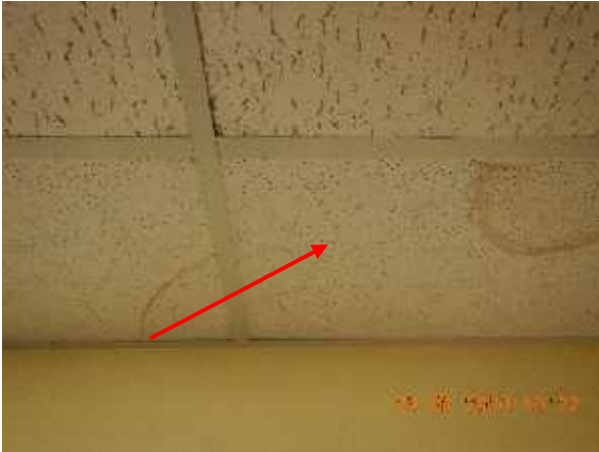
Photo 17
Description: Acoustic ceiling tile 6 – 2'x4' small and large pinhole
Location: Basement Classroom Corridor
Asbestos: Suspect

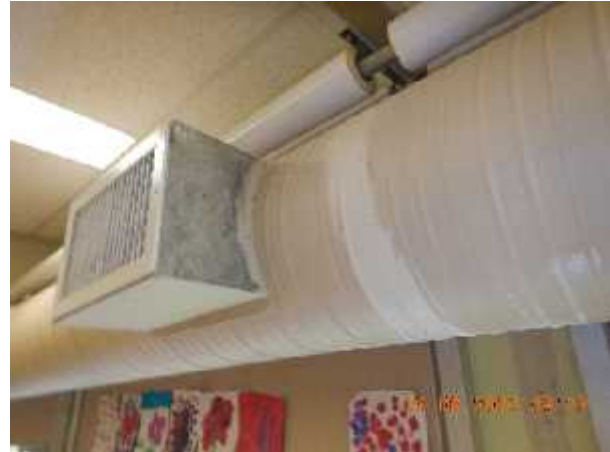
Description	System	Locations	Status	Quantity	Accessibility	Friability	Condition	Mgmt Recommendation
Mastic 1 – Grey (painted white in some locations)	Ducting	Classroom: 7, 12, D, E, F, K Boys Washroom, Corridor Adjacent Basement Washrooms, Crawl Space, Mechanical Room Adjacent Electrical Shop, Basement Girls Washroom, Gym Mechanical Room, Basement Janitor Room, Library, Mechanical Room (Basement Storage), Mechanical Room (Exterior Access),	Suspect	Select areas on ducting in areas listed	Access A – Accessible to all building users	Non- Friable	Good	Action 5 – Proactive ACM removal / Action 7 – Routinely monitor condition Test prior to impact
Mastic 2 – Gold	Sink	Classroom: 1, 3, 4, 5A, 7, 8, 9, 10, 11, 12, D, E, F, K Washroom Adjacent Classroom E, Gym Kitchen, 9-12 Wing Handicap Washroom,	Suspect	18 sinks	Access A – Accessible to all building users	Non- Friable	Good	Action 5 – Proactive ACM removal / Action 7 – Routinely monitor condition Test prior to impact

Photo 18
Description: Mastic 1- Grey (painted white in some locations)
Location: Classroom D
Asbestos: Suspect

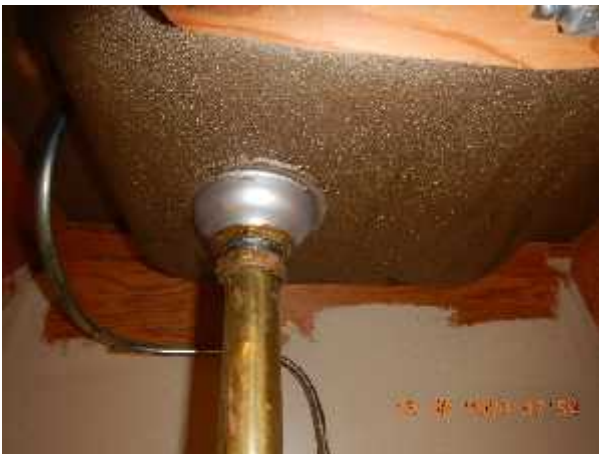
Photo 19
Description: Mastic 2 – Gold
Location: Classroom 7
Asbestos: Suspect

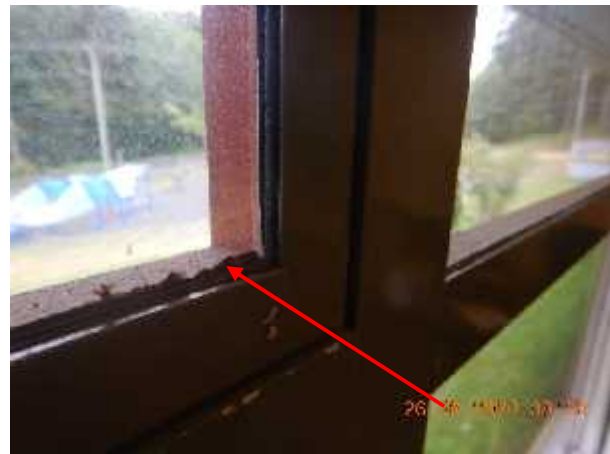
Window putty 1 – Black	Window	Classroom: 1, 2, 3, 4, 4A, 5, 5A, 6, 7, 8, 9, 10, 11, 12, D, E, F 9-12 Wing Boys Washroom, 9-12 Wing Girls Washroom, Library, Main Office, Office A, Office B, Staff Room, 9-12 Wing Stairway to Basement	Suspect	90 windows	Access A – Accessible to all building users	Non- Friable	Good	Action 5 – Proactive ACM removal / Action 7 – Routinely monitor condition Test prior to impact
Stair tread – Marbled grey	Stairs	9-12 Wing Stairway to Basement	Suspect	200 ft ²	Access A – Accessible to all building users	Non- Friable	Good	Action 5 – Proactive ACM removal / Action 7 – Routinely monitor condition Test prior to impact
Penetration caulking – Red	Wall	Boiler/Hot Water Room	Suspect	Select locations throughout areas listed	Access B – Accessible to maintenance workers	Non- Friable	Good	Action 5 – Proactive ACM removal / Action 7 – Routinely monitor condition Test prior to impact

Photo 20
Description: Window putty 1 – Black
Location: Classroom 11
Asbestos: Suspect

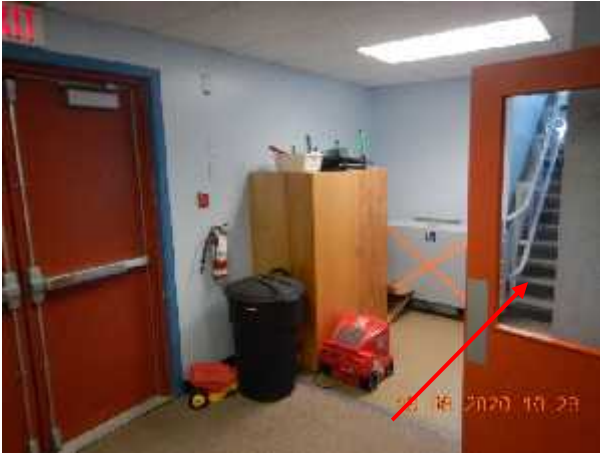
Photo 21
Description: Stair tread – Marbled grey
Location: 9-12 Wing Stairway to Basement
Asbestos: Suspect

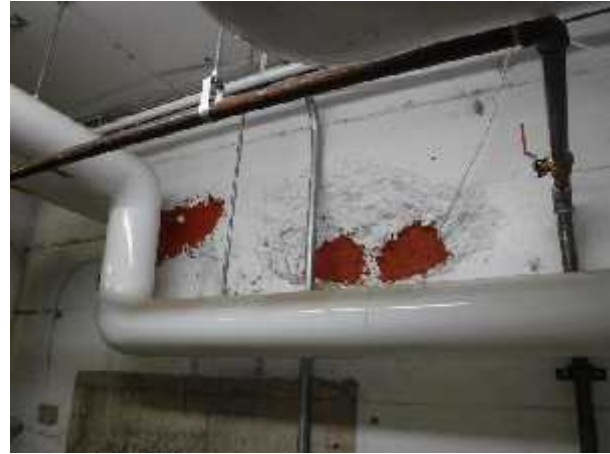
Photo 22
Description: Penetration caulking – Red
Location: Boiler/Hot Water Room
Asbestos: Suspect

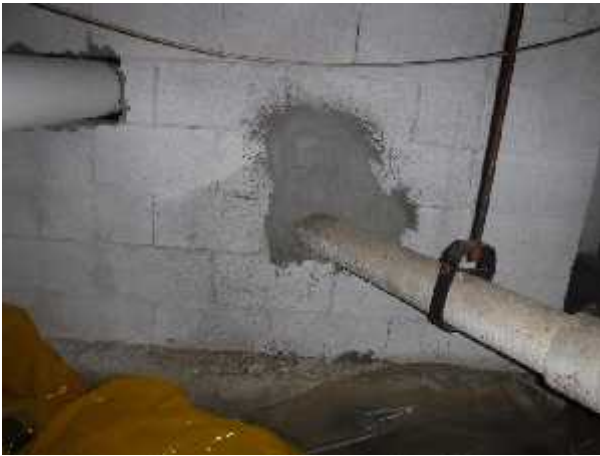
Parging – Grey	Wall	Crawl Space	Suspect	Select locations throughout areas listed	Access B – Accessible to maintenance workers	Non- Friable	Good	Action 5 – Proactive ACM removal / Action 7 – Routinely monitor condition Test prior to impact
Cement pipe	Plumbing	Crawl Space	Confirmed	55 linear feet	Access B – Accessible to maintenance workers	Non- Friable	Good	Action 5 – Proactive ACM removal / Action 7 – Routinely monitor condition Test prior to impact
Cement pipe – Painted blue	Plumbing	Gym	Suspect	50 linear feet	Access C(e) – Exposed over 8 ft	Non- Friable	Good	Action 5 – Proactive ACM removal / Action 7 – Routinely monitor condition Test prior to impact

Photo 23
Description: Parging – Grey
Location: Crawl Space
Asbestos: Suspect

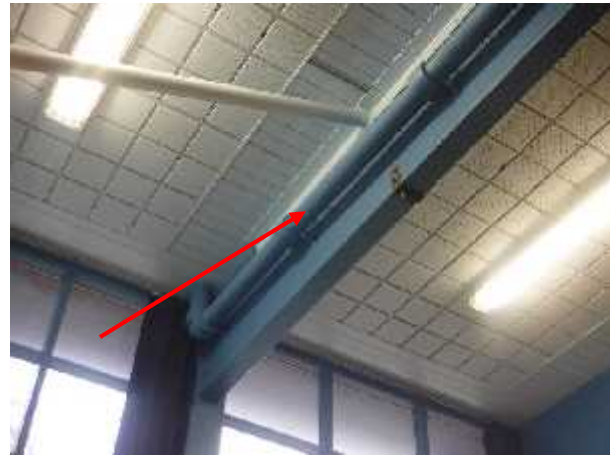
Photo 24
Description: Cement pipe – Painted blue
Location: Gym
Asbestos: Suspect

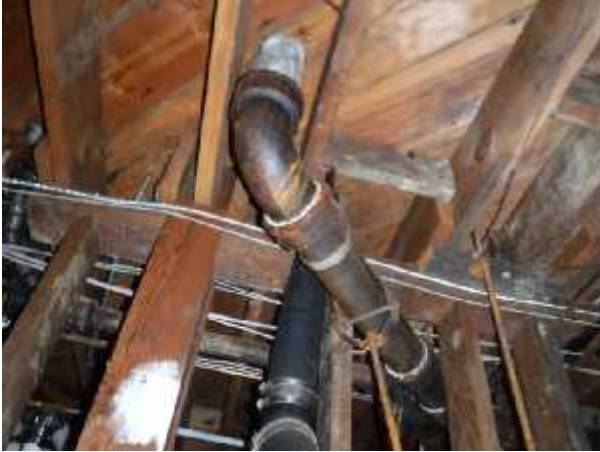
Description	System	Locations	Status	Quantity	Accessibility	Friability	Condition	Mgmt Recommendation
Bell and spigot pipe gaskets	Plumbing	Crawl Space, Mechanical Room Adjacent Electrical Shop	Suspect	103 gaskets	Access B – Accessible to maintenance workers	Non- Friable	Good	Action 5 – Proactive ACM removal / Action 7 – Routinely monitor condition Test prior to impact
Pipe gaskets	Piping	Boiler/Hot Water Room	Suspect	4 gaskets	Access B – Accessible to maintenance workers	Non- Friable	Good	Action 5 – Proactive ACM removal / Action 7 – Routinely monitor condition Test prior to impact
Baseboard adhesive	Wall	Throughout building	Suspect	Throughout building	Access A – Accessible to all building users	Non- Friable	Good	Action 5 – Proactive ACM removal / Action 7 – Routinely monitor condition Test prior to impact

Photo 25
Description: Bell and spigot pipe gaskets
Location: Crawl Space
Asbestos: Suspect

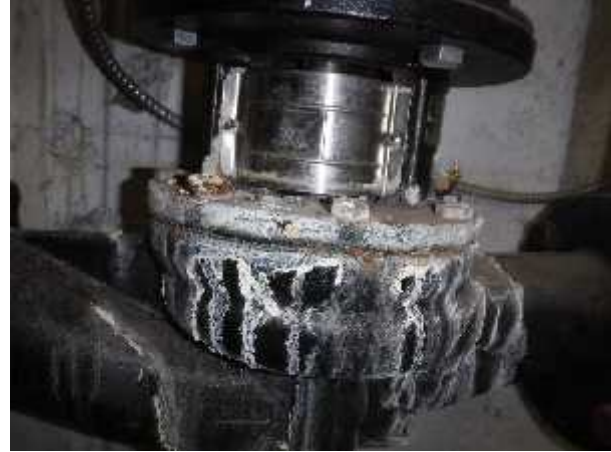
Photo 26
Description: Pipe gaskets
Location: Boiler/Hot Water Room
Asbestos: Suspect

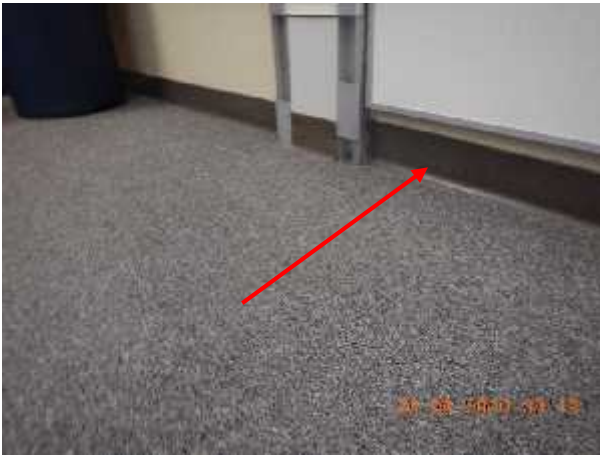
Photo 27
Description: Baseboard adhesive
Location: Classroom 3
Asbestos: Suspect
