School District 85

Seaview Carpentry Shop 901 Marine Drive, Port Alice, BC Asbestos Management Inventory

NWest File: 39957 AMI1 V1.0
Date Issued: November 16, 2020

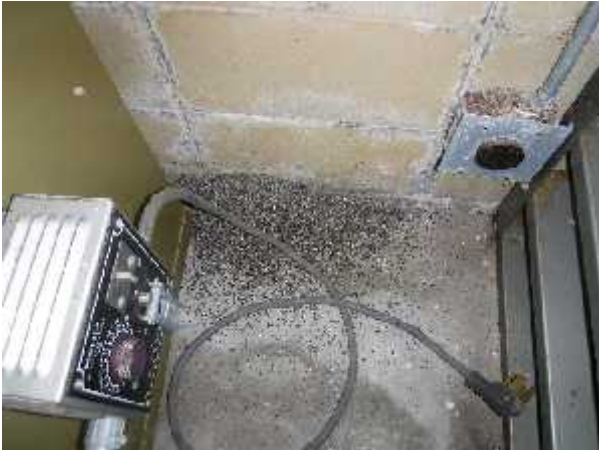
Photo 1
Description: Concrete block (contains vermiculite insulation)
Location: Storage Room B
Asbestos: 0.5% Actinolite
Sample(s): 39957-53b

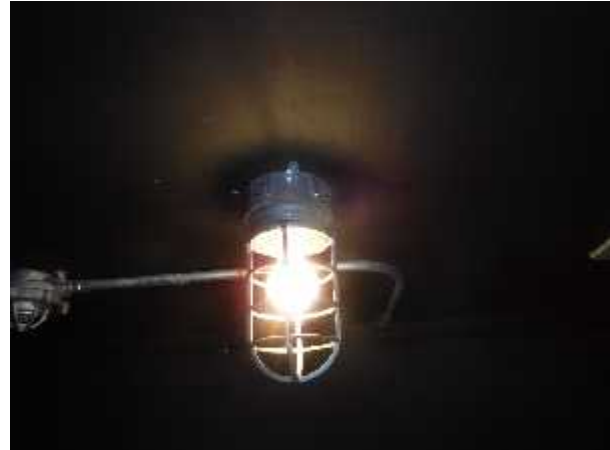
Photo 2
Description: Gasket 1
Location: Dark Room
Asbestos: Suspect

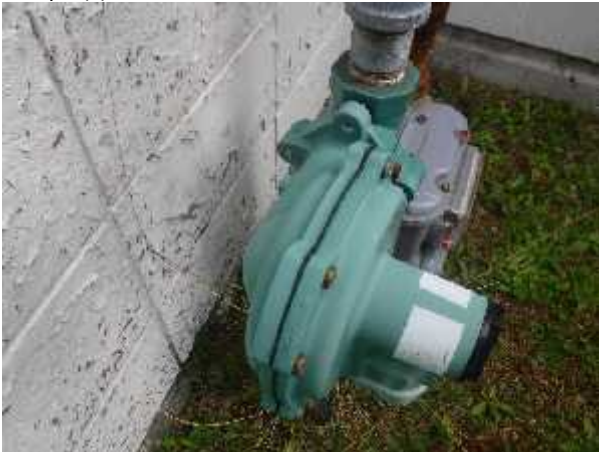
Gasket 2	Plumbing	Exterior	Suspect	1 gasket	Access A – Accessible to all building users	Non-friable	Good	Action 5 – Proactive ACM removal / Action 7 – Routinely monitor condition Test prior to impact
Drywall with joint compound	Ceiling	Boiler Room	Suspect	120 ft ²	Access A – Accessible to all building users	Non-friable	Good	Action 5 – Proactive ACM removal / Action 7 – Routinely monitor condition Test prior to impact
Drywall with joint compound	Wall	Dark Room	Suspect	100 ft ²	Access A – Accessible to all building users	Non-friable	Good	Action 5 – Proactive ACM removal / Action 7 – Routinely monitor condition Test prior to impact

Photo 3
Description: Gasket 2
Location: Exterior
Asbestos: Suspect

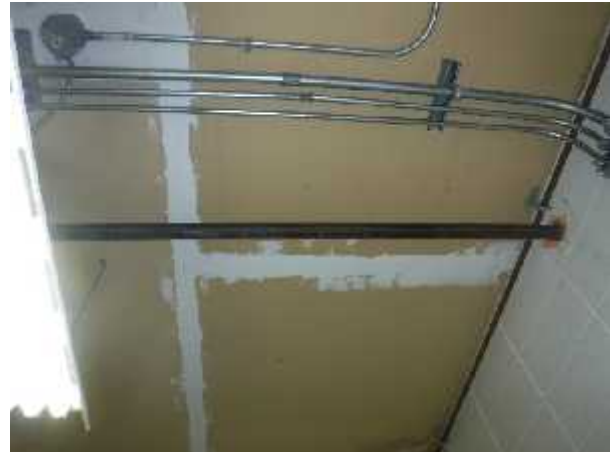
Photo 4
Description: Drywall with joint compound
Location: Boiler Room
Asbestos: Suspect

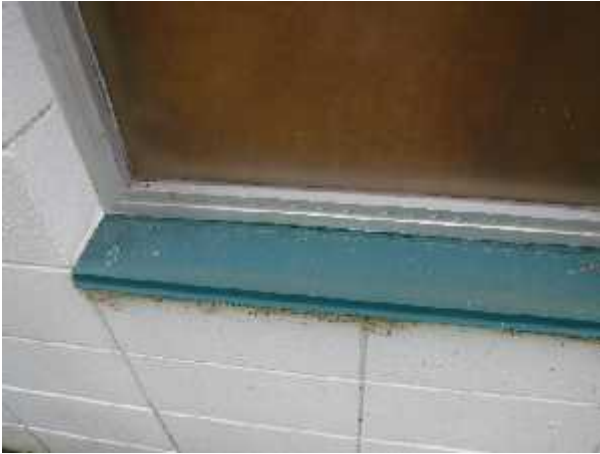
Photo 5
Description: Caulking 1 – Grey
Location: Exterior
Asbestos: Suspect

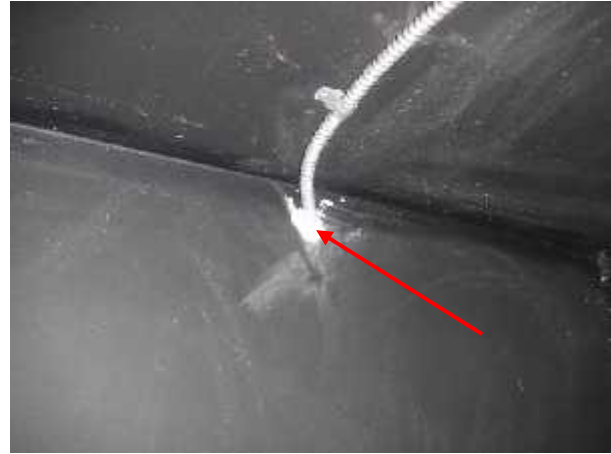
Photo 6
Description: Penetration insulation 1 – White
Location: Dark Room
Asbestos: Suspect

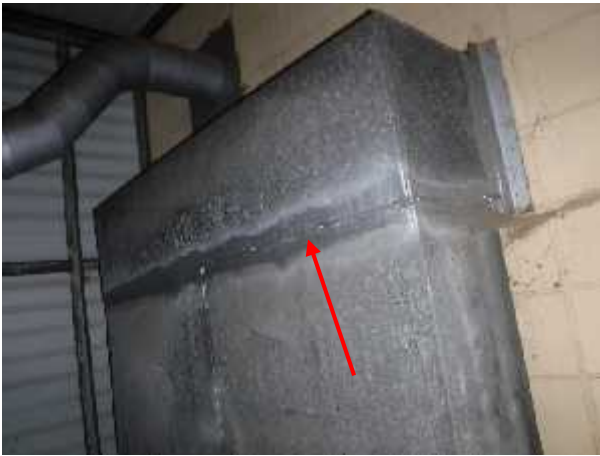
Photo 7
Description: Mastic – Grey
Location: Dust Collection Room
Asbestos: Suspect

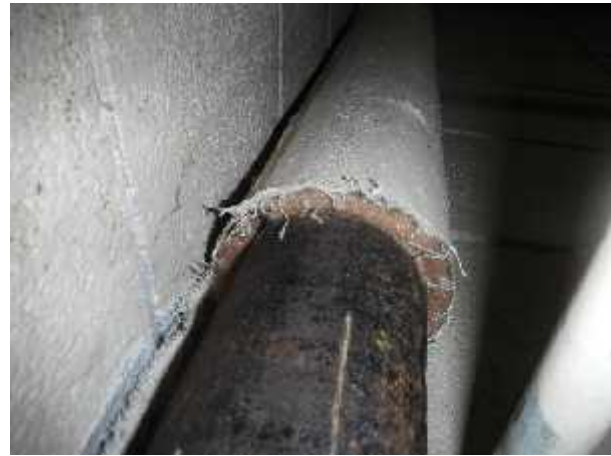
Photo 8
Description: Texture wrapped fibreglass insulation
Location: Welding Room
Asbestos: Suspect
