**Sea View Elementary School  
1120 Nigei Street, Port Alice, BC  
Asbestos Management Inventory**

**North West  
Environmental Group Ltd.**

NWest File: 39957 AMI V1.0  
Date Issued: November 16, 2020

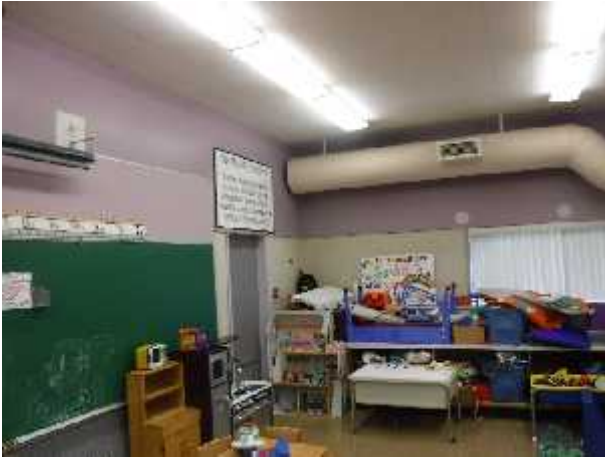
Photo 1  
Description: Drywall Joint Compound  
Location: Classroom 1  
**Asbestos: 1.6% Chrysotile**  
Sample(s): 30709-8 (layer 2)

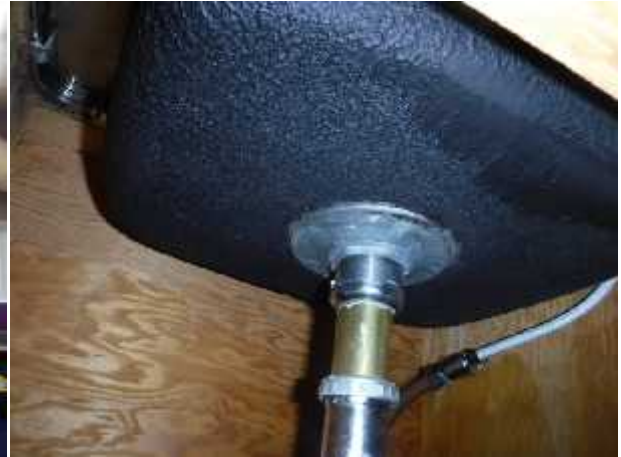
Photo 2  
Description: Mastic – Black on Sink  
Location: Classroom 1  
**Asbestos: 10% Chrysotile**  
Sample(s): 30709-7

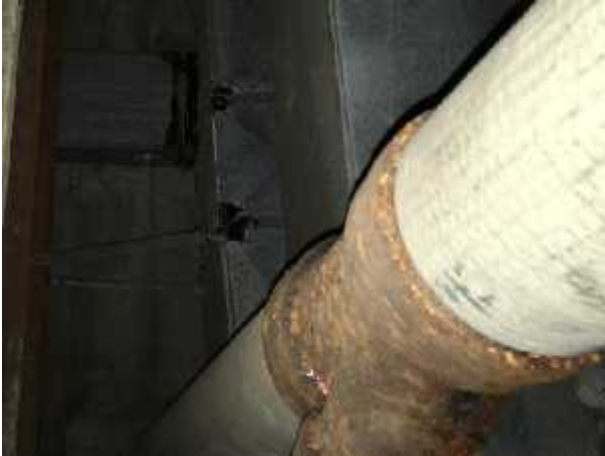
Photo 3  
Description: Cement Pipe  
Location: Crawlspace  
**Asbestos: 30% Chrysotile  
10% Crocidolite**  
Sample(s): 30709-11

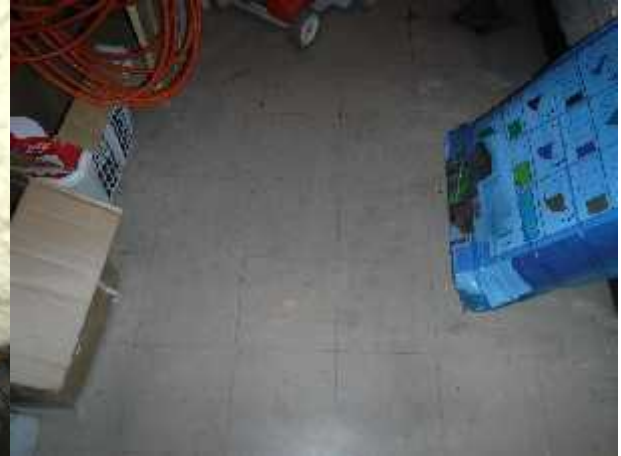
Photo 4  
Description: Floor Tile 3: 9"x9" beige tile  
Location: Custodian/Janitor Room  
**Asbestos: 1.2% Chrysotile**  
Sample(s): 30709-11

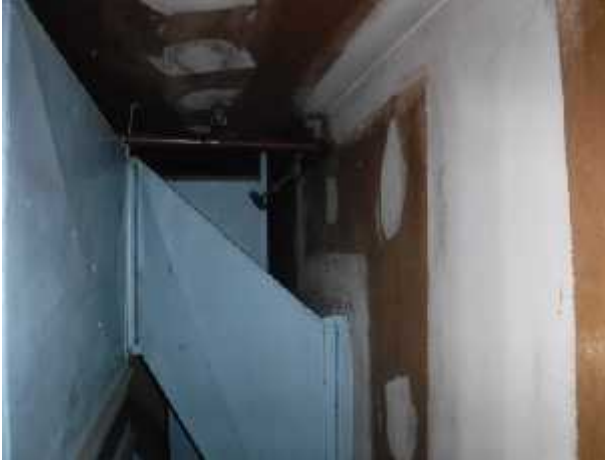
Photo 5  
Description: Ductwork caulking (grey)  
Location: Mechanical Room  
**Asbestos: 10% Chrysotile**  
Sample(s): 30709-21b

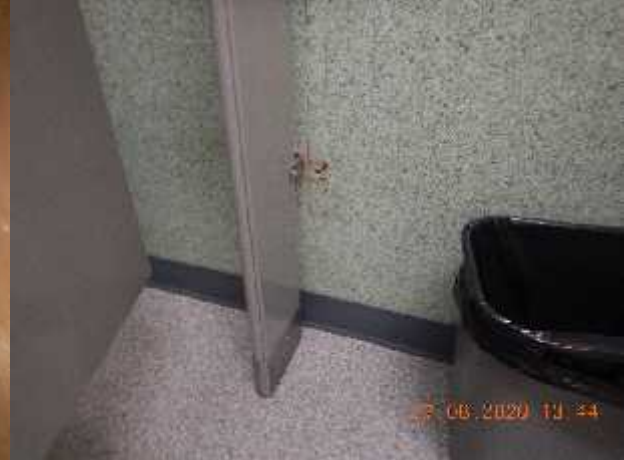
Photo 6  
Description: Cement board  
Location: Storage Room  
**Asbestos: 31% Chrysotile**  
Sample(s): 39957-56b

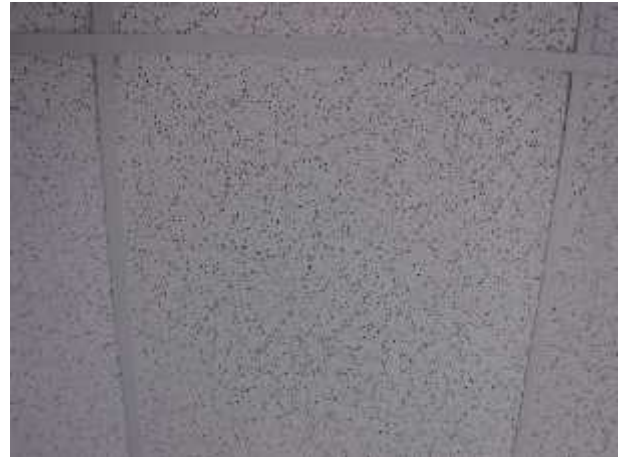
Photo 8  
Description: Ceiling tile (acoustic) type 1 - patterned fissure  
Location: Classroom 5  
**Asbestos: Suspect**

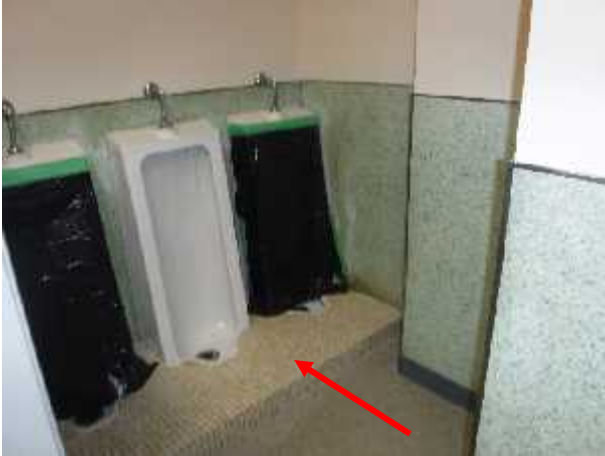
Photo 9  
Description: 1"x1" White and gold ceramic tile grout and thinset  
Location: Boy's Washroom  
**Asbestos: Suspect**

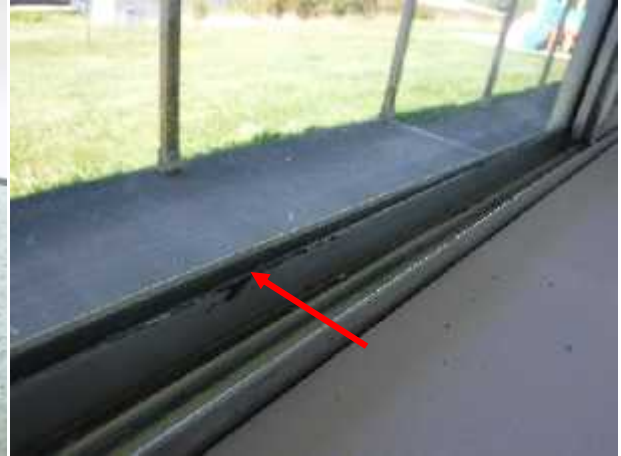
Photo 10  
Description: Window putty – Black  
Location: Classroom 1  
**Asbestos: Suspect**

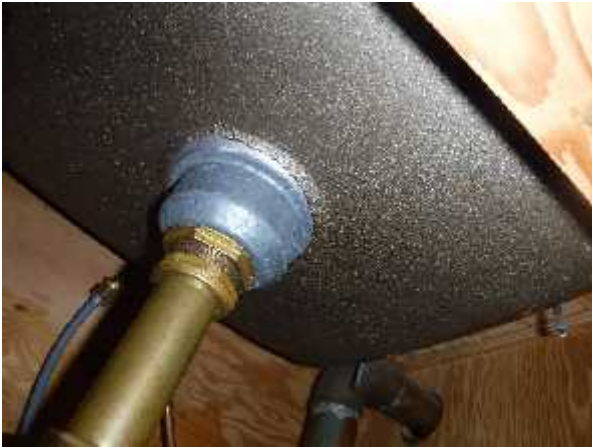
Photo 11  
Description: Mastic – Gold on sink  
Location: Teachers Work Area  
**Asbestos: Suspect**

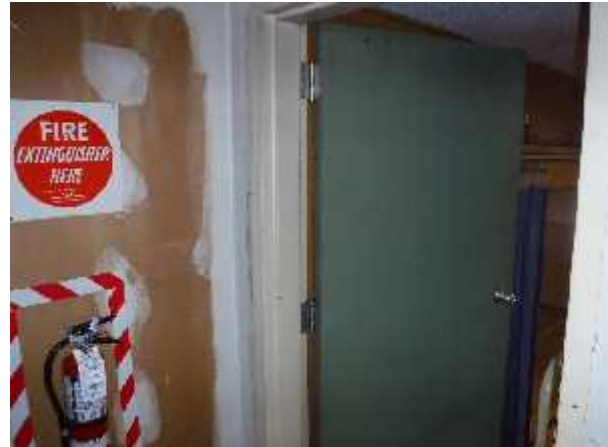
Photo 12  
Description: Fire door  
Location: Mechanical Room  
**Asbestos: Suspect**

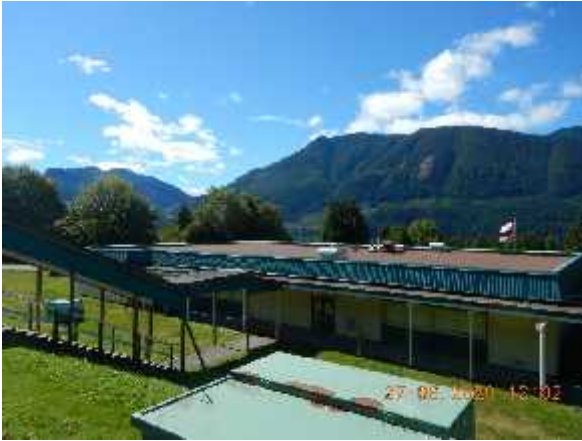
Photo 13  
Description: Torch-on roofing  
Location: Building roof  
**Asbestos:** **Suspect**

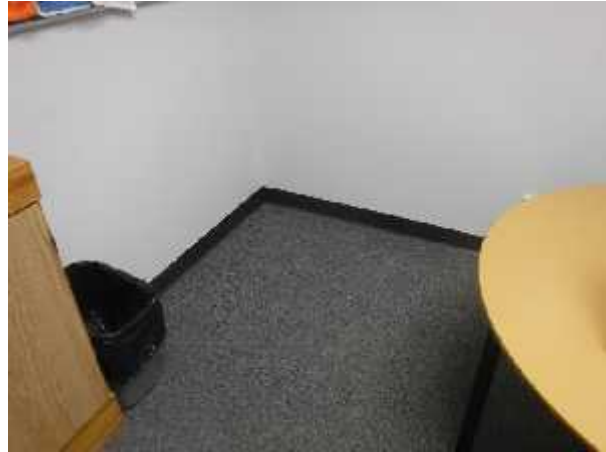
Photo 14  
Description: Baseboard adhesive  
Location: Library office  
**Asbestos:** **Suspect**

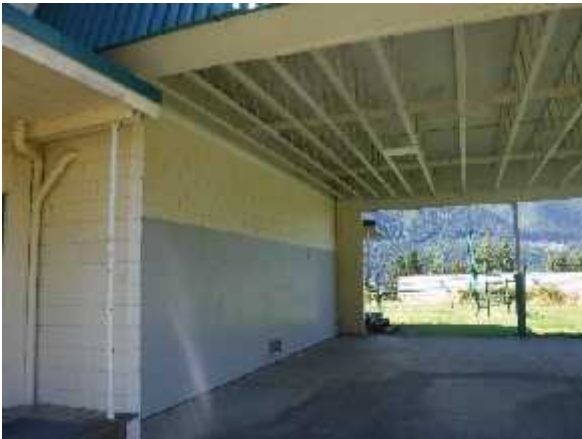
Photo 15  
Description: Potential vermiculite insulation in concrete block wall cavities  
Location: Gym  
**Asbestos:** **Suspect**
