## School District 85

**Sea View Secondary School  
1120 Nigei Street, Port Alice, BC  
Asbestos Management Inventory**

NWest File: 39957 AMI V1.0  
Date Issued: November 16, 2020

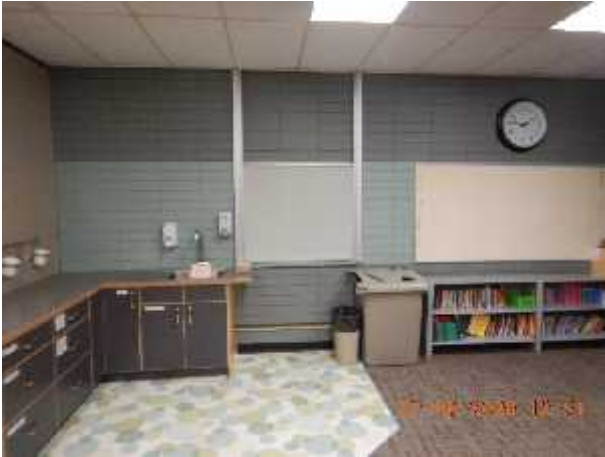
Photo 1  
Description: Sheet flooring type 3 – unknown pattern below sheet flooring type 2 (circles pattern)  
Location: Room 2  
**Asbestos: 15% Chrysotile**  
Sample(s): 30012-7 (layer 1)

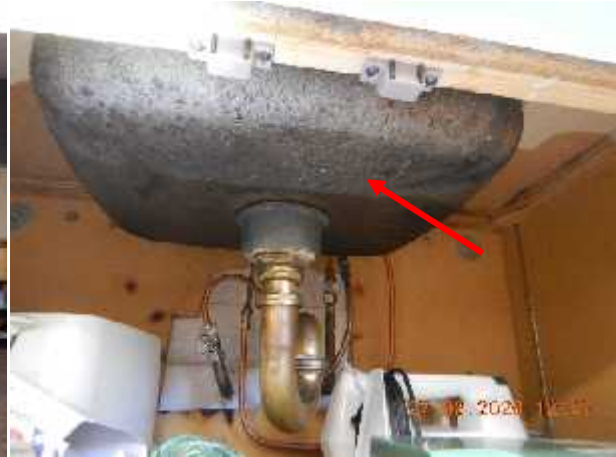
Photo 2  
Description: Mastic – Black/brown on sink  
Location: Room 1  
**Asbestos: 3.2% Chrysotile**  
Sample(s): 30012-9

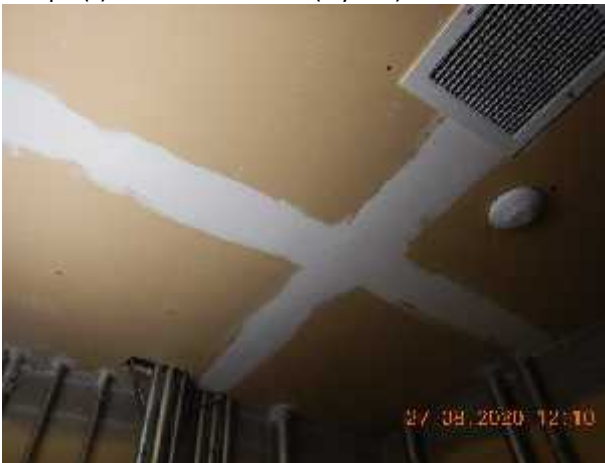
Photo 3  
Description: Drywall joint compound  
Location: Electrical Room  
**Asbestos: Suspect**

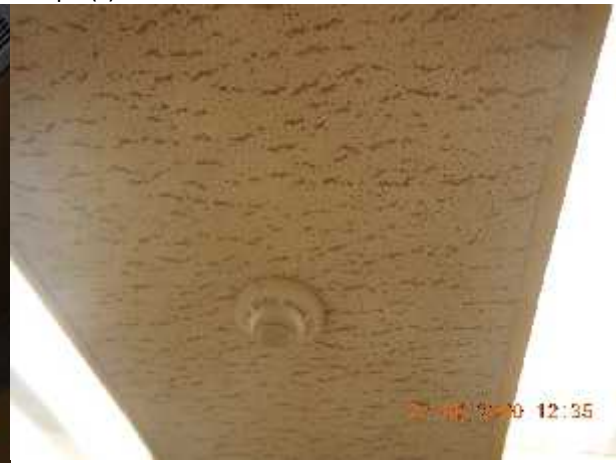
Photo 4  
Description: Ceiling tile (acoustic) type 3 – vertical fissure with small and large pinholes  
Location: Janitor/ Custodian Room  
**Asbestos: Suspect**

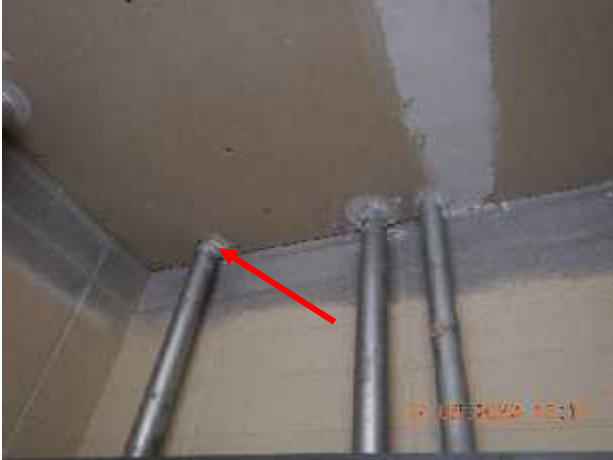
Photo 5  
Description: Penetration caulking – white  
Location: Electrical Room  
Asbestos: Suspect

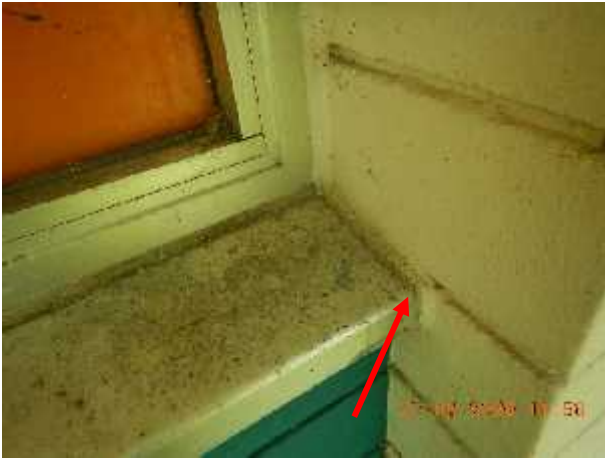
Photo 7  
Description: Window caulking – grey/black  
Location: Exterior  
Asbestos: Suspect

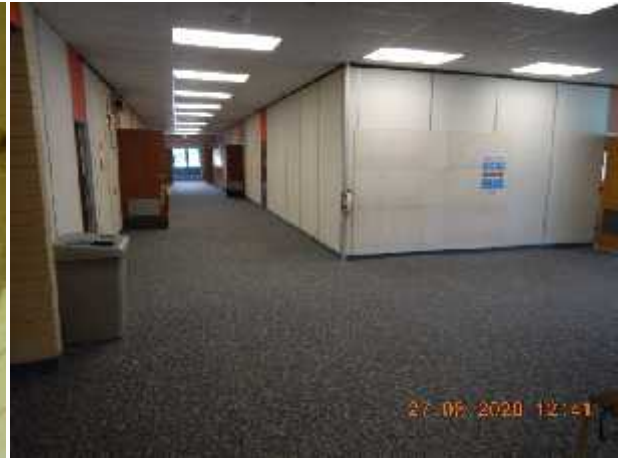
Photo 8  
Description: Carpet adhesive  
Location: Hallway  
Asbestos: Suspect

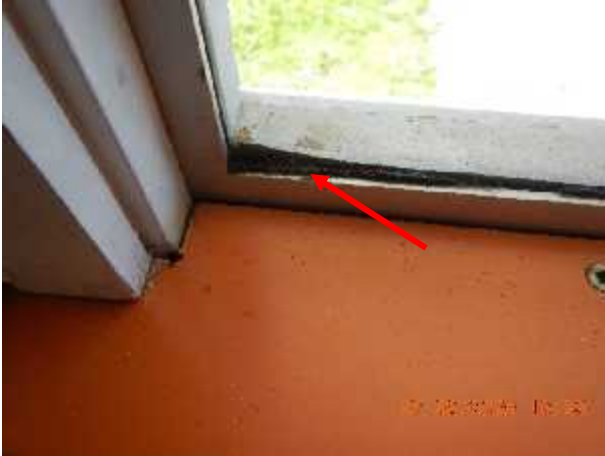
Photo 9  
Description: Window putty – black  
Location: Room 5  
**Asbestos: Suspect**

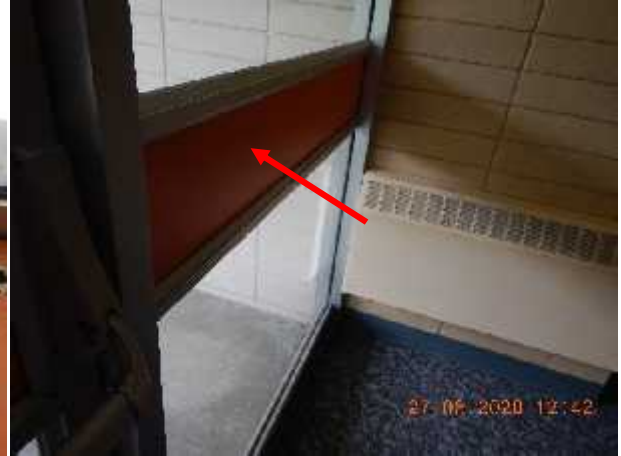
Photo 10  
Description: Door panels  
Location: Foyer (West Entrance)  
**Asbestos: Suspect**

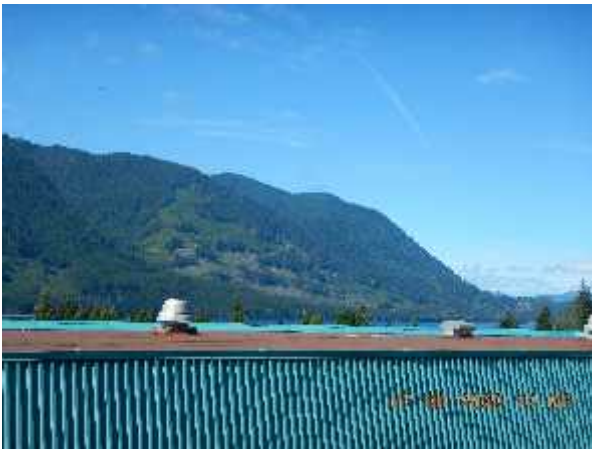
Photo 11  
Description: Torch on roofing  
Location: Building roof  
**Asbestos: Suspect**

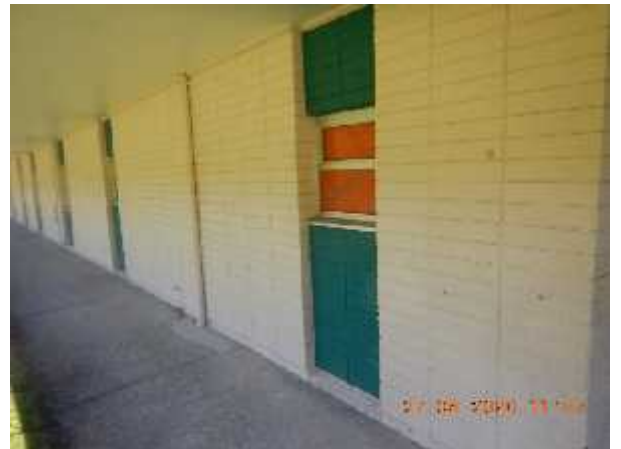
Photo 12  
Description: Vermiculite insulation  
Location: Perimeter walls  
**Asbestos: Suspect**

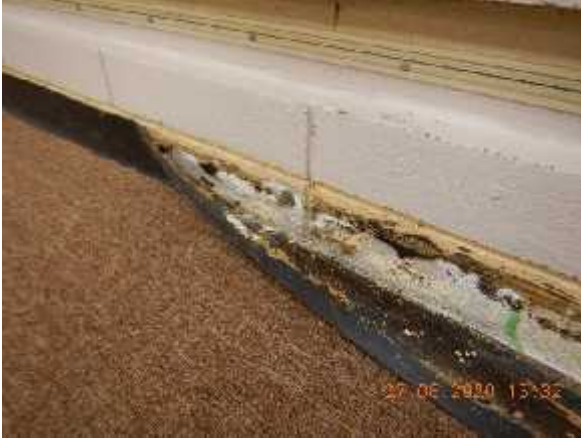
Photo 13  
Description: Baseboard adhesive  
Location: Room 4  
**Asbestos:** **Suspect**

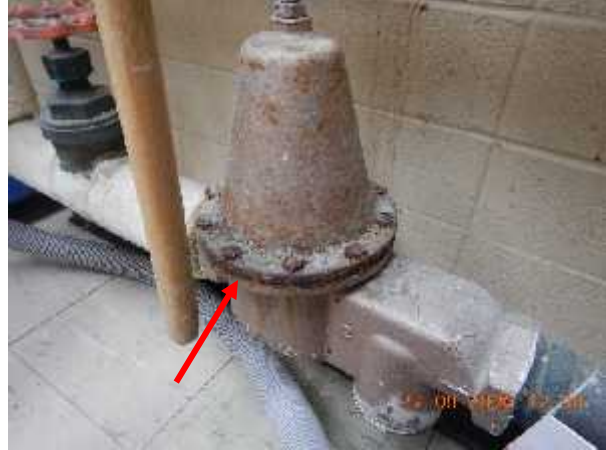
Photo 14  
Description: Fitting gasket  
Location: Janitor / Custodian Room  
**Asbestos:** **Suspect**
