## School District 85

### Seaview Activity Centre 901 Marine Drive, Port Alice, BC Asbestos Management Inventory

NWest File: 39957 AMI1 V1.0  
Date Issued: November 16, 2020

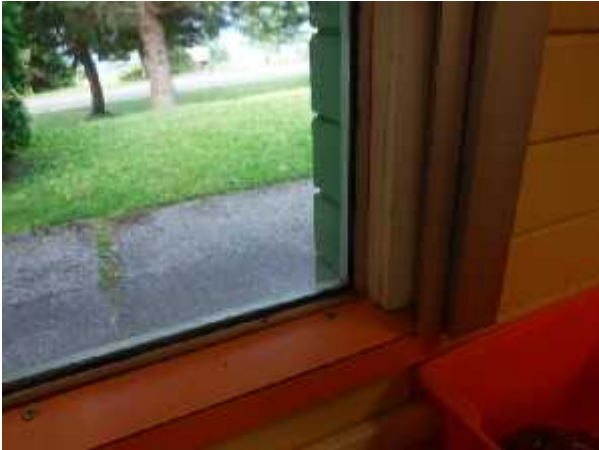
Photo 1  
Description: Window putty (Black)  
Location: Thrift Store  
**Asbestos: 12% Chrysotile**  
Sample(s): 39957-51

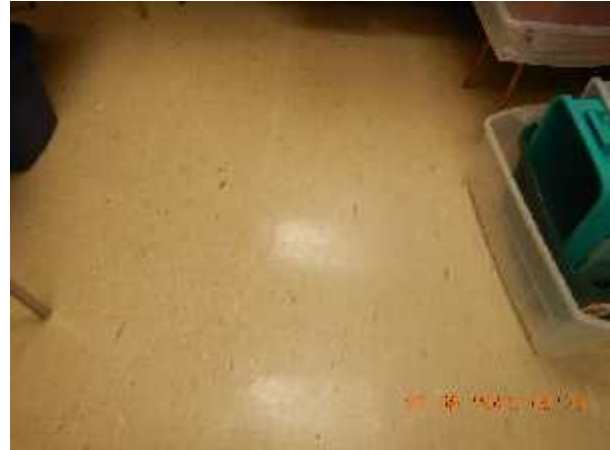
Photo 2  
Description: Floor tile 1 – Beige 12"x12" with white/black smear  
Location: Staff Room  
**Asbestos: 2.3% Chrysotile**  
Sample(s): 30710-2

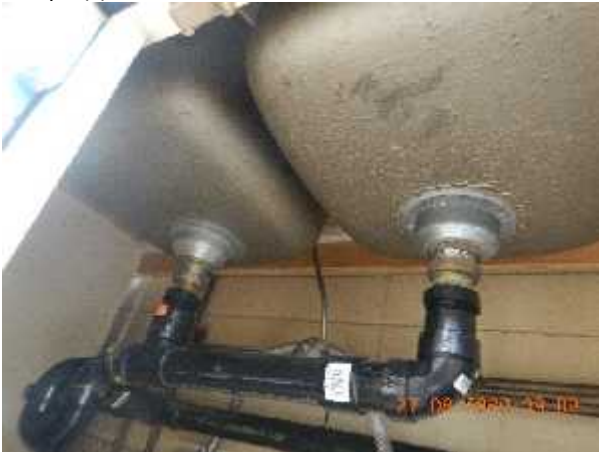
Sink mastic – Gold	Sink	Room 2, Room 4 (Home Economic), Staff Room,	Confirmed	6 sinks	Access A – Accessible to all building users	Non-friable	Good	Action 5 – Proactive ACM removal / Action 7 – Routinely monitor condition Test prior to impact

Photo 3  
Description: Sink mastic – Gold  
Location: Room 4 (Home Economics)  
**Asbestos: 1.9% Chrysotile**  
Sample(s): 30710-6

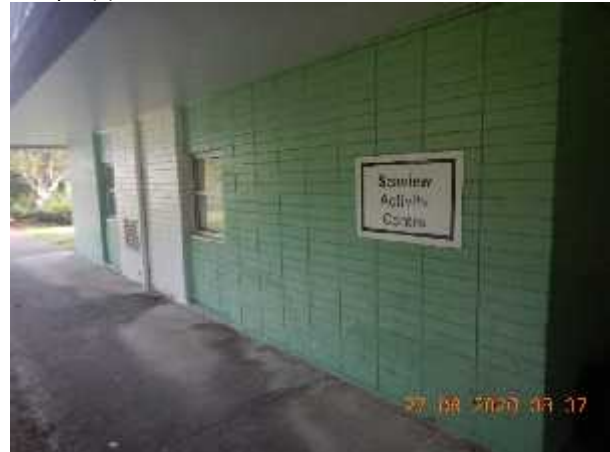
Photo 4  
Description: Concrete black (may contain vermiculite)  
Location: Exterior  
**Asbestos: Suspect**

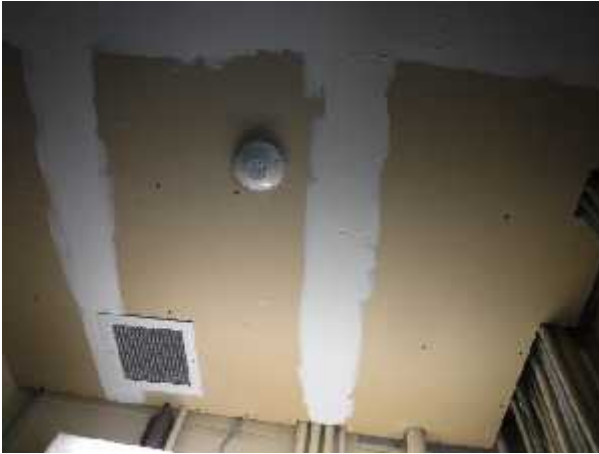
Photo 5  
Description: Drywall with joint compound  
Location: Electrical Room  
Asbestos: Suspect

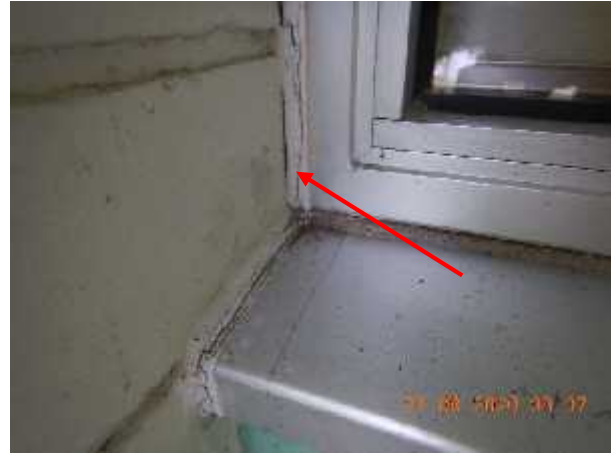
Photo 6  
Description: Caulking type 1 – Grey  
Location: Exterior  
Asbestos: Suspect

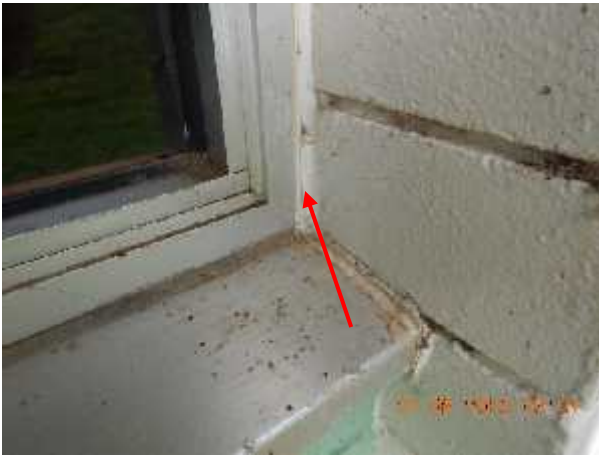
Description	System	Locations	Status	Quantity	Accessibility	Friability	Condition	Mgmt Recommendation
Caulking type 2 – White	Window	Exterior	Suspect	All exterior windows	Access A – Accessible to all building users	Non-friable	Good	Action 5 – Proactive ACM removal / Action 7 – Routinely monitor condition Test prior to impact
Acoustic ceiling tile 1 – Patterned fissure small and large pinholes	Ceiling	Book Store off Thrift Store, Boys Washroom, Foyer, Girls Washroom, Hallway, Janitor’s Room, Office A, Office B, Office C, Room 2, Room 2 Storage, Room 3 (Weight Room), Room 4 (Home Economic), Room 5, Staff Room, Washroom 1, Washroom 2 (Gentlemen),	Suspect	5,060 ft <sup>2</sup>	Access A – Accessible to all building users	Friable	Good	Action 5 – Proactive ACM removal / Action 7 – Routinely monitor condition Test prior to impact
Acoustic ceiling tile 2 – Lateral fissure	Ceiling	Book Store off Thrift Store, Hallway	Suspect	60 ft <sup>2</sup>	Access A – Accessible to all building users	Friable	Good	Action 5 – Proactive ACM removal / Action 7 – Routinely monitor condition Test prior to impact

Photo 5  
Description: Caulking type 2 – White  
Location: Exterior  
Asbestos: Suspect

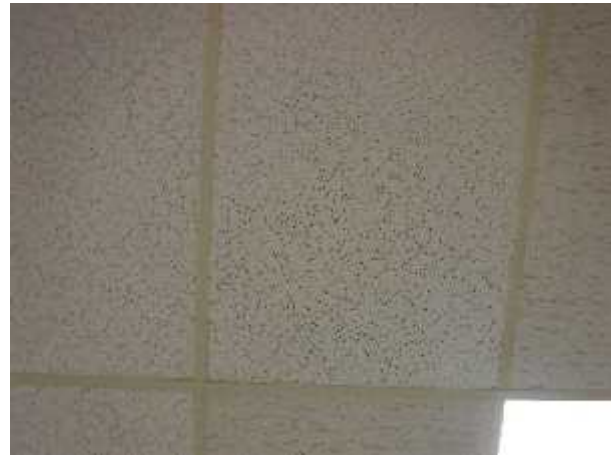
Photo 6  
Description: Acoustic ceiling tile 1 – Patterned  
fissure small and large pinholes  
Location: Hallway  
Asbestos: Suspect

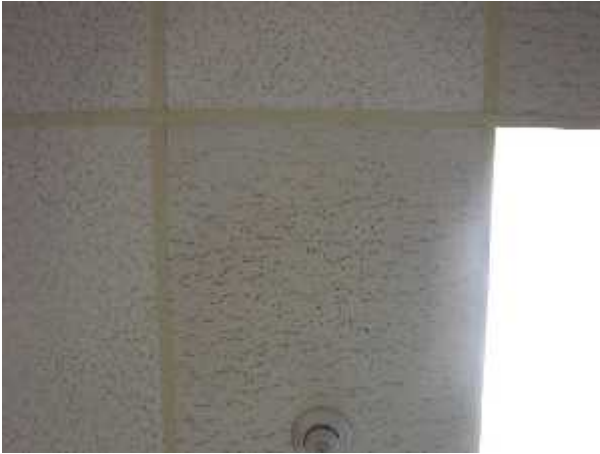
Photo 5  
Description: Acoustic ceiling tile 2 – Lateral fissure  
Location: Hallway  
**Asbestos: Suspect**

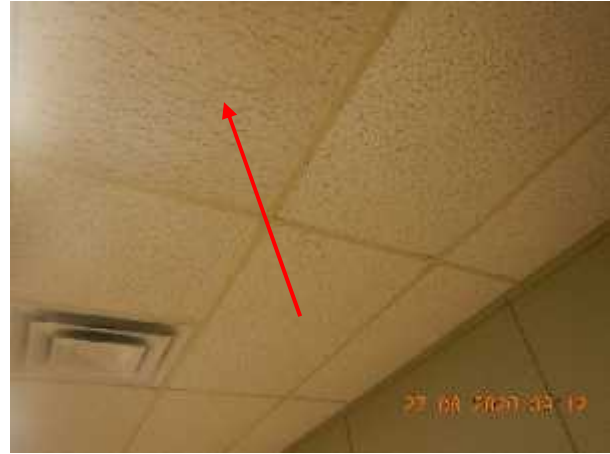
Acoustic ceiling tile 3 – Vertical fissure	Ceiling	Boys Washroom, Foyer, Girls Washroom, Office A, Office B, Room 2, Room 2 Storage, Room 3 (Weight Room), Room 4 (Home Economic), Room 5, Staff Room, Thrift Store, Washroom 1, Washroom 2 (Gentlemen),	Suspect	345 ft <sup>2</sup>	Access A – Accessible to all building users	Friable	Good	Action 5 – Proactive ACM removal / Action 7 – Routinely monitor condition Test prior to impact
Window Putty – Black	Window	Book Store off Thrift Store, Girls Washroom, Office A, Room 2, Room 3 (Weight Room), Room 4 (Home Economic), Room 5, Thrift Store,	Confirmed	23 windows	Access A – Accessible to all building users	Non-friable	Good	Action 5 – Proactive ACM removal / Action 7 – Routinely monitor condition Test prior to impact
Floor tile 1 – Beige 12”x12” with white/black smear	Floor	Boys Washroom, Electrical Room, Foyer, Girls Washroom, Hallway, Janitor’s Room, Room 2, Room 2 Storage, Room 4 (Home Economic), Staff Room, Washroom 1, Washroom 2 (Gentlemen),	Confirmed	4,290 ft <sup>2</sup>	Access A – Accessible to all building users	Non-friable	Good	Action 5 – Proactive ACM removal / Action 7 – Routinely monitor condition Test prior to impact

Photo 6  
Description: Acoustic ceiling tile 3 – Vertical fissure  
Location: Room 2  
**Asbestos: Suspect**

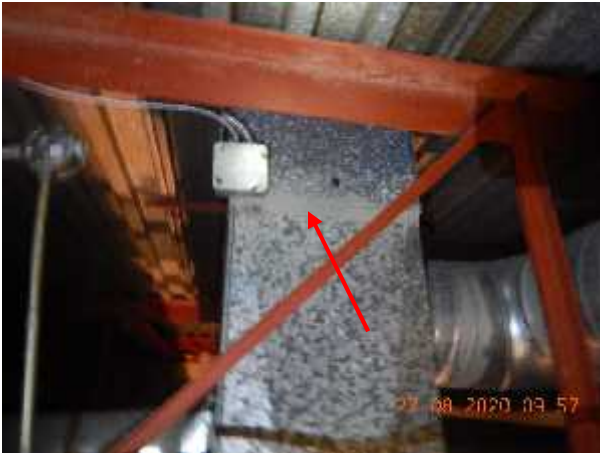
Description	System	Locations	Status	Quantity	Accessibility	Friability	Condition	Mgmt Recommendation
Duct mastic – Grey	HVAC	Janitor’s Room	Suspect	Concealed (assumed on all ducting throughout building)	Access B – Accessible to maintenance workers	Non-friable	Good	Action 5 – Proactive ACM removal / Action 7 – Routinely monitor condition Test prior to impact
Black mastic on fibreglass pipe insulation	Lagging	Janitor’s Room	Suspect	Patches on insulation in areas listed	Access B – Accessible to maintenance workers	Non-friable	Good	Action 5 – Proactive ACM removal / Action 7 – Routinely monitor condition Test prior to impact
Gasket	Piping	Janitor’s Room	Suspect	1 gasket	Access B – Accessible to maintenance workers	Non-friable	Good	Action 5 – Proactive ACM removal / Action 7 – Routinely monitor condition Test prior to impact
Fume hood liner	Fume hood	Room 2	Suspect	1 fume hood	Access A – Accessible to all building users	Non-friable	Good	Action 5 – Proactive ACM removal / Action 7 – Routinely monitor condition Test prior to impact

Photo 5  
Description: Duct mastic – Grey  
Location: Janitor's Room  
**Asbestos: Suspect**

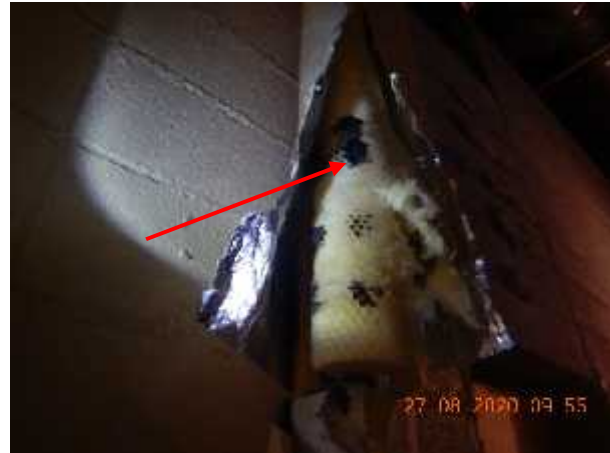
Photo 6  
Description: Black mastic on fibreglass pipe insulation  
Location: Janitor's Room  
**Asbestos: Suspect**

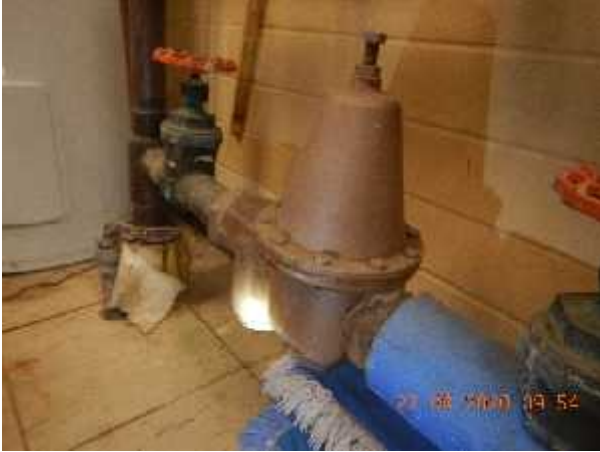
Photo 5  
Description: Gasket  
Location: Janitor's Room  
**Asbestos: Suspect**

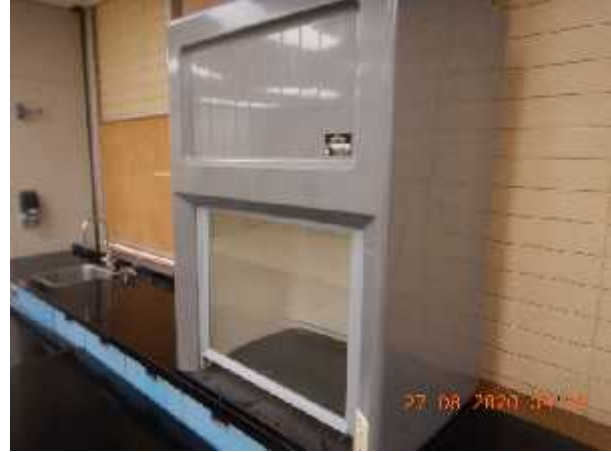
Photo 6  
Description: Fume hood liner  
Location: Room 2  
**Asbestos: Suspect**

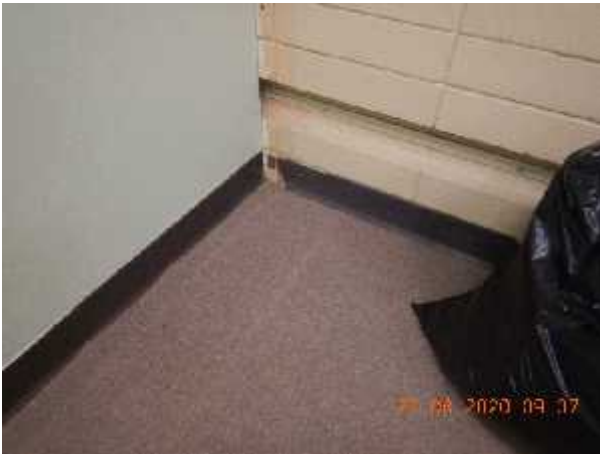
Baseboard adhesive	Wall	Throughout building	Suspect	Throughout building	Access A – Accessible to all building users	Non-friable	Good	Action 5 – Proactive ACM removal / Action 7 – Routinely monitor condition Test prior to impact

Photo 5  
Description: Baseboard adhesive  
Location: Office A  
**Asbestos: Suspect**
