School District 85

**Cheslakees Elementary School
2853 Mine Road, Port McNeill, BC
Asbestos Management Inventory**

NWest File: 39957 AMI1 V1.0
Date Issued: November 10, 2020

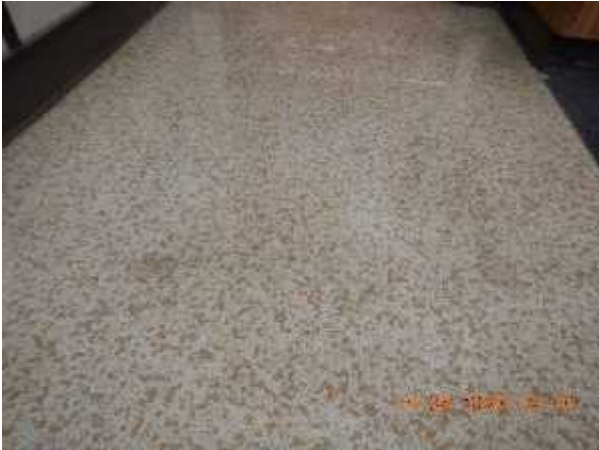
Sheet flooring 1 – Beige mosaic	Floor	Boys Change Room, Girls Washroom by Entry, Boys Washroom by Entry, First Aid Washroom, Girls Change Room, Gym Entranceway, Hallway by Room 107, Entry Hallway, Hallway by Room 103, Hallway by Room 105, Kitchen off Gym, Room 101, CRIB Storage Adjacent Room 101, Room 102, Room 103, Room 104, Room 105, Room 106, Room 107, Room 107 Washroom, Staff Washroom North, Staff Washroom South	20% Chrysotile	3,240 ft ²	Access A – Accessible to all building users	Friable	Good	Action 5 – Proactive ACM removal / Action 7 – Routinely monitor condition Test prior to impact

Photo 1
Description: Sheet flooring 1 – Beige mosaic
Location: Room 104
Asbestos: 20% Chrysotile
Sample(s): 30001-1

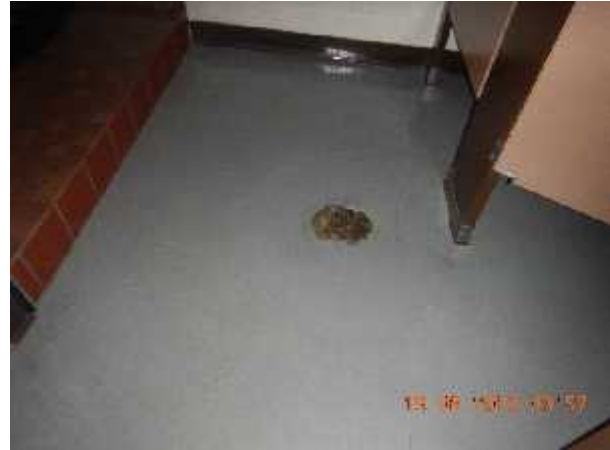
Sheet flooring 2 - Grey	Floor	Boys Washroom by Staff Room, Girls Washroom by Staff Room	20% Chrysotile	255 ft ²	Access A – Accessible to all building users	Friable	Good	Action 5 – Proactive ACM removal / Action 7 – Routinely monitor condition Test prior to impact

Photo 2
Description: Sheet flooring 2 – Grey
Location: Boys Washroom by Staff Room
Asbestos: 20% Chrysotile
Sample(s): 30001-5

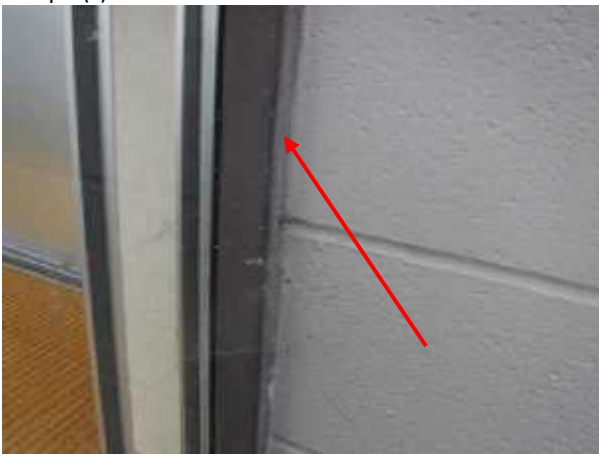
Photo 3
Description: Caulking – Brown
Location: Exterior
Asbestos: Suspect

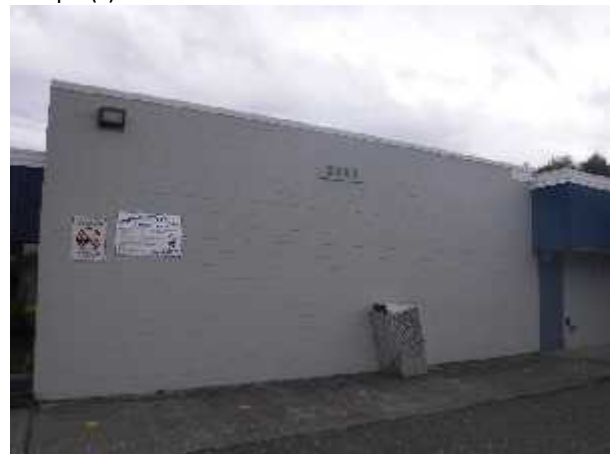
Photo 4
Description: Concrete block
Location: Exterior
Asbestos: Suspect (may contain vermiculite insulation)

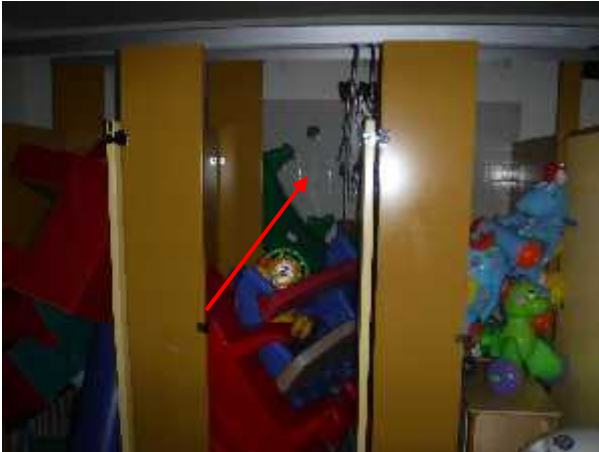
Ceramic tile grout and thinset	Floor	Boys Change Room, Girls Change Room	Suspect	100 ft ²	Access A – Accessible to all building users	Non-friable	Good	Action 5 – Proactive ACM removal / Action 7 – Routinely monitor condition Test prior to impact
Ceramic tile grout and thinset	Wall	Boys Change Room, Girls Change Room	Suspect	210 ft ²	Access A – Accessible to all building users	Non-friable	Good	Action 5 – Proactive ACM removal / Action 7 – Routinely monitor condition Test prior to impact
Beige 6"x6" ceramic tile grout and thinset	Wall	Boys Washroom by Staff Room	Suspect	90 ft ²	Access A – Accessible to all building users	Non-friable	Good	Action 5 – Proactive ACM removal / Action 7 – Routinely monitor condition Test prior to impact
Brown 2"x2" ceramic tile grout and thinset	Urinal platform	Boys Washroom by Staff Room	Suspect	20 ft ²	Access A – Accessible to all building users	Non-friable	Good	Action 5 – Proactive ACM removal / Action 7 – Routinely monitor condition Test prior to impact

Photo 5
 Description: Ceramic tile grout and thinset
 Location: Girl's Change Room
Asbestos: Suspect concealed asbestos leveling compound(s)

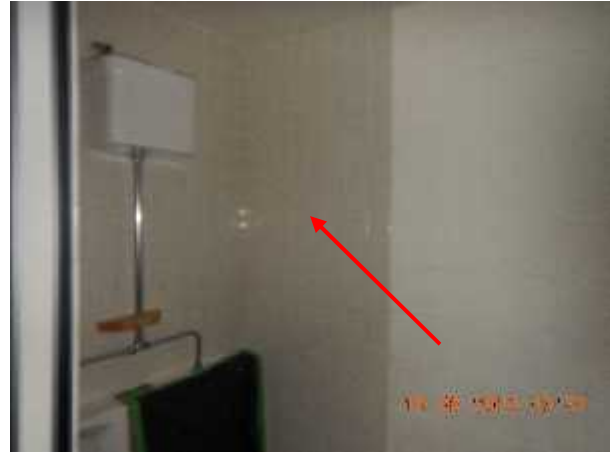
Photo 6
 Description: Beige 6"x6" ceramic tile grout and thinset
 Location: Boys Washroom by Staff Room
Asbestos: Suspect concealed asbestos leveling compound(s)

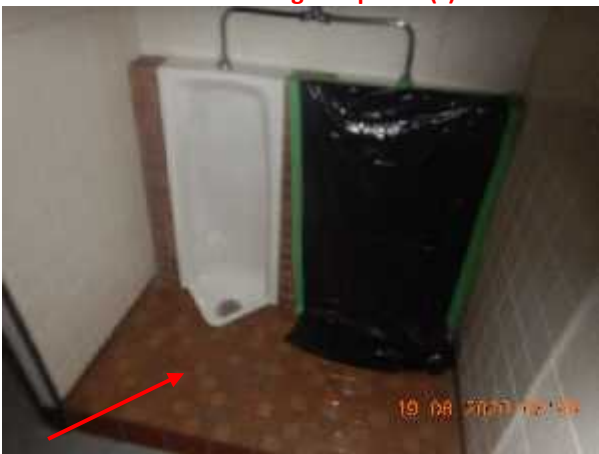
Photo 7
 Description: Brown 2"x2" ceramic tile grout and thinset
 Location: Boys Washroom by Staff Room
Asbestos: Suspect concealed asbestos leveling compound(s)

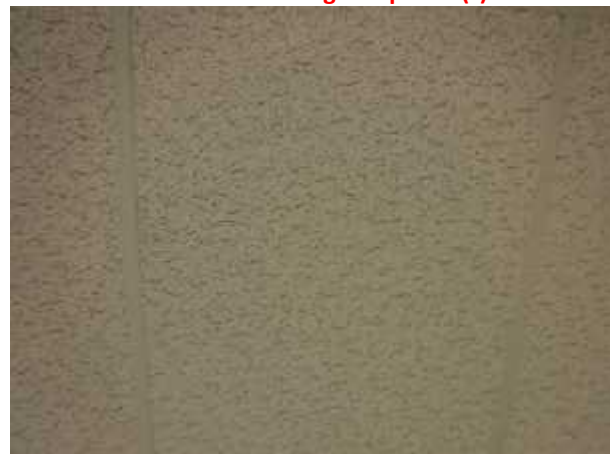
Description	System	Locations	Status	Quantity	Accessibility	Friability	Condition	Mgmt Recommendation
Acoustic ceiling tile type 2 – Latitudinal fissure small and large pinhole	Ceiling	Copy Room, First Aid Room, Office A, First Aid Washroom, Hallway by Room 107, Entry Hallway, Hallway by Room 103, Hallway by Room 105, Main Office, Principals Office, Room 101, CRIB Storage Adjacent Room 101, Room 102, Room 103, Room 104, Room 105, Room 106, Room 107, Room 107 Washroom, Staff Room, Staff Room Foyer, Staff Washroom North, Staff Washroom South, Storage Room A Off Library, Storage Room B Opp. Room 104, Storage Room C Opp. Room 106	Suspect	8,205 ft ²	Access A – Accessible to all building users	Friable	Good	Action 5 – Proactive ACM removal / Action 7 – Routinely monitor condition Test prior to impact
Acoustic ceiling tile type 4 – Pinhole with random small and large fissures	Ceiling	Room 103	Suspect	100 ft ²	Access A – Accessible to all building users	Friable	Good	Action 5 – Proactive ACM removal / Action 7 – Routinely monitor condition Test prior to impact

Photo 8
 Description: Acoustic ceiling tile type 2 – Latitudinal fissure small and large pinhole
 Location: Room 105
Asbestos: Suspect

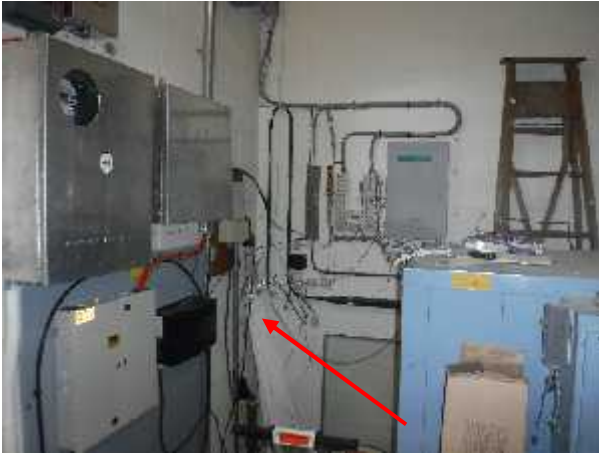
Photo 9
Description: Cement asbestos pipe

Location: Mechanical Room (corner of room)

Asbestos: Suspect

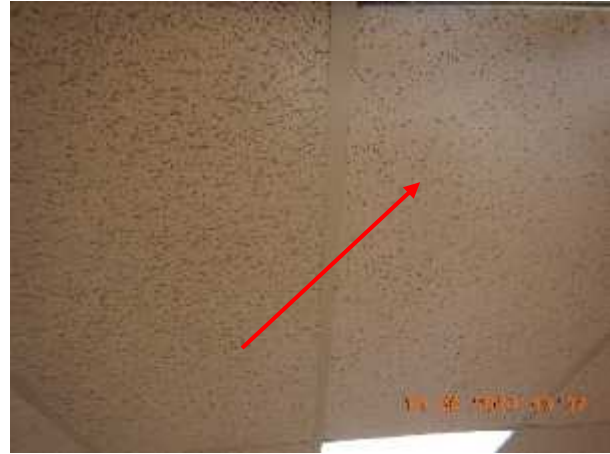
Photo 10
Description: Acoustic ceiling tile type 4 – Pinhole with random small and large fissures

Location: Room 103

Asbestos: Suspect

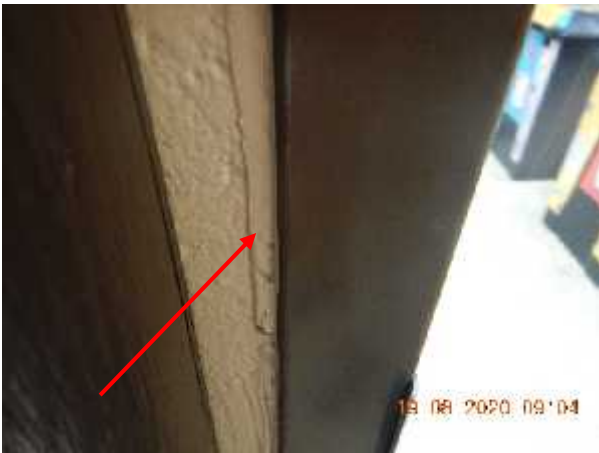
Photo 11
Description: Caulking – Grey

Caulking – Grey	Door Seal	First Aid Room, Office A	Suspect	2 doors	Access A – Accessible to all building users	Non-friable	Good	Action 5 – Proactive ACM removal / Action 7 – Routinely monitor condition Test prior to impact
Caulking – White	Plumbing Seal	First Aid Washroom, Janitor Closet by Mechanical, Staff Washroom South	Suspect	2 toilets, 1 floor drain	Access A – Accessible to all building users	Non-friable	Good	Action 5 – Proactive ACM removal / Action 7 – Routinely monitor condition Test prior to impact
Caulking – Brown	Windows	Exterior	Suspect	All exterior windows	Access A – Accessible to all building users	Non-friable	Good	Action 5 – Proactive ACM removal / Action 7 – Routinely monitor condition Test prior to impact
Spray on insulation – Grey	Ceiling insulation	Gym	Suspect	3,840 ft ²	Access C(e) – Exposed over 8 ft	Friable	Good	Action 5 – Proactive ACM removal / Action 7 – Routinely monitor condition Test prior to impact

Location: First Aid Room

Asbestos: Suspect

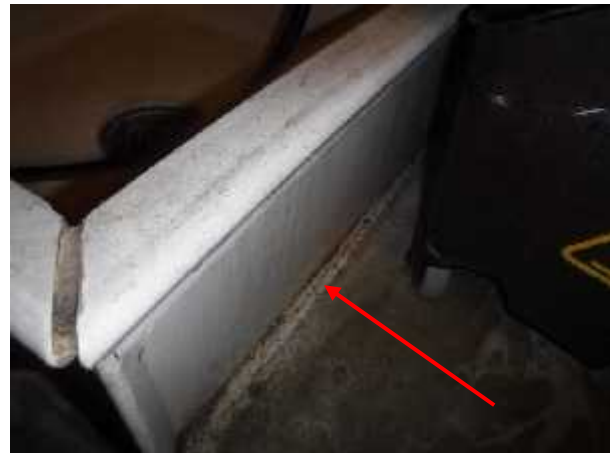
Photo 12
Description: Caulking – White

Location: Janitor Closet by Mechanical

Asbestos: Suspect

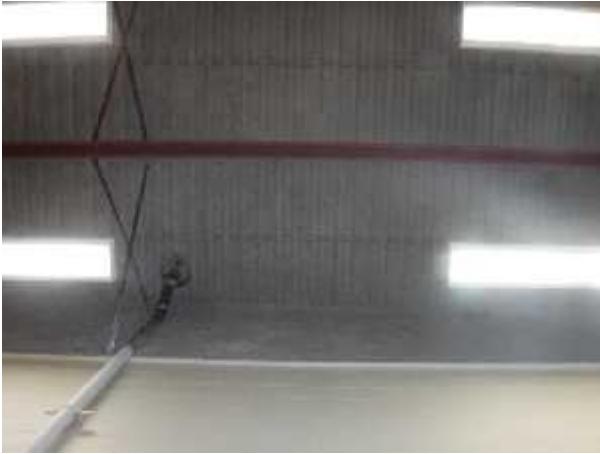
Photo 13
Description: Spray on insulation – Grey
Location: Gym
Asbestos: Suspect

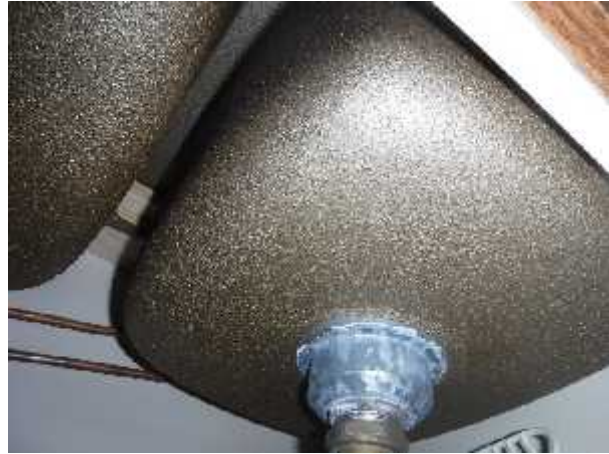
Mastic type 1 – Gold/silver	Sink insulation	Kitchen off Gym, Room 101, Room 102, Room 103, Room 104, Room 105, Room 106, Room 107, Staff Room, Storage Room C Opp. Room 106	Suspect	10 sinks	Access A – Accessible to all building users	Non-friable	Good	Action 5 – Proactive ACM removal / Action 7 – Routinely monitor condition Test prior to impact

Photo 14
Description: Mastic type 1 – Gold/silver
Location: Kitchen off Gym
Asbestos: Suspect

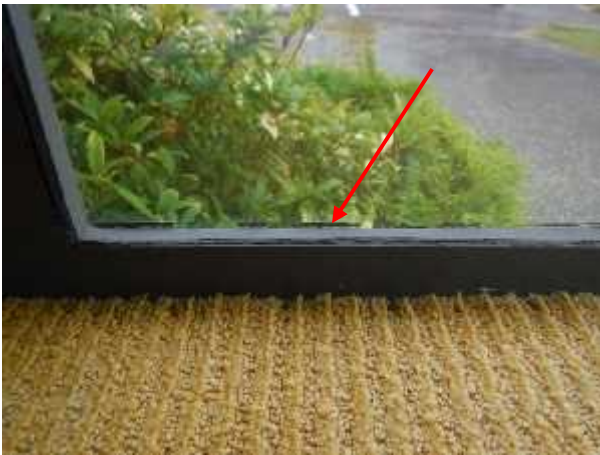
Description	System	Locations	Status	Quantity	Accessibility	Friability	Condition	Mgmt Recommendation
Mastic – Black	Windows	Main Office, Principals Office, Room 101, Room 102, Room 103, Room 104, Room 105, Room 106, Room 107, Staff Room	Suspect	40 windows	Access A – Accessible to all building users	Non-friable	Good	Action 5 – Proactive ACM removal / Action 7 – Routinely monitor condition Test prior to impact
Mastic – Brown (Where metal frame meets concrete block)	Windows	Entry Hallway	Suspect	2 windows	Access A – Accessible to all building users	Non-friable	Good	Action 5 – Proactive ACM removal / Action 7 – Routinely monitor condition Test prior to impact
Mastic –Grey	HVAC Ducting	Mechanical Room	Suspect	On all metal ducting and HVAC machinery	Access B – Accessible to maintenance workers	Non-friable	Good	Action 5 – Proactive ACM removal / Action 7 – Routinely monitor condition Test prior to impact

Photo 15
Description: Mastic – Black
Location: Room 105
Asbestos: Suspect

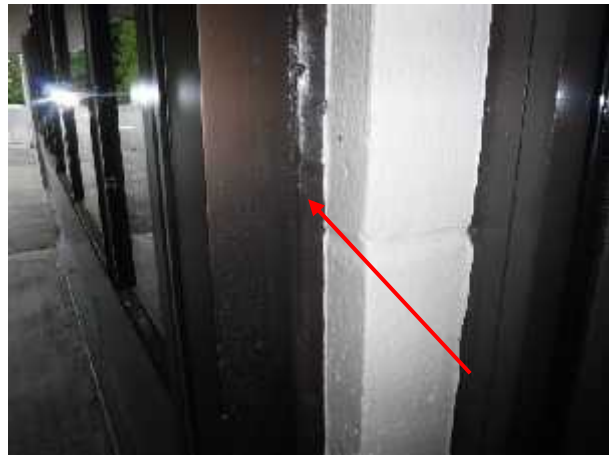
Photo 16
Description: Mastic – Brown (Where metal frame meets concrete block)
Location: Entry Hallway
Asbestos: Suspect

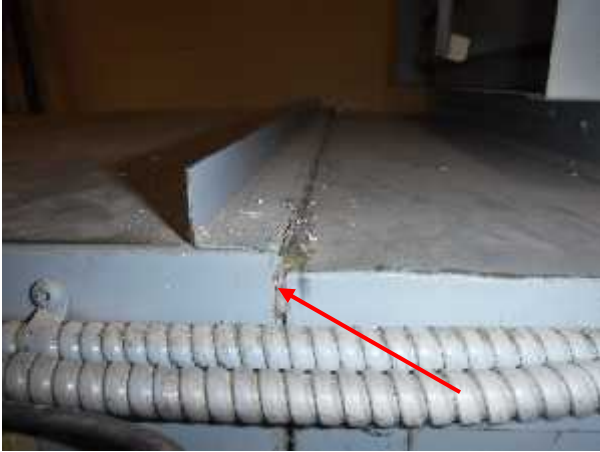
Photo 17
Description: Mastic –Grey
Location: Mechanical Room
Asbestos: Suspect

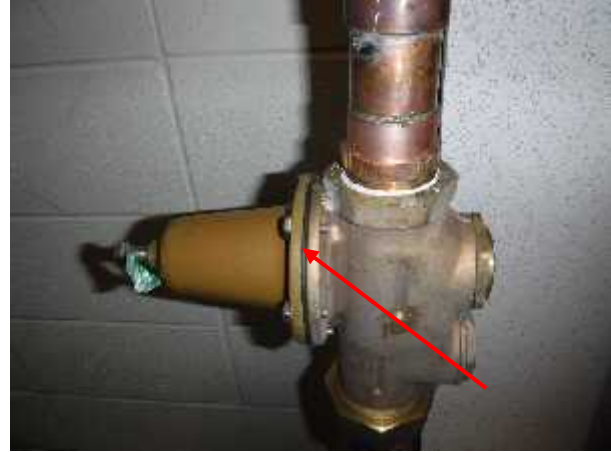
Gasket	Piping	Mechanical Room	Suspect	3 gaskets	Access B – Accessible to maintenance workers	Non-friable	Good	Action 5 – Proactive ACM removal / Action 7 – Routinely monitor condition Test prior to impact
Penetration parging	Wall	Mechanical Room	Suspect	2 penetrations (or 1 ft ²)	Access B – Accessible to maintenance workers	Non-friable	Good	Action 5 – Proactive ACM removal / Action 7 – Routinely monitor condition Test prior to impact
Cement asbestos pipe	Piping	Mechanical Room	Suspect	4 linear feet	Access B – Accessible to maintenance workers	Non-friable	Good	Action 5 – Proactive ACM removal / Action 7 – Routinely monitor condition Test prior to impact
Baseboard adhesive	Wall	Throughout building	Suspect	Throughout building	Access A – Accessible to all building users	Non-friable	Good	Action 5 – Proactive ACM removal / Action 7 – Routinely monitor condition Test prior to impact

Photo 18
Description: Gasket
Location: Mechanical Room
Asbestos: Suspect

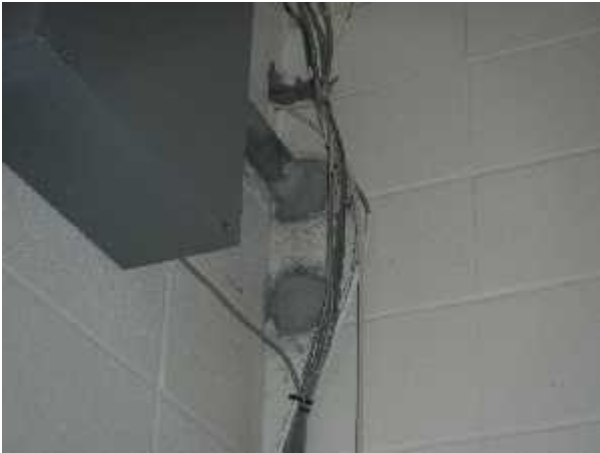
Photo 19
Description: Penetration parging
Location: Mechanical Room
Asbestos: Suspect

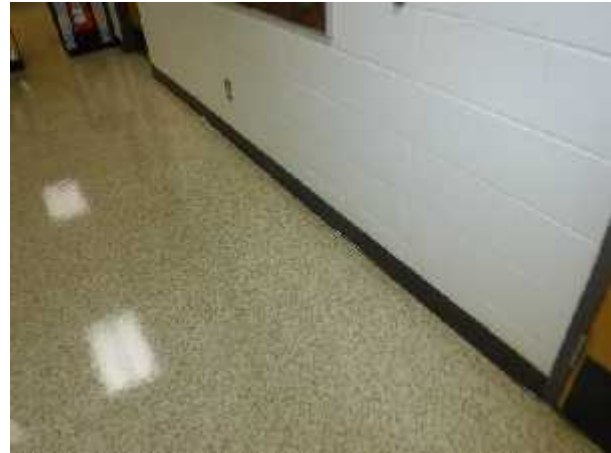
Photo 20
Description: Baseboard adhesive
Location: Hallway
Asbestos: Suspect

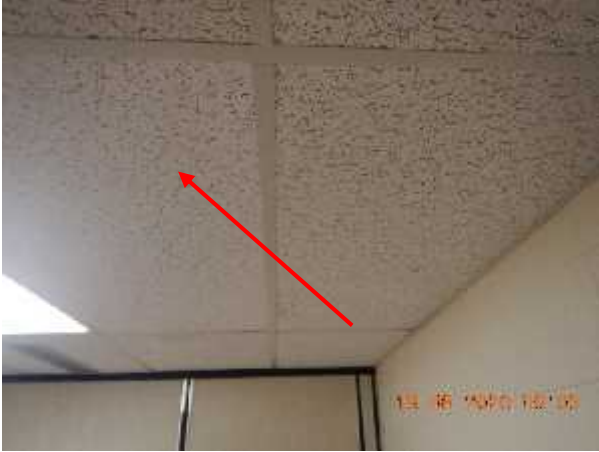
Photo 21

Acoustic ceiling tile type 1 – Patterned fissure small and large pinhole	Ceiling	First Aid Room, Hallway by Room 107, Entry Hallway, Library	Suspect	365 ft ²	Access A – Accessible to all building users	Friable	Good	Action 5 – Proactive ACM removal / Action 7 – Routinely monitor condition Test prior to impact

Description: Acoustic ceiling tile type 1 –
Patterned fissure small and large
pinhole

Location: First Aid Room

Asbestos: **Suspect**
