**Eagle View Elementary School
PO Box 369, Port Hardy, BC
Asbestos Management Inventory**

**North West
Environmental Group Ltd.**

NWest File: 39957 AMI1 V1.0

Date Issued: January 4, 2021

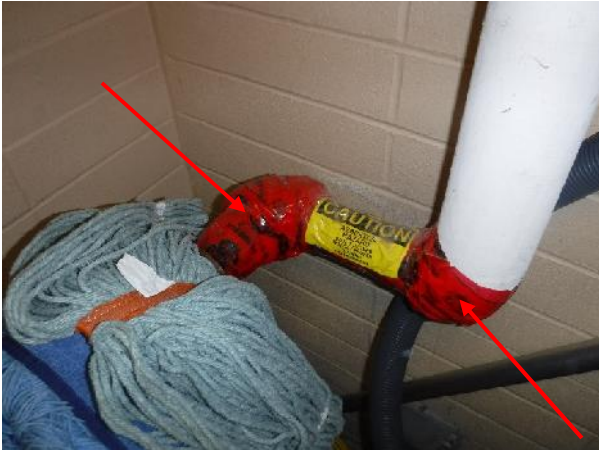
Photo 1
Description: Fittings insulation
Location: Room 207
Asbestos: 40 % Chrysotile
Sample(s): 30004-11

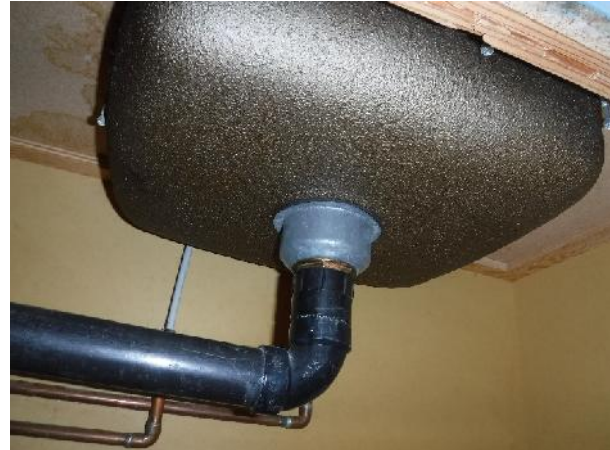
Photo 2
Description: Mastic – Silver/black
Location: Room 204
Asbestos: 1.4% Chrysotile
Sample(s): 30004-14

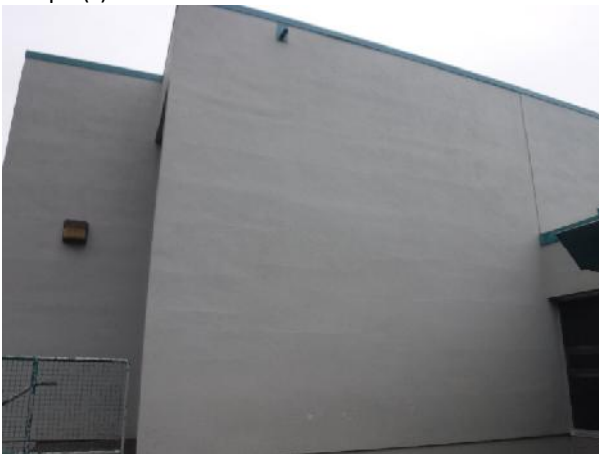
Photo 3
Description: Stucco
Location: Exterior
Asbestos: Suspect

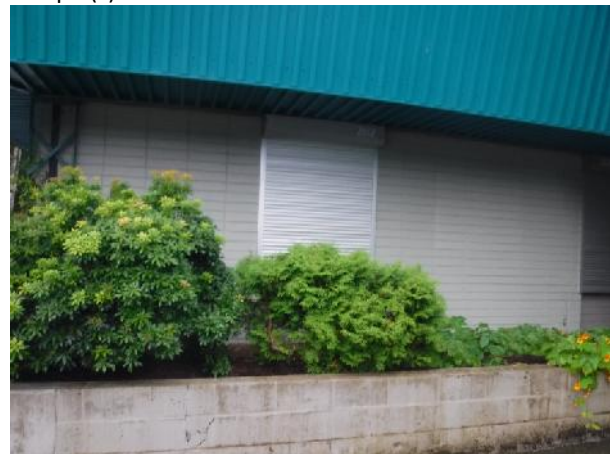
Photo 4
Description: Concrete block
Location: Exterior
Asbestos: Suspect in cavity

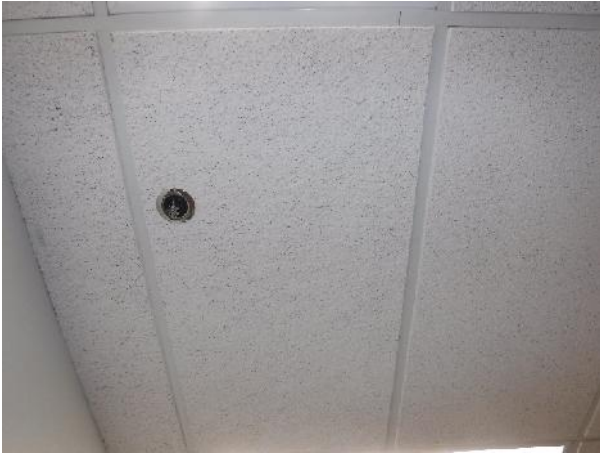
Photo 5
Description: Acoustic ceiling tile type 1 – Random fissure, dimpled, pinholes
Location: Room 101
Asbestos: Suspect

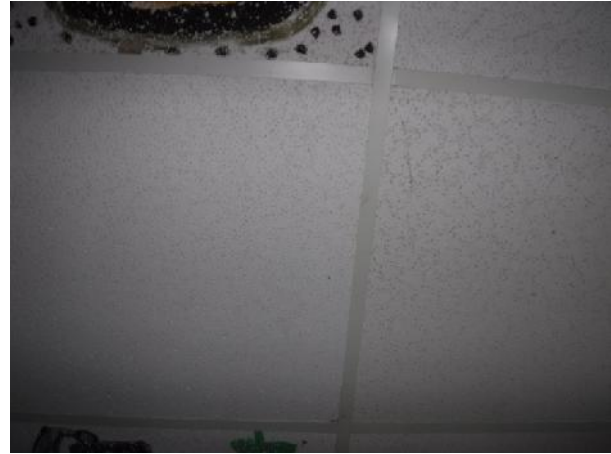
Photo 6
Description: Acoustic ceiling tile type 2 - Patterned fissures small and large pinhole
Location: Hallway 4
Asbestos: Suspect

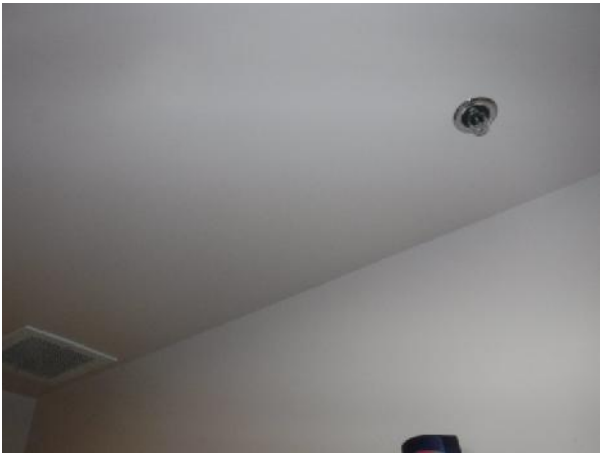
Photo 7
Description: Drywall joint compound
Location: Room 107
Asbestos: Suspect

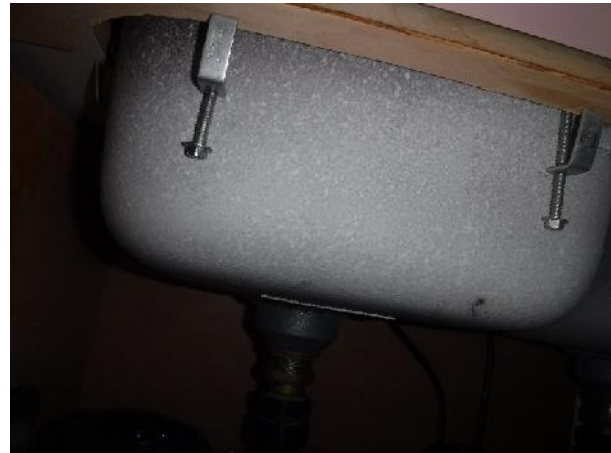
Photo 8
Description: Mastic – White
Location: Room 303 sink
Asbestos: Suspect

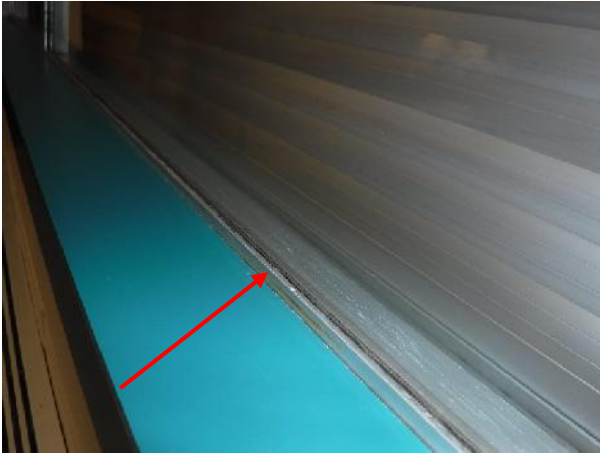
Photo 9
Description: Mastic – Black
Location: Room 108 window
Asbestos: Suspect

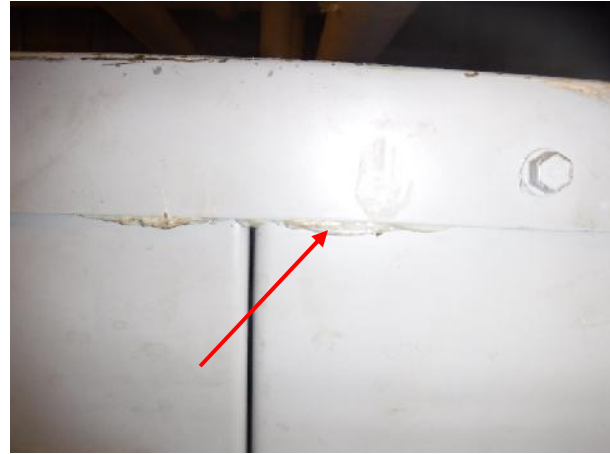
Caulking type 1 – Grey	Ducting	Room 307 Mezzanine	Suspect	Suspect on all ducting joints (pained over in some places)	Access B – Accessible to maintenance workers	Non-friable	Good	Action 5 – Proactive ACM removal / Action 7 – Routinely monitor condition Test prior to impact

Photo 10
Description: Caulking type 1 – Grey
Location: Room 307 mezzanine
Asbestos: Suspect

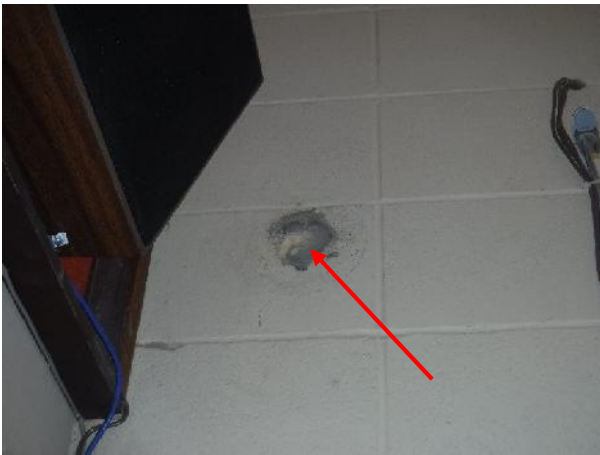
Description	System	Locations	Status	Quantity	Accessibility	Friability	Condition	Mgmt Recommendation
Caulking 2 – Grey/white	Wall penetration	Gym	Suspect	1 penetration	Access C(e) – Exposed over 8 ft	Non-friable	Good	Action 5 – Proactive ACM removal / Action 7 – Routinely monitor condition Test prior to impact
Pipe fittings insulation	Pipe elbow insulation	Room: 207, 210, 311, 312, 313 Janitor Closet Off Room 311	Confirmed	28 elbow fittings	Access A – Accessible to all building users	Friable	Fair	Action 5 – Proactive ACM removal / Action 6 – ACM repair Test prior to impact
Pipe run insulation	Pipe insulation	Room: 310	Suspect	25 linear feet	Access C(e) – Exposed over 8 ft	Friable	Good	Action 5 – Proactive ACM removal / Action 7 – Routinely monitor condition Test prior to impact
Vibration dampener	Ducting	Room 307 Mezzanine	Suspect	2 Dampeners	Access B – Accessible to maintenance workers	Non-friable	Good	Action 5 – Proactive ACM removal / Action 7 – Routinely monitor condition Test prior to impact

Photo 11
Description: Caulking type 2 – Grey/white
Location: Gym
Asbestos: Suspect

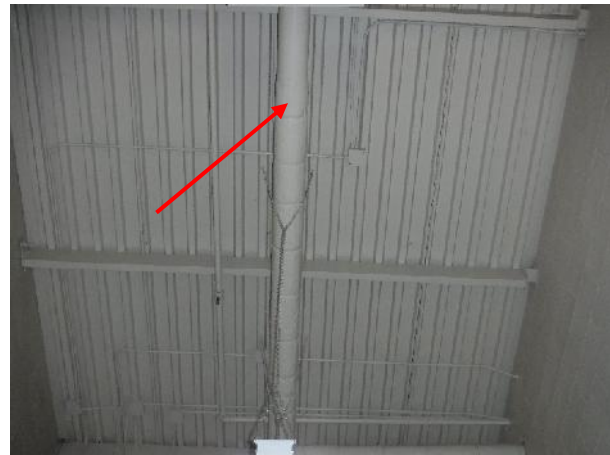
Photo 12
Description: Pipe run insulation
Location: Room 310
Asbestos: Suspect

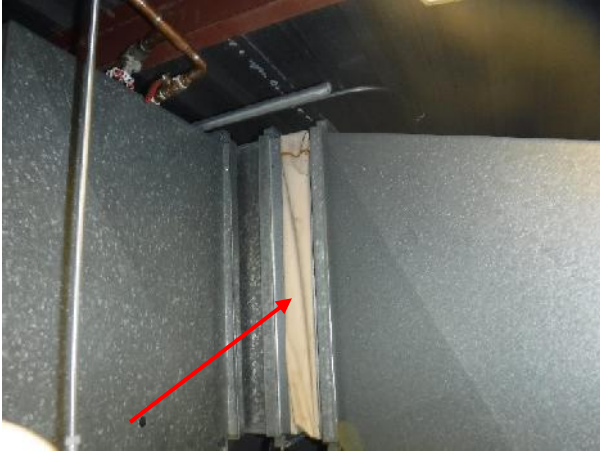
Photo 13
Description: Vibration dampeners
Location: Room 307 mezzanine
Asbestos: Suspect

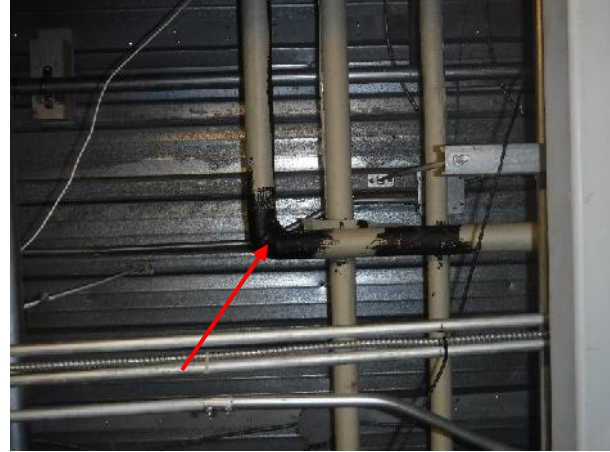
Black mastic on fiberglass pipe insulation	Piping	Room : 207, 210	Suspect	Patches on piping in rooms listed	Access B – Accessible to maintenance workers	Non-friable	Good	Action 5 – Proactive ACM removal / Action 7 – Routinely monitor condition Test prior to impact
White 6”x6” ceramic tile grout and thinset	Wall	Room: 208, 209, 211, 212, 311, 410, 411, 412, 413	Suspect	800 ft ²	Access A – Accessible to all building users	Non-friable	Good	Action 5 – Proactive ACM removal / Action 7 – Routinely monitor condition Test prior to impact
Green 2”x2” ceramic tile grout and tinset	Floor	Room209	Suspect	155 ft ²	Access A – Accessible to all building users	Non-friable	Good	Action 5 – Proactive ACM removal / Action 7 – Routinely monitor condition Test prior to impact
Red 1/2”x1/2” ceramic tile grout and thinset	Floor	Room: 311, 313	Suspect	780 ft ²	Access A – Accessible to all building users	Non-friable	Good	Action 5 – Proactive ACM removal / Action 7 – Routinely monitor condition Test prior to impact

Photo 14
Description: Black mastic on fiberglass pipe insulation
Location: Room 210
Asbestos: Suspect

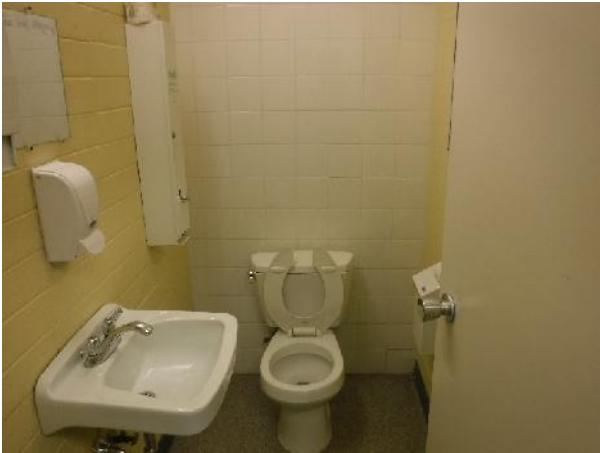
Photo 15
Description: White 6"x6" ceramic tile grout and thinset
Location: Room 211
Asbestos: Suspect

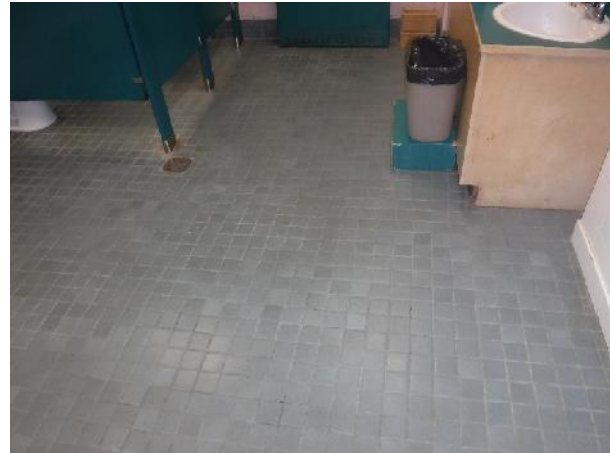
Photo 16
Description: Green 2"x2" ceramic tile grout and thinset
Location: Room 209
Asbestos: Suspect

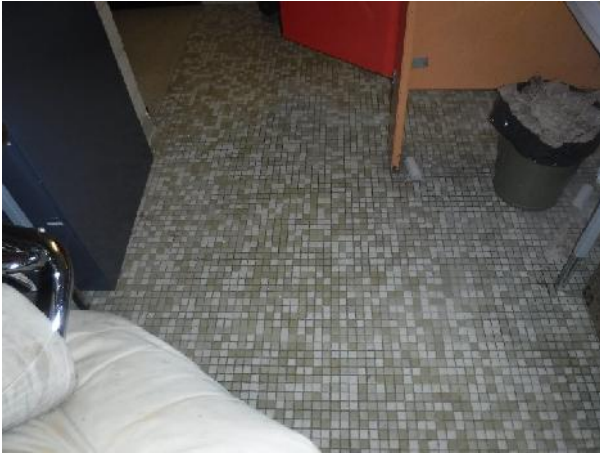
Photo 17
Description: 1/2"x1/2" ceramic tile grout and thinset
Location: Room 311
Asbestos: Suspect

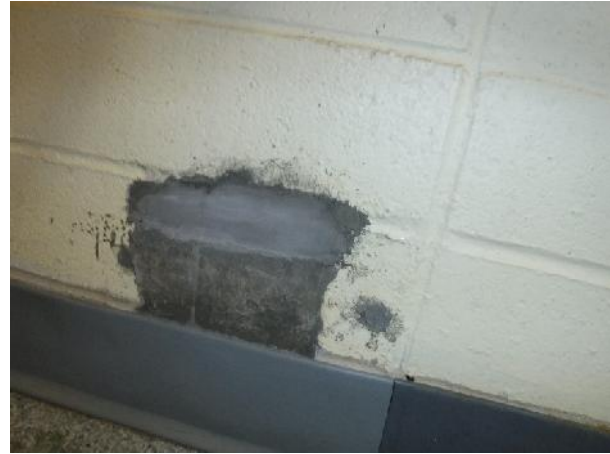
Grey parging	Wall	Room: 208, 210	Suspect	2 ft ²	Access A – Accessible to all building users	Non-friable	Good	Action 5 – Proactive ACM removal / Action 7 – Routinely monitor condition Test prior to impact
Red stair tread	Stairs	Room 314 Stairwells	Suspect	180 ft ²	Access A – Accessible to all building users	Non-friable	Good	Action 5 – Proactive ACM removal / Action 7 – Routinely monitor condition Test prior to impact

Photo 18
Description: Grey parging
Location: Room 208
Asbestos: Suspect

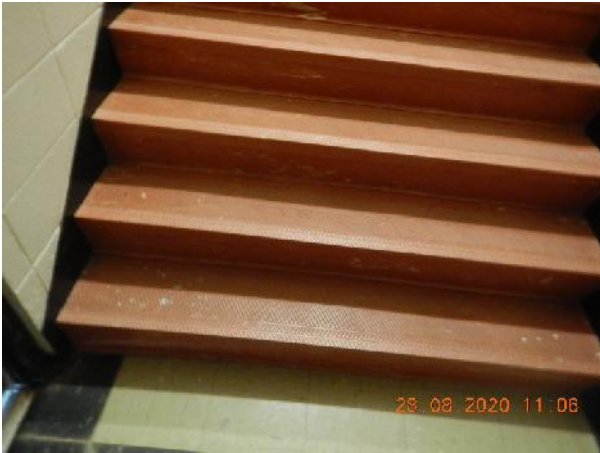
Photo 19
Description: Red stair tread
Location: Room 314 stairwells
Asbestos: Suspect

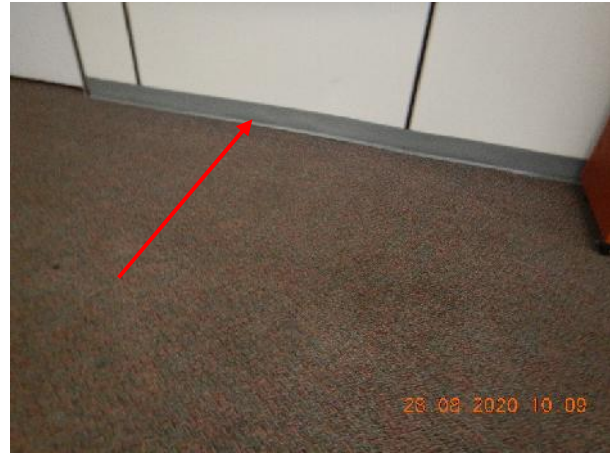
Description	System	Locations	Status	Quantity	Accessibility	Friability	Condition	Mgmt Recommendation
Baseboard adhesive	Suspect	Throughout Building	Suspect	Baseboards throughout building	Access A – Accessible to all building users	Non-friable	Good	Action 5 – Proactive ACM removal / Action 7 – Routinely monitor condition Test prior to impact

Photo 20
Description: Baseboard adhesive
Location: Room 406
Asbestos: Suspect
