**Fort Rupert Elementary School
5520 Beaver Harbour Road, Port Hardy, BC
Asbestos Management Inventory**

NWest File: 39957 AMI1 V1.0

Date Issued: January 4, 2021

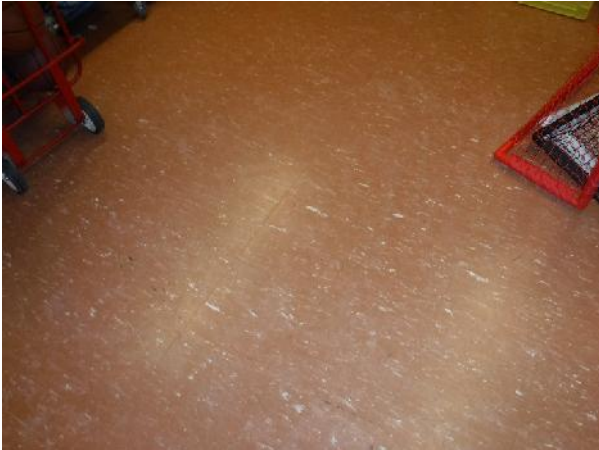
Photo 1
Description: Floor tile 1 – 12"x12" Rose with white streaks
Location: Gym Equipment Storage Room
Asbestos: 0.75% Chrysotile
Sample(s): 30006-18

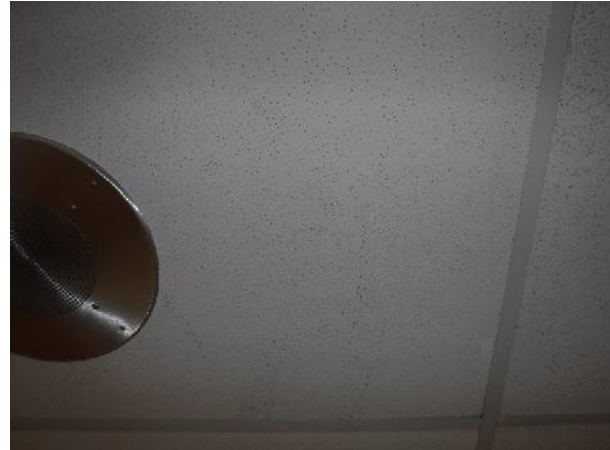
Photo 2
Description: Acoustic ceiling tile 1 – Small pinhole
Location: Main Entry Hallway
Asbestos: Suspect

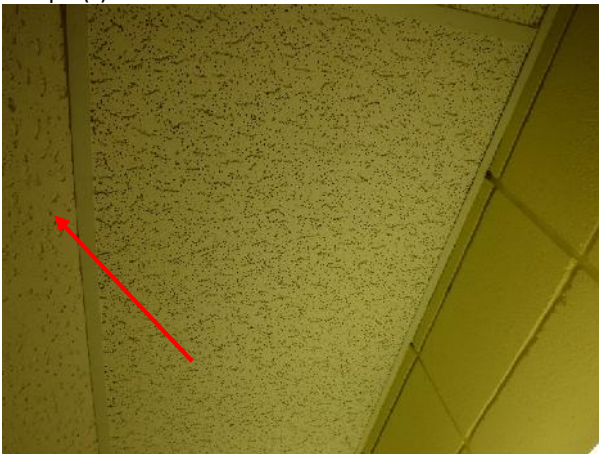
Acoustic ceiling tile 3 – Longitudinal fissure small pinhole	Ceiling	Washroom: Girls, Boys, Community Rental B Washroom	Suspect	80 ft ²	Access A – Accessible to all building users	Friable	Good	Action 5 – Proactive ACM removal / Action 7 – Routinely monitor condition Test prior to impact

Photo 3
Description: Acoustic ceiling tile 3 – Longitudinal fissure small pinhole
Location: Boys Washroom
Asbestos: Suspect

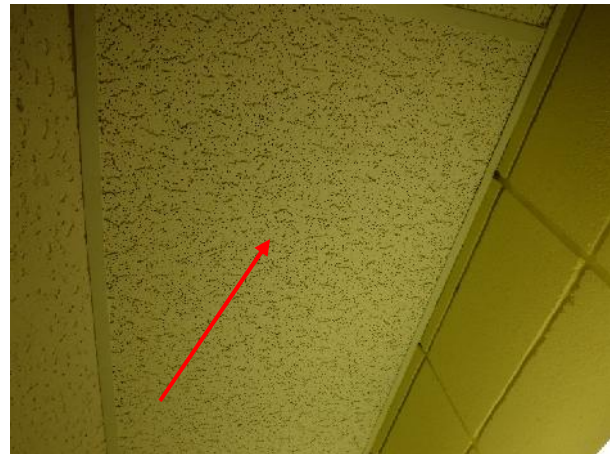
Photo 4
Description: Acoustic ceiling tile 4 – Horizontal fissure small pinhole
Location: Boys Washroom
Asbestos: Suspect

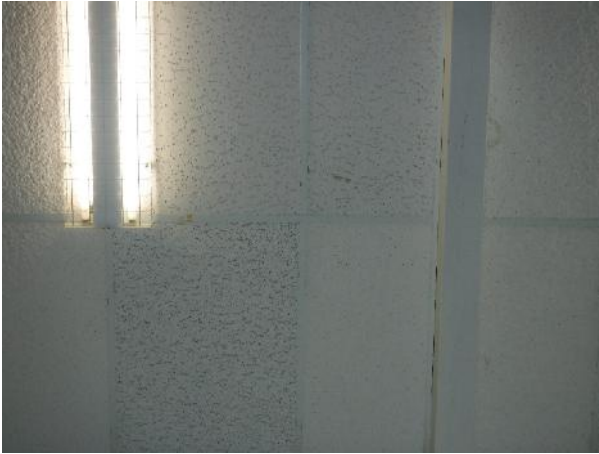
Photo 5
Description: Acoustic ceiling tile 5 – Textured 2'x4'
Location: Gym
Asbestos: Suspect

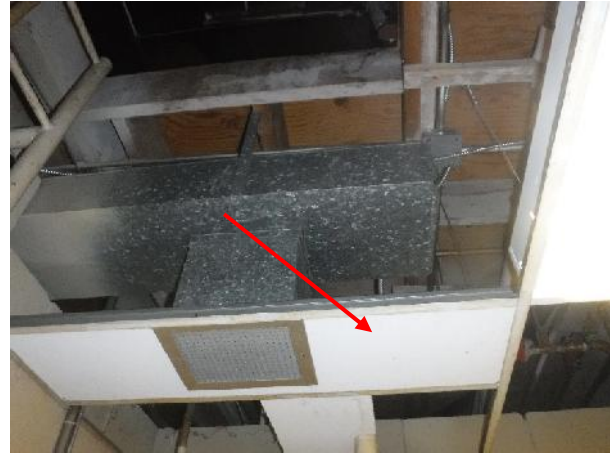
Photo 6
Description: Acoustic ceiling tile 6 – Textured ceiling tile
Location: Janitor Room
Asbestos: Suspect

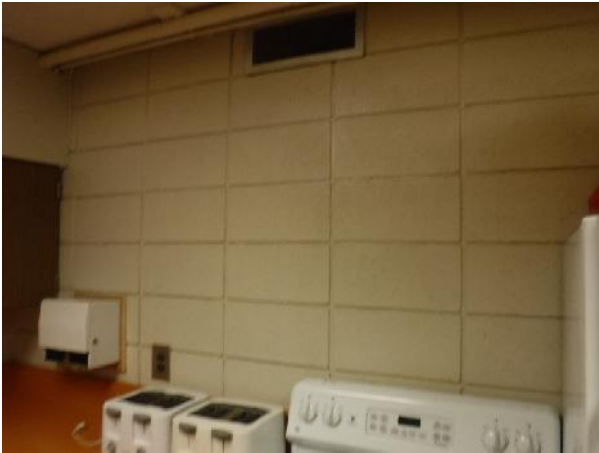
Photo 7
Description: Concrete blocks (may contain vermiculite)
Location: Kitchen by Gym
Asbestos: Suspect

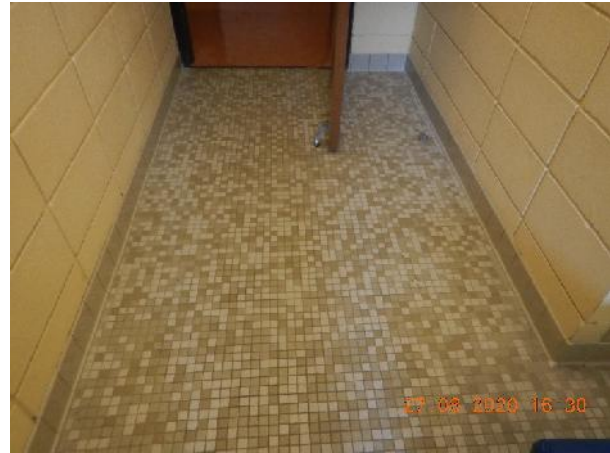
Photo 8
Description: 1"x1" ceramic tile grout and thinset
Location: Room 110 Girls Changeroom
Asbestos: Suspect concealed asbestos leveling compound(s)

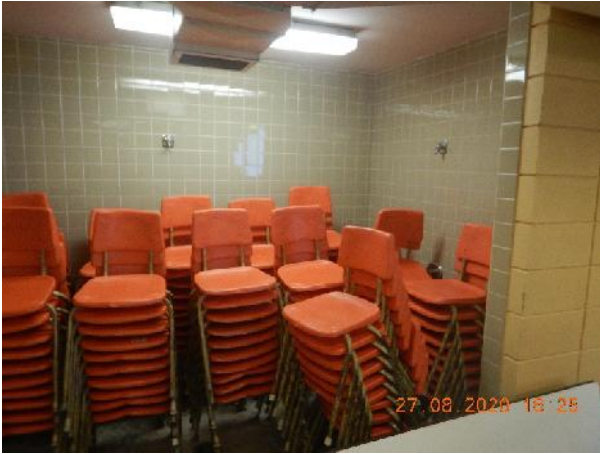
Photo 9
Description: 4"x4" ceramic tile grout and thinset
Location: Room 109 Boys Changeroom
Asbestos: **Suspect concealed asbestos leveling compound(s)**

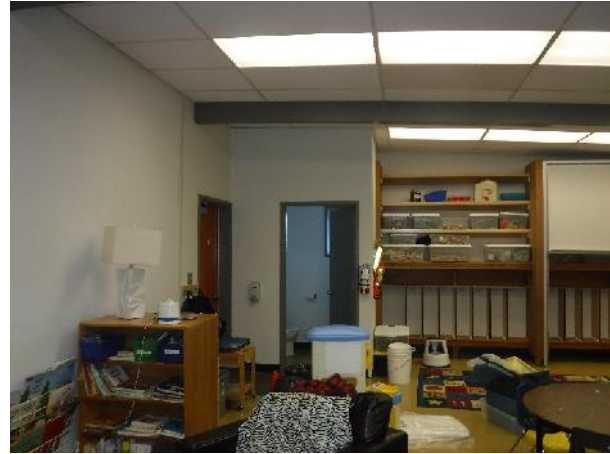
Photo 10
Description: Drywall with joint compound
Location: Community Rental B
Asbestos: **Suspect**

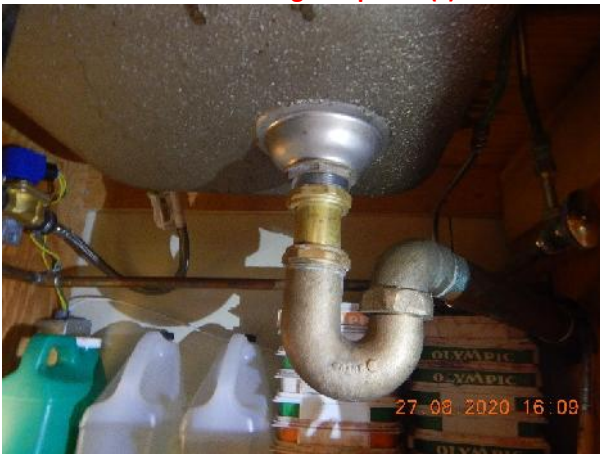
Photo 11
Description: Mastic 1 – Gold/silver
Location: Room 105
Asbestos: **Suspect**

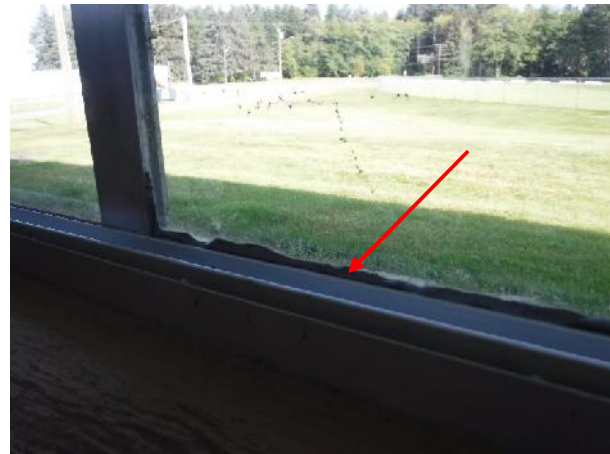
Photo 12
Description: Mastic 2 – Grey
Location: Community Rental A
Asbestos: **Suspect**

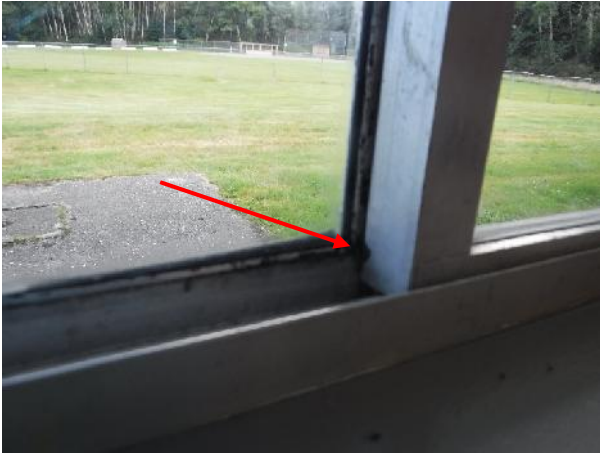
Photo 13
Description: Mastic 3 – Black
Location: Community Rental B
Asbestos: Suspect

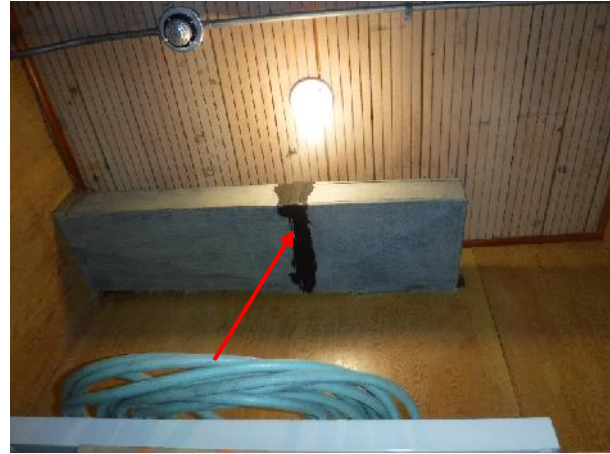
Mastic 4 – Black	Ductwork	Community Rental A Janitor, Room 101 Hot Water Tank Room	Suspect	Patches on ducting in rooms mentioned	Access B – Accessible to maintenance workers	Non-friable	Good	Action 5 – Proactive ACM removal / Action 7 – Routinely monitor condition Test prior to impact
Caulking 1 – Grey (painted white)	Ductwork	Room: 100, 101, 102, 103, 104, 105, 106 First Aid Room, Room 101 A/V, Main Office	Suspect	At duct joints in mentioned rooms	Access A – Accessible to all building users	Non-friable	Good	Action 5 – Proactive ACM removal / Action 7 – Routinely monitor condition Test prior to impact
Caulking 2 – White	Wall penetration	Janitor Room by Gym	Suspect	1 ft ²	Access A – Accessible to all building users	Non-friable	Good	Action 5 – Proactive ACM removal / Action 7 – Routinely monitor condition Test prior to impact

Photo 14
Description: Mastic 4 – Black
Location: Community Rental A Janitor
Asbestos: Suspect

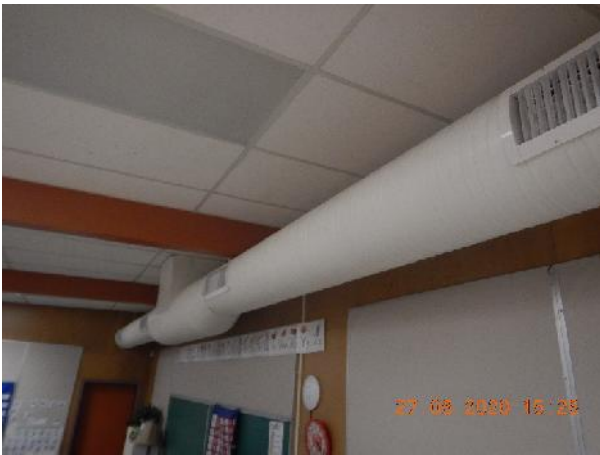
Photo 15
Description: Caulking 1 – Grey (painted white)
Location: Room 100
Asbestos: Suspect

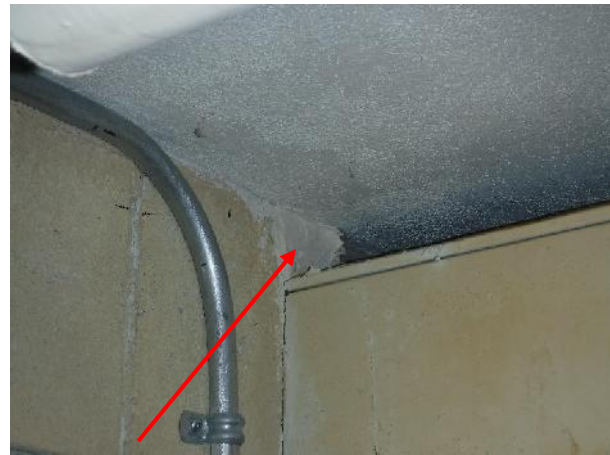
Photo 16
Description: Caulking 2 – White
Location: Janitor Room by Gym
Asbestos: Suspect

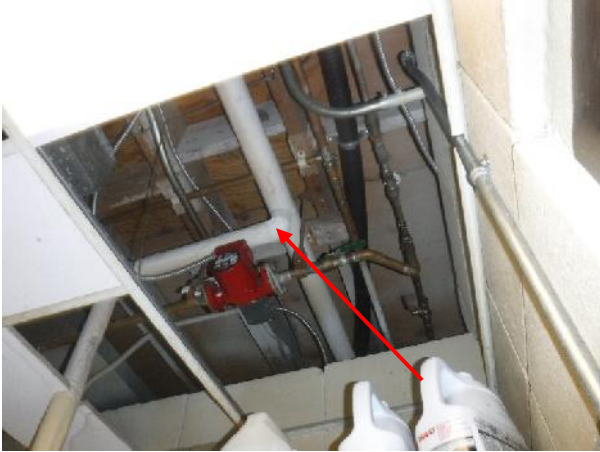
Photo 17
Description: Fittings insulation 1 -
Cementitious
Location: Janitor Room
Asbestos: Suspect

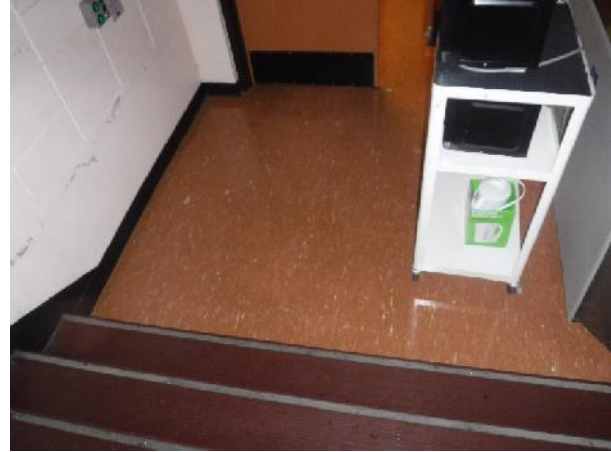
Photo 18
Description: Brown stair tread
Location: Hall by Gym
Asbestos: Suspect

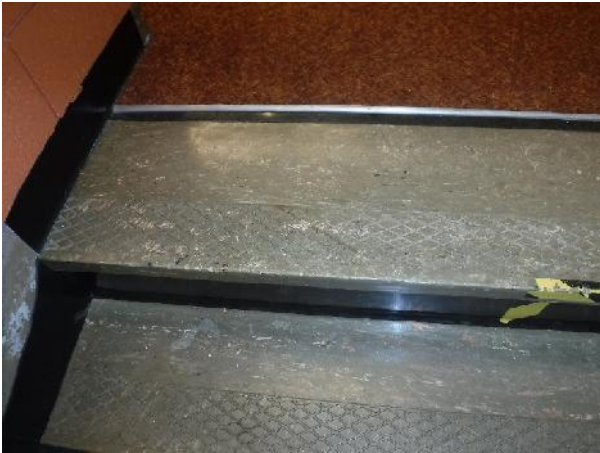
Photo 19
Description: Grey stair tread
Location: Mezzanine Accessed by Gym
Asbestos: Suspect

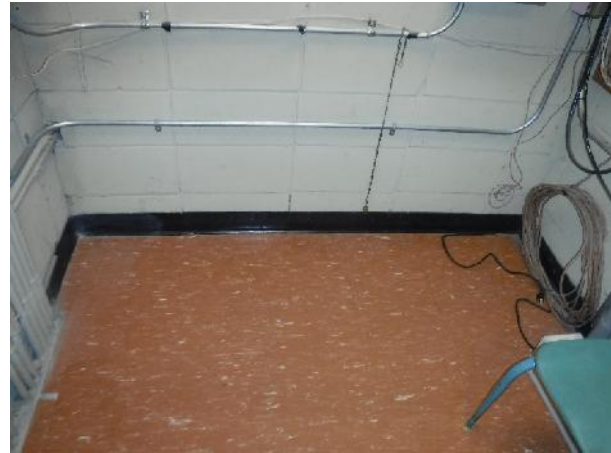
Photo 20
Description: Baseboard adhesive
Location: Electrical Room
Asbestos: Suspect

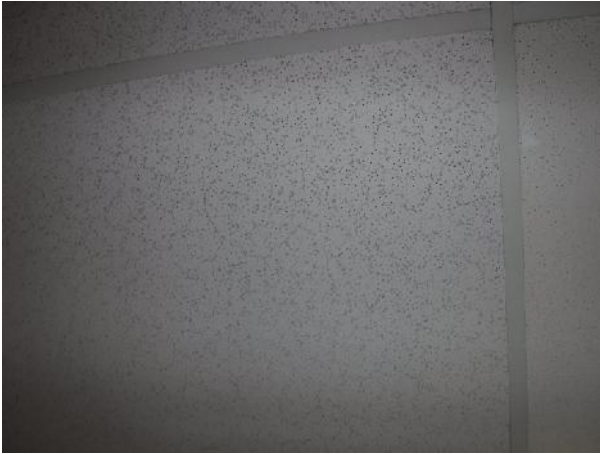
Photo 21
Description: Acoustic ceiling tile 2 – Patterned fissure small and large pinhole
Location: Main Entry Hallway
Asbestos: Suspect

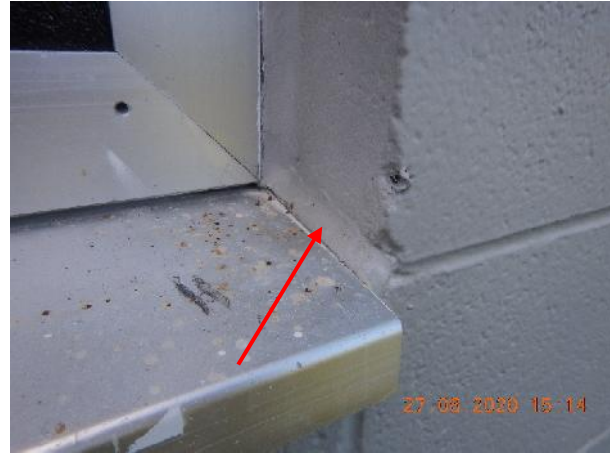
Description	System	Locations	Status	Quantity	Accessibility	Friability	Condition	Mgmt Recommendation
Caulking 3 – Grey	Windows	Exterior	Suspect	All exterior windows	Access A – Accessible to all building users	Non-friable	Good	Action 5 – Proactive ACM removal / Action 7 – Routinely monitor condition Test prior to impact
Fittings insulation 1 – Cementitious	Pipe insulation	Gym Equipment Storage Room, Janitor Room, Janitor Room by Gym, Room 110 Girls Changeroom	Suspect	13 fitting elbows	Access A – Accessible to all building users	Friable	Good	Action 5 – Proactive ACM removal / Action 7 – Routinely monitor condition Test prior to impact
Brown stair tread	Stair	Hall By Gym	Suspect	65	Access A – Accessible to all building users	Non-friable	Good	Action 5 – Proactive ACM removal / Action 7 – Routinely monitor condition Test prior to impact
Grey stair tread	Stair	Mezzanine Accessed by Gym	Suspect	200	Access A – Accessible to all building users	Non-friable	Good	Action 5 – Proactive ACM removal / Action 7 – Routinely monitor condition Test prior to impact

Photo 22
Description: Caulking 3 – Grey
Location: Exterior
Asbestos: Suspect

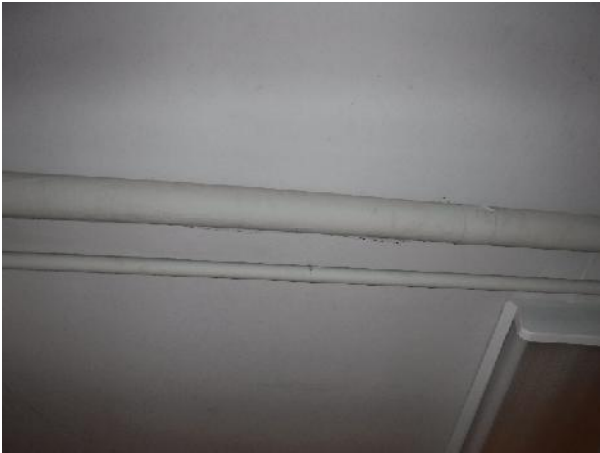
Asbestos cement parging	Ceiling	Gym Equipment Storage Room, Hallway by Gym, Janitor Room by Gym, Kitchen by Gym, Room 109 Boys Changeroom, Room 110 Girls Changeroom	Confirmed	1,530 ft ²	Access A – Accessible to all building users	Non-friable	Good	Action 5 – Proactive ACM removal / Action 7 – Routinely monitor condition Test prior to impact
Baseboard adhesive	Wall	Throughout building	Suspect	Throughout building	Access A – Accessible to all building users	Non-friable	Good	Action 5 – Proactive ACM removal / Action 7 – Routinely monitor condition Test prior to impact

Photo 21
Description: Asbestos cement parging
Location: Hallway by Gym
Asbestos: 5% Chrysotile
Sample(s): 10555-06
