## School District 85

### **Maintenance Shop Building 2 2071 McNeill Road, Port McNeill, BC Asbestos Management Inventory**

NWest File: 39957 AMI1 V1.0

Date Issued: January 4, 2021

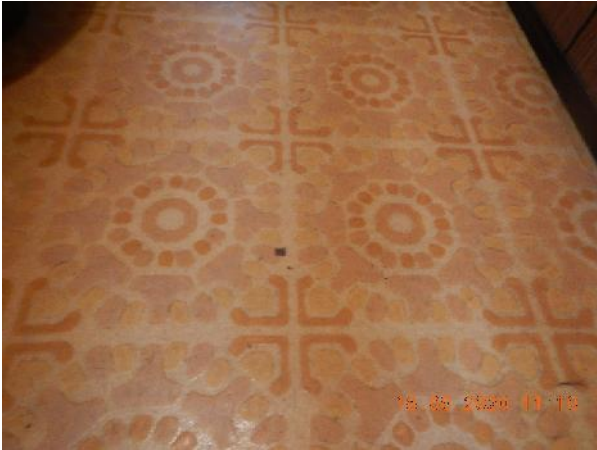
Sheet flooring 9 – Yellow brown flower	Floor	Room: 4, 6	Confirmed	160 ft <sup>2</sup>	Access A – Accessible to all building users	Friable	Good	Action 5 – Proactive ACM removal / Action 7 – Routinely monitor condition Test prior to impact
Mastic 1 – Black	Window	Room: 1, 3, 7, 8	Suspect	6 windows	Access A – Accessible to all building users	Non-friable	Good	Action 5 – Proactive ACM removal / Action 7 – Routinely monitor condition Test prior to impact
Mastic 2 – Gold/silver	Sink	Room: 1	Suspect	1 sink	Access A – Accessible to all building users	Non-friable	Good	Action 5 – Proactive ACM removal / Action 7 – Routinely monitor condition Test prior to impact

Photo 1  
Description: Sheet flooring 9 – Yellow brown flower  
Location: Room 6  
**Asbestos:** 20% Chrysotile  
Sample(s): 30008-2

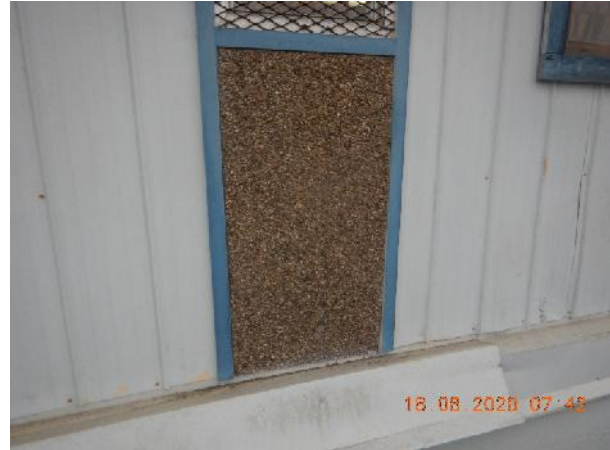
Photo 2  
Description: Aggregate panel  
Location: Exterior  
**Asbestos:** Suspect

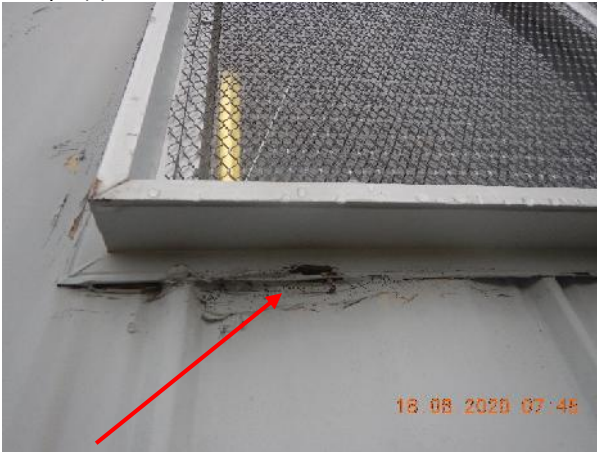
Photo 3  
Description: Caulking 1 – Grey  
Location: Exterior  
**Asbestos:** Suspect

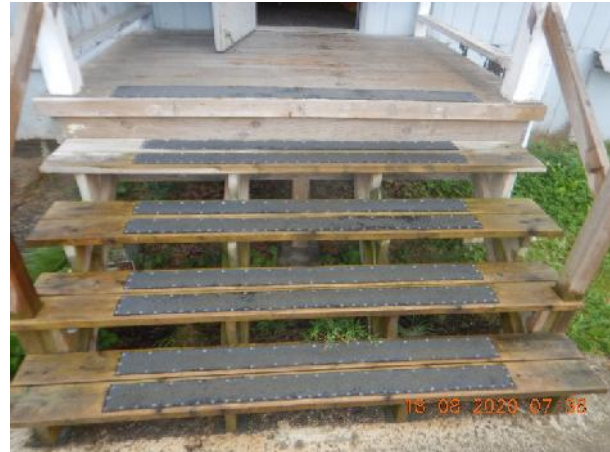
Photo 4  
Description: Asphalt stair tread  
Location: Exterior  
**Asbestos:** Suspect

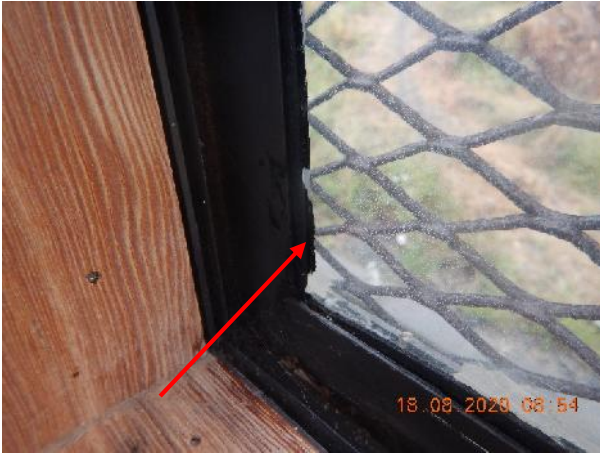
Photo 5  
Description: Mastic 1 – Black  
Location: Room 1  
Asbestos: Suspect

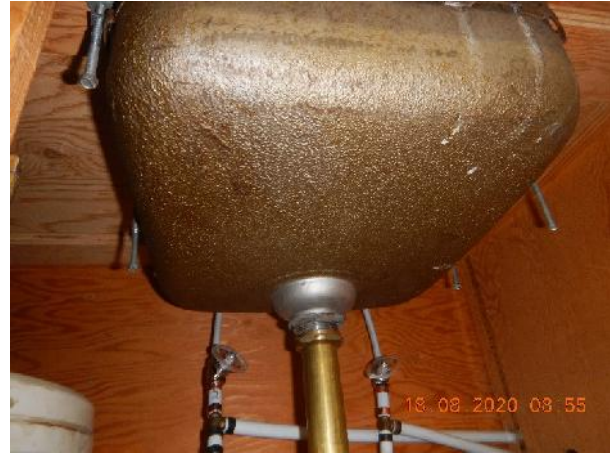
Photo 6  
Description: Mastic 2 – Gold/silver  
Location: Room 1  
Asbestos: Suspect

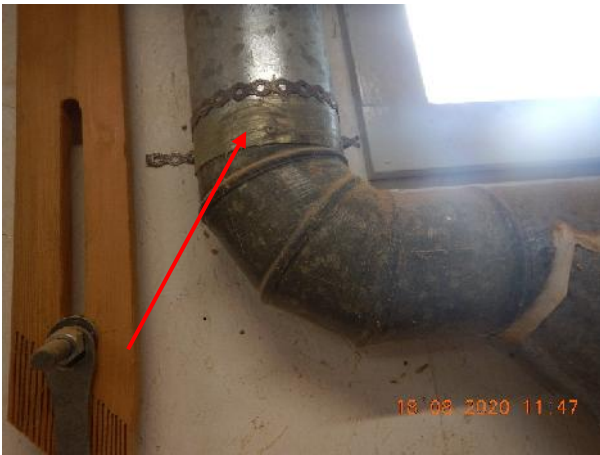
Photo 7  
Description: Mastic 3 – Grey  
Location: Room 9  
Asbestos: Suspect

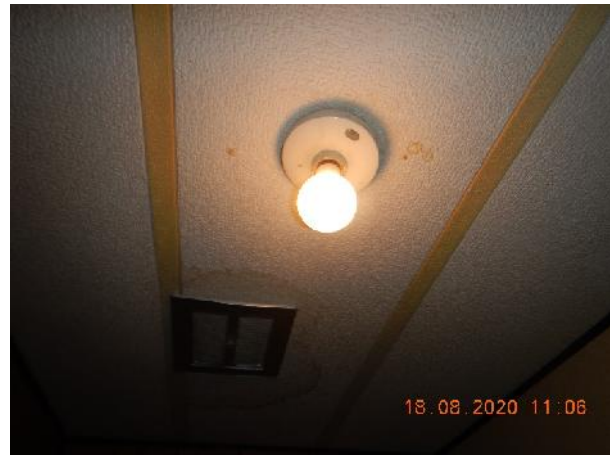
Photo 8  
Description: Incandescent light gasket  
Location: Room 5  
Asbestos: Suspect

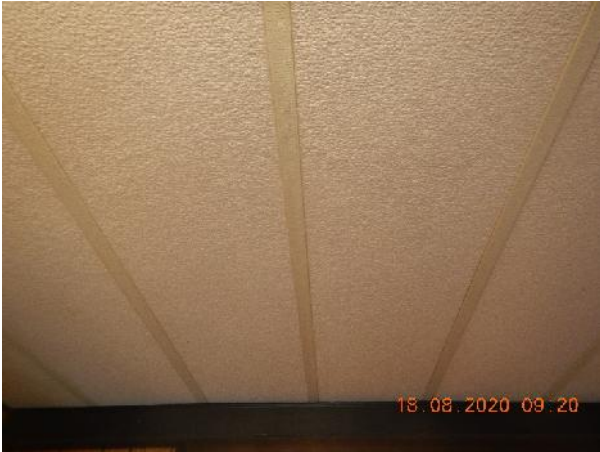
Photo 9  
Description: Acoustic ceiling tile 1 – Textured

Location: Room 4  
**Asbestos: Suspect**

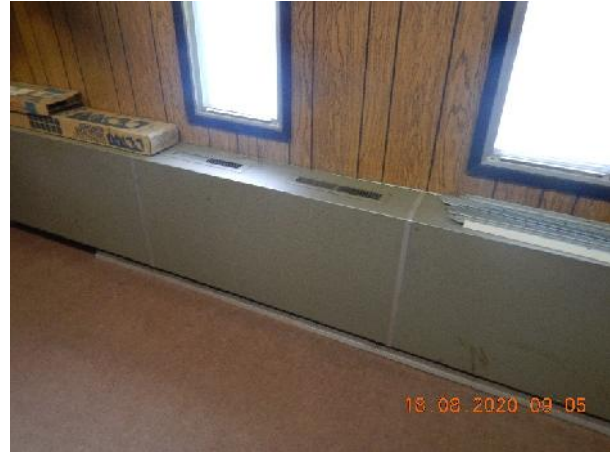
Photo 10  
Description: Radiator (may contain concealed ACM insulation)

Location: Room 2  
**Asbestos: Suspect**

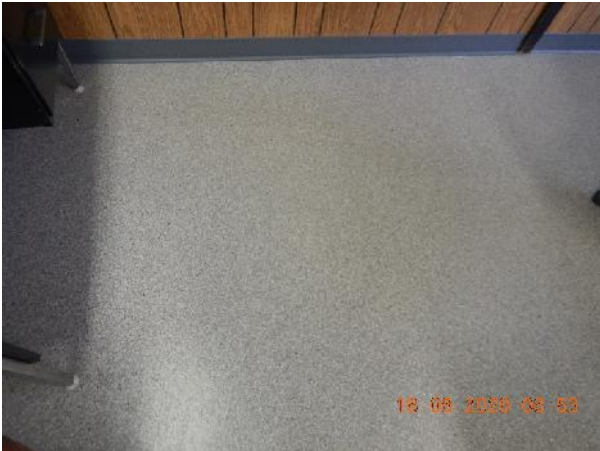
Photo 11  
Description: Baseboard Adhesive

Location: Room 1  
**Asbestos: Suspect**
