TACAN Maintenance Offices and Shop 6150 Brass Road, Port Hardy, BC Asbestos Management Inventory

**North West
Environmental Group Ltd.**

NWest File: 39957 AMI1 V1.0

Date Issued: April 13, 2021

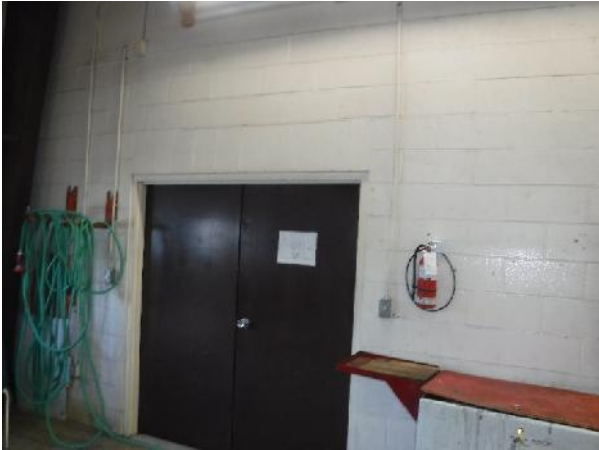
Description	System	Locations	Status	Quantity	Accessibility	Friability	Condition	Mgmt Recommendation
Concrete block wall (may contain vermiculite)	Wall	Garage, Part Storage, Tire Stores 1	Suspect	670 ft ²	Access A – Accessible to all building users	Non-friable	Good	Action 5 – Proactive ACM removal / Action 7 – Routinely monitor condition Test prior to impact
Drywall with joint compound	Wall	2 nd Floor: Admin Assistant, Men’s Washroom, Copier Room, Drafting Area, Women’s Washroom, Mezzanine Landing, Lunch Room, Maintenance, Mezzanine Hallway, Mezzanine Washroom Hallway, Mezzanine Storage. Carpentry Shop, Carpentry Storage, Electrical Room, Entryway, Garage, Hallway from Carpentry Shop to Entryway, Janitor Closet off Entryway, Locksmith, Office A, Part Storage, Staff Washroom, Stairs for Entryway to Mezzanine	Suspect	10,865 ft ²	Access A – Accessible to all building users	Non-friable	Good	Action 5 – Proactive ACM removal / Action 7 – Routinely monitor condition Test prior to impact

Photo 1
Description: Concrete block wall (may contain vermiculite)
Location: Garage
Asbestos: Suspect

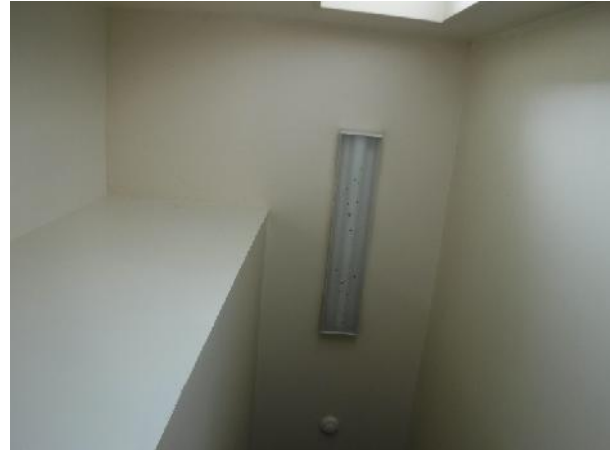
Drywall with joint compound	Ceiling	Carpentry Storage, Entryway, Hallway from Carpentry Shop to Entryway, Janitor Closet off Entryway, Locksmith, Stairs for Entryway to Mezzanine	Suspect	765 ft ²	Access A – Accessible to all building users	Non-friable	Good	Action 5 – Proactive ACM removal / Action 7 – Routinely monitor condition Test prior to impact

Photo 2
Description: Drywall with joint compound
Location: Stairs for Entryway to Mezzanine
Asbestos: Suspect

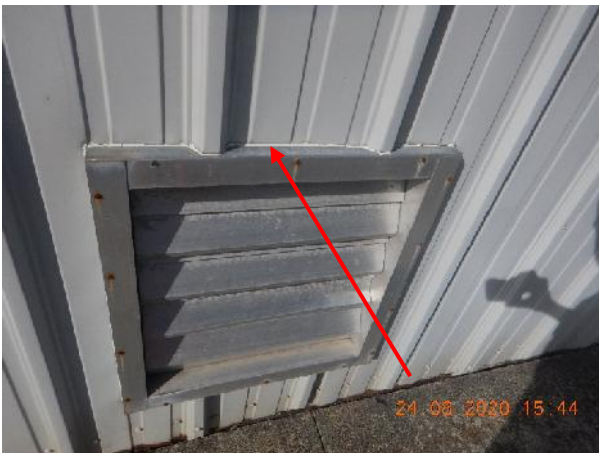
Description	System	Locations	Status	Quantity	Accessibility	Friability	Condition	Mgmt Recommendation
Caulking – White	Windows and vents	Exterior	Suspect	20 windows	Access A – Accessible to all building users	Non-friable	Good	Action 5 – Proactive ACM removal / Action 7 – Routinely monitor condition Test prior to impact
Caulking –Grey	Garage door windows	Exterior	Suspect	12 windows	Access A – Accessible to all building users	Non-friable	Good	Action 5 – Proactive ACM removal / Action 7 – Routinely monitor condition Test prior to impact
Window Putty – Black	Garage door windows	Carpentry Shop	Suspect	All garage door windows in areas listed	Access A – Accessible to all building users	Non-friable	Good	Action 5 – Proactive ACM removal / Action 7 – Routinely monitor condition Test prior to impact
Acoustic ceiling tile 1 – Vertical fissures and pinholes	Ceiling	2 nd Floor: Admin Assistant, Men’s Washroom, Copier Room, Women’s Washroom, Lunch Room, Maintenance Office, Managers Office, Mezzanine Washroom Hallway. Electrical Room, Office A, Part Storage, Staff Washroom	Suspect	1,535 ft ²	Access A – Accessible to all building users	Friable	Good	Action 5 – Proactive ACM removal / Action 7 – Routinely monitor condition Test prior to impact

Photo 3
Description: Caulking – White
Location: Exterior
Asbestos: Suspect

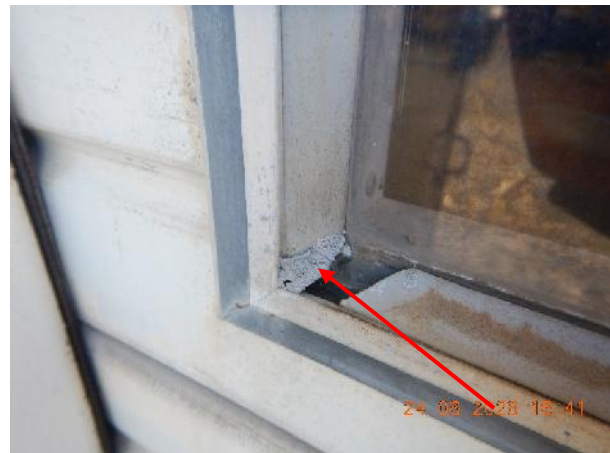
Photo 4
Description: Caulking – Grey
Location: Exterior Garage Door Window
Asbestos: Suspect

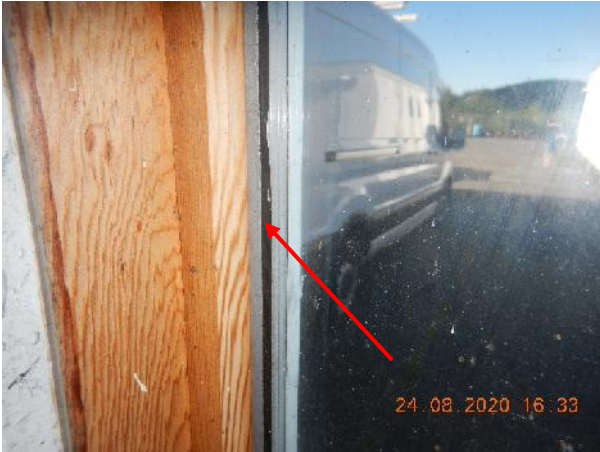
Photo 5
Description: Window Putty – Black
Location: Carpentry Shop
Asbestos: Suspect

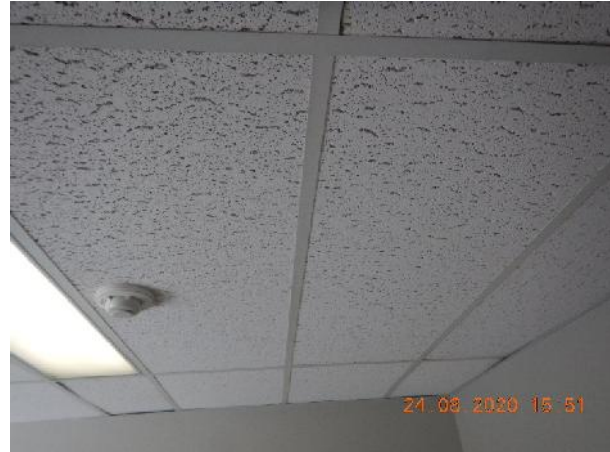
Photo 6
Description: Acoustic ceiling tile 1 – Vertical fissures and pinholes
Location: 2nd Floor Admin Assistant
Asbestos: Suspect concealed asbestos leveling compound(s)

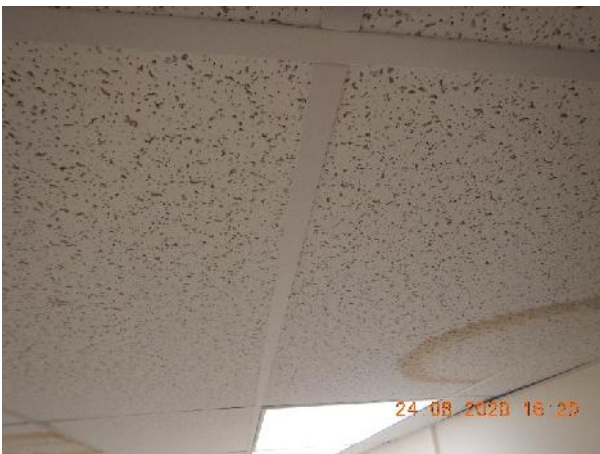
Acoustic ceiling tile 2 – Patterned fissure small and large pinhole	Ceiling	2 nd Floor: Admin Assistant, Drafting Area, Managers Office	Suspect	170 ft ²	Access A – Accessible to all building users	Friable	Good	Action 5 – Proactive ACM removal / Action 7 – Routinely monitor condition Test prior to impact
Acoustic sink insulation – Gold	Sink	2 nd Floor Lunch Room	Suspect	1 sink	Access A – Accessible to all building users	Non-friable	Good	Action 5 – Proactive ACM removal / Action 7 – Routinely monitor condition Test prior to impact
Gasket	Dust Collector	Dust Collection Room	Suspect	2 gaskets	Access A – Accessible to all building users	Non-friable	Good	Action 5 – Proactive ACM removal / Action 7 – Routinely monitor condition Test prior to impact
Gasket	Plumbing	Office A	Suspect	1 gasket	Access A – Accessible to all building users	Non-friable	Good	Action 5 – Proactive ACM removal / Action 7 – Routinely monitor condition Test prior to impact

Photo 5
Description: Acoustic ceiling tile 2 – Patterned fissure small and large pinhole
Location: 2nd Floor Drafting Area
Asbestos: Suspect

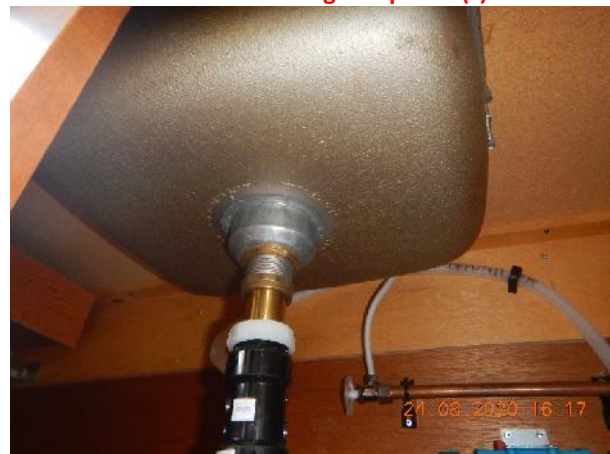
Photo 6
Description: Acoustic sink insulation – Gold
Location: 2nd Floor Lunch Room
Asbestos: Suspect

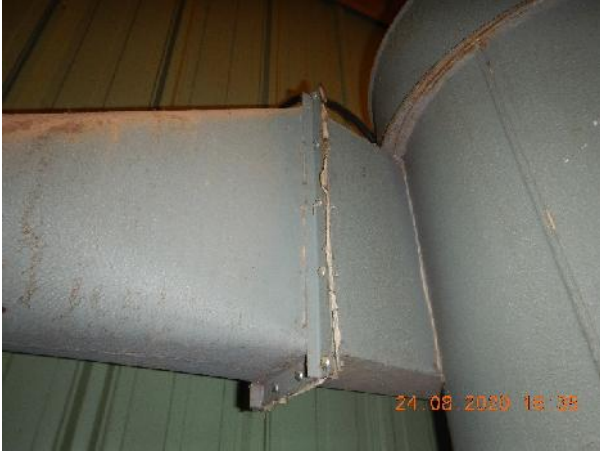
Photo 5
Description: Gasket
Location: Dust Collection Room
Asbestos: Suspect

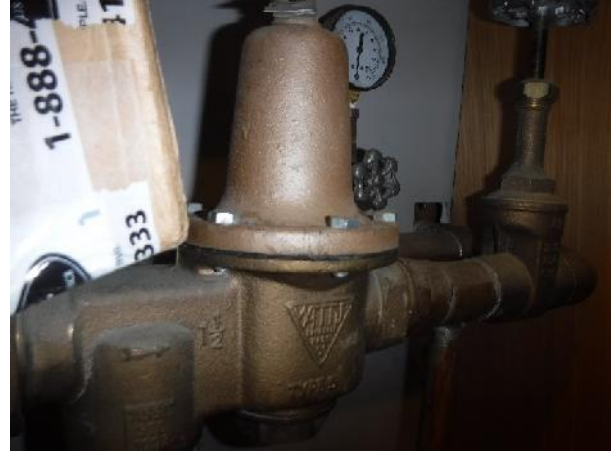
Photo 6
Description: Gasket
Location: Office A
Asbestos: Suspect

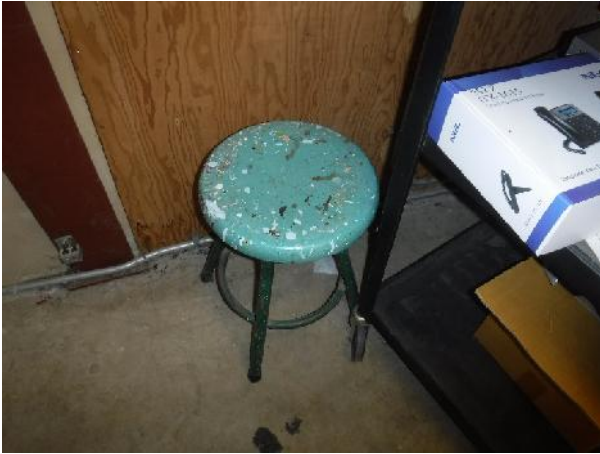
Chair seat	Chair	Electrical Room	Suspect	1 chair	Access A – Accessible to all building users	Non-friable	Good	Action 5 – Proactive ACM removal / Action 7 – Routinely monitor condition Test prior to impact

Photo 5
Description: Chair seat
Location: Electrical Room
Asbestos: Suspect

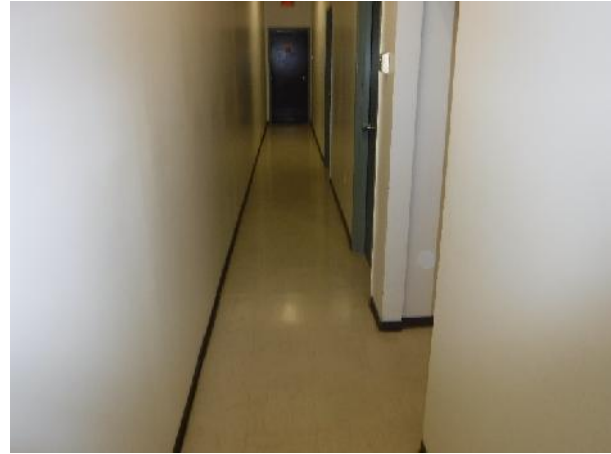
Description	System	Locations	Status	Quantity	Accessibility	Friability	Condition	Mgmt Recommendation
Baseboard adhesive	Wall	Throughout	Suspect	Throughout building	Access A – Accessible to all building users	Non-friable	Good	Action 5 – Proactive ACM removal / Action 7 – Routinely monitor condition Test prior to impact

Photo 6
Description: Baseboard adhesive
Location: Entryway
Asbestos: Suspect
