## School District 85

### 84 MacRae Drive, Woss, BC Asbestos Management Inventory

NWest File: 39957 AMI1 V1.0

Date Issued: April 20, 2021

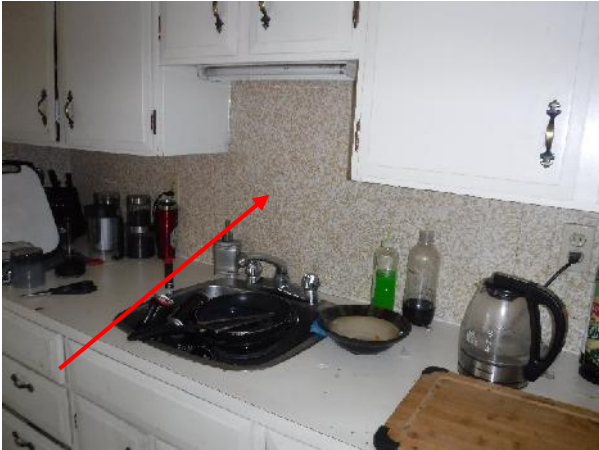
Sheet flooring 1 – beige mosaic	Backsplash	Kitchen	Suspect	25 ft <sup>2</sup>	Access A – Accessible to all building users	Friable	Good	Action 5 – Proactive ACM removal / Action 7 – Routinely monitor condition Test prior to impact

Photo 1  
Description: Sheet flooring 1 – beige mosaic  
Location: Kitchen backsplash  
**Asbestos: Suspect**

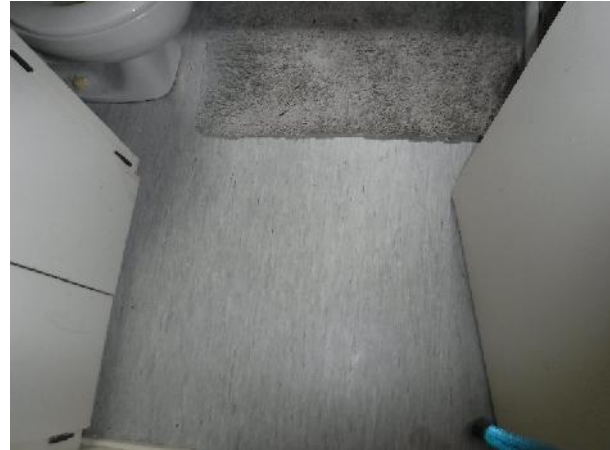
Sheet flooring 2 – grey streaked	Floor	Bathroom	Suspect	20 ft <sup>2</sup>	Access A – Accessible to all building users	Friable	Good	Action 5 – Proactive ACM removal / Action 7 – Routinely monitor condition Test prior to impact

Photo 2  
Description: Sheet flooring 2 – grey streaked  
Location: Bathroom  
**Asbestos: Suspect**

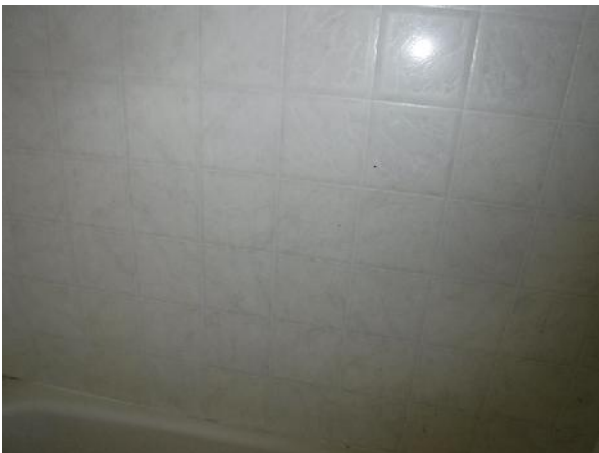
Sheet flooring 3 – off white 9”x9” pattern	Wall	Bathroom	Suspect	50 ft <sup>2</sup>	Access A – Accessible to all building users	Friable	Good	Action 5 – Proactive ACM removal / Action 7 – Routinely monitor condition Test prior to impact
Drywall with joint compound	Wall	Kitchen, Living Room, Laundry Room, Bathroom Bedroom 1, Bedroom 2	Suspect	1400 ft <sup>2</sup>	Access A – Accessible to all building users	Non friable	Good	Action 5 – Proactive ACM removal / Action 7 – Routinely monitor condition Test prior to impact
Drywall with joint compound	Ceiling	Bathroom	Suspect	35 ft <sup>2</sup>	Access A – Accessible to all building users	Non friable	Good	Action 5 – Proactive ACM removal / Action 7 – Routinely monitor condition Test prior to impact
Acoustic sink insulation – black	Sink	Kitchen	Suspect	1 sink	Access A – Accessible to all building users	Non friable	Good	Action 5 – Proactive ACM removal / Action 7 – Routinely monitor condition Test prior to impact

Photo 3  
Description: Sheet flooring 3 – off white 9"x9" pattern  
Location: Bathroom  
**Asbestos: Suspect**

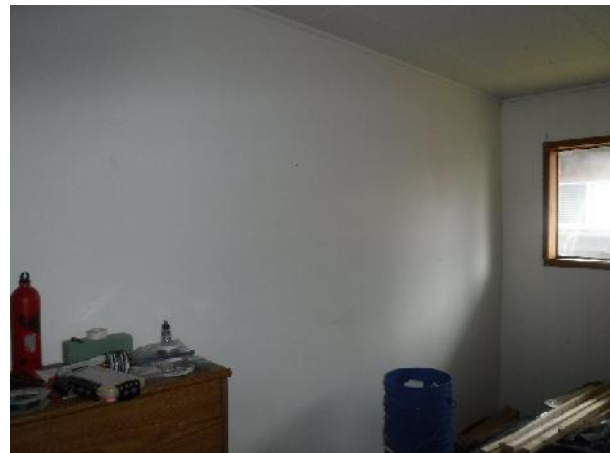
Photo 4  
Description: Drywall with joint compound  
Location: Bedroom 1  
**Asbestos: Suspect**

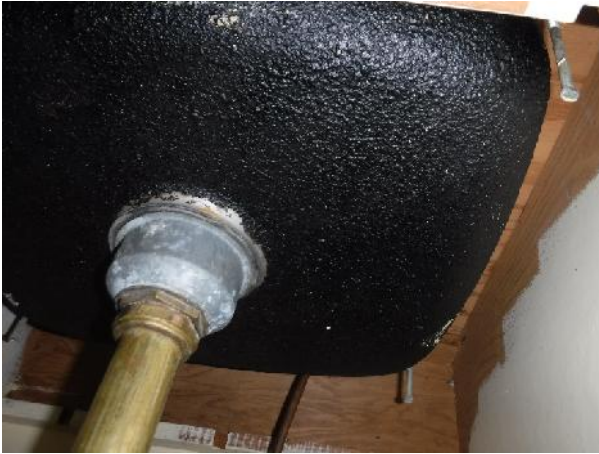
Photo 5

Description: Acoustic sink insulation – black

Location: Kitchen

**Asbestos:** **Suspect**
