**86 MacRae Drive, Woss, BC
Asbestos Management Inventory**

**North West
Environmental Group Ltd.**

NWest File: 39957 AMI1 V1.0

Date Issued: April 20, 2021

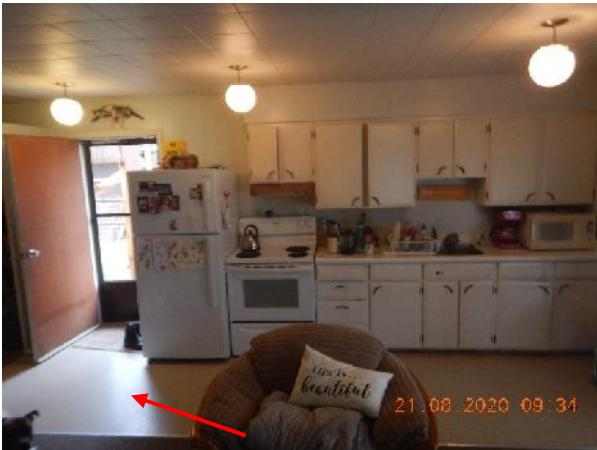
Description	System	Locations	Status	Quantity	Accessibility	Friability	Condition	Mgmt Recommendation
Sheet flooring 1 – light grey with white and grey specks	Floor	Kitchen	Suspect	100 ft ²	Access A – Accessible to all building users	Friable	Good	Action 5 – Proactive ACM removal / Action 7 – Routinely monitor condition Test prior to impact

Photo 1
Description: Sheet flooring 1 – light grey with white and grey specks
Location: Kitchen
Asbestos: Suspect

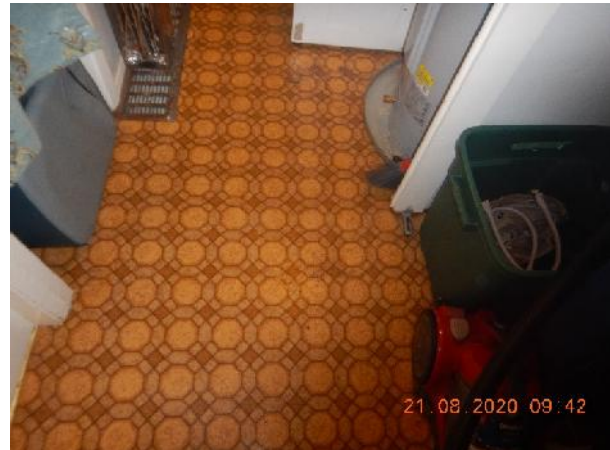
Sheet flooring 2 – brown hexagonal mosaic	Floor	Hallway	Confirmed	60 ft ²	Access A – Accessible to all building users	Friable	Good	Action 5 – Proactive ACM removal / Action 7 – Routinely monitor condition Test prior to impact
Ceramic tile – 9”x9” rose pattern	Wall	Bathroom	Suspect	65 ft ²	Access A – Accessible to all building users	Non friable	Good	Action 5 – Proactive ACM removal / Action 7 – Routinely monitor condition Test prior to impact
Drywall with joint compound	Wall	Kitchen, Hallway, Bedroom 1, Bedroom 2	Suspect	1195 ft ²	Access A – Accessible to all building users	Non friable	Good	Action 5 – Proactive ACM removal / Action 7 – Routinely monitor condition Test prior to impact
Textured drywall with joint compound	Wall	Living Room	Suspect	135 ft ²	Access A – Accessible to all building users	Non friable	Good	Action 5 – Proactive ACM removal / Action 7 – Routinely monitor condition Test prior to impact

Photo 2
Description: Sheet flooring 2 – brown hexagonal mosaic
Location: Hallway
Asbestos: 35% Chrysotile
Sample 39957-38b

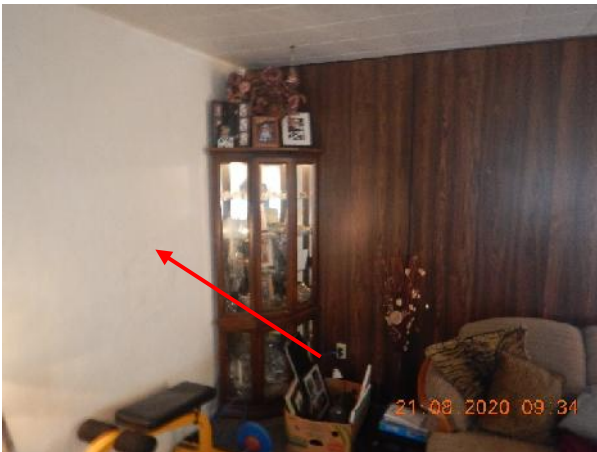
Photo 3
Description: Textured drywall with joint compound
Location: Living Room
Asbestos: Suspect

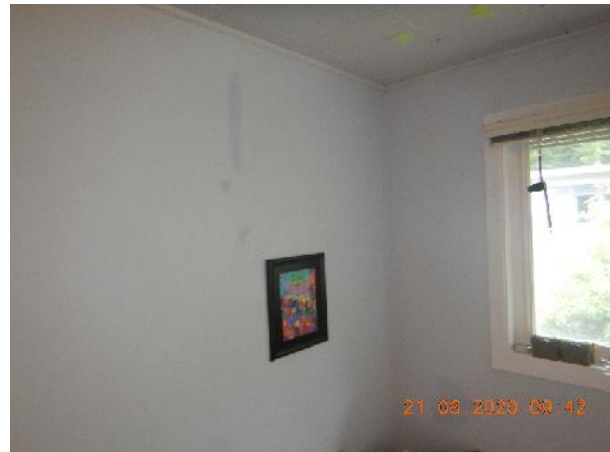
Photo 4
Description: Drywall with joint compound
Location: Bedroom 2
Asbestos: Suspect

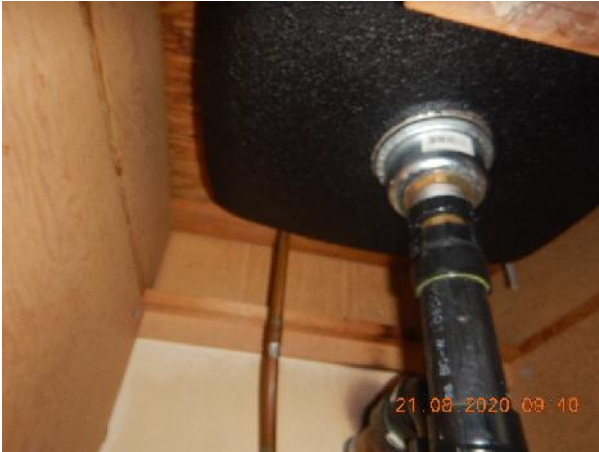
Photo 5

Acoustic sink insulation – black	Sink	Kitchen	Suspect	1 sink	Access A – Accessible to all building users	Non friable	Good	Action 5 – Proactive ACM removal / Action 7 – Routinely monitor condition Test prior to impact

Description: Acoustic sink insulation – black

Location: Kitchen

Asbestos: **Suspect**

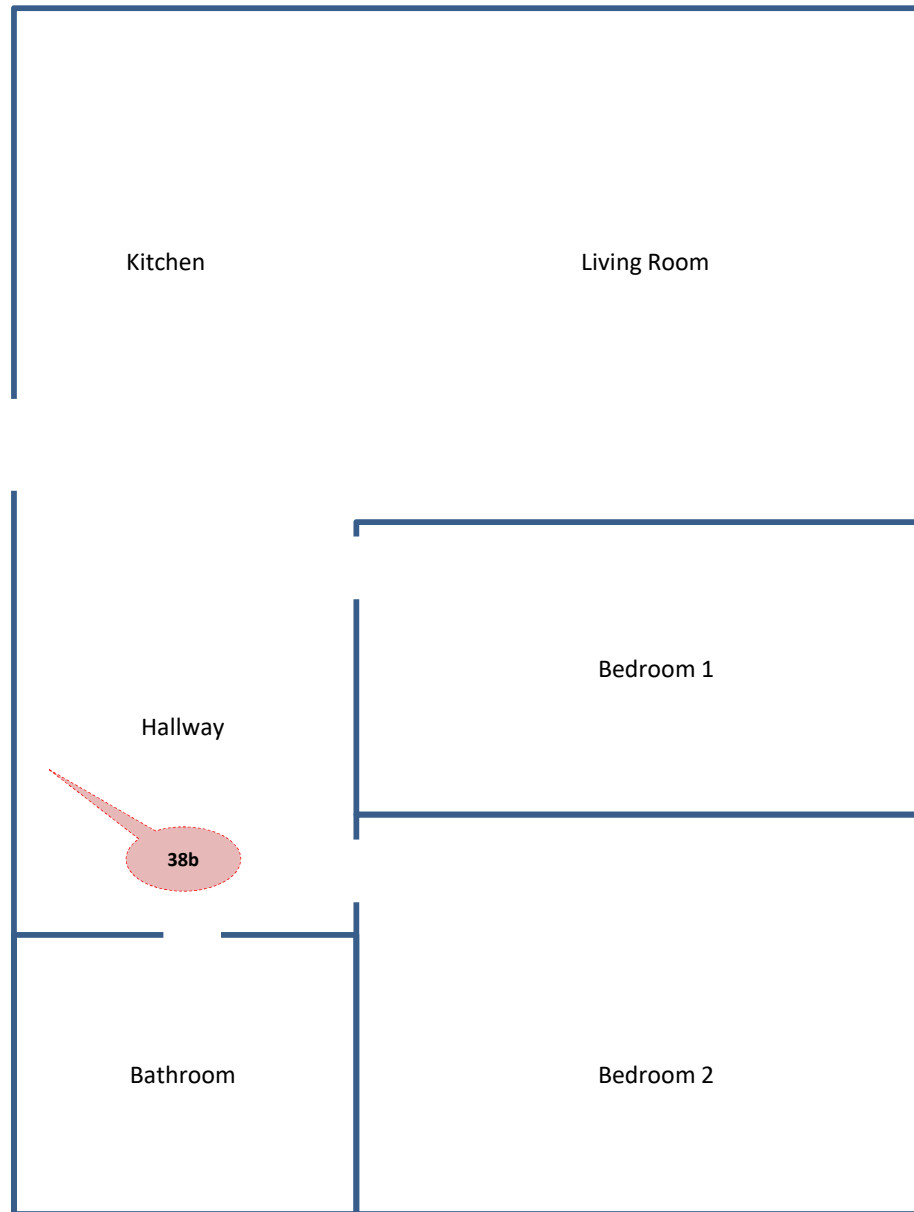
Location: 86 MacRae Drive, Woss, BC
Drawing Title: Sample Locations
Project No: 39957
Drawing No: 001
Surveyed By: LK
Survey Date: August 21, 2020

38b Sheet flooring 2 – brown hexagonal mosaic
