**ATCO Double Wide Trailer  
6150 Brass Road, Port Hardy, BC  
Asbestos Management Inventory**

**North West  
Environmental Group Ltd.**

NWest File: 39957 AMI1 V1.0

Date Issued: April 20, 2021

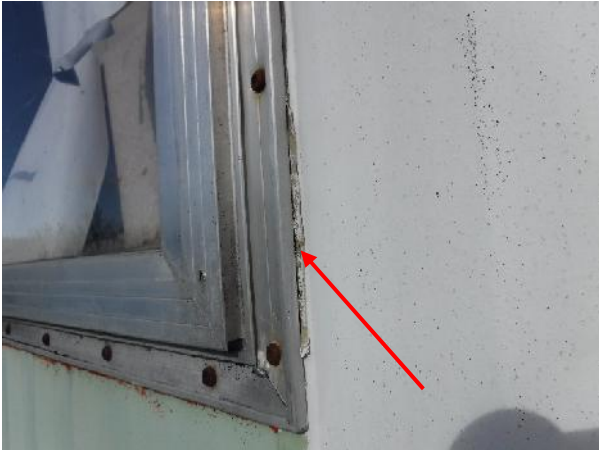
Description	System	Locations	Status	Quantity	Accessibility	Friability	Condition	Mgmt Recommendation
Caulking – off white	Windows	Main Room	Confirmed	6 windows	Access A – Accessible to all building users	Non friable	Good	Action 5 – Proactive ACM removal / Action 7 – Routinely monitor condition Test prior to impact
Drywall joint compound	Ceiling	Main Room, Storage Room	Suspect	1,070 ft <sup>2</sup>	Access A – Accessible to all building users	Non friable	Good	Action 5 – Proactive ACM removal / Action 7 – Routinely monitor condition Test prior to impact
Drywall joint compound	Wall	Main Room, Storage Room	Suspect	1,580 ft <sup>2</sup>	Access A – Accessible to all building users	Non friable	Good	Action 5 – Proactive ACM removal / Action 7 – Routinely monitor condition Test prior to impact
Asphalt stair tread	Stair	Exterior stairs	Suspect	100 ft <sup>2</sup>	Access A – Accessible to all building users	Non friable	Good	Action 5 – Proactive ACM removal / Action 7 – Routinely monitor condition Test prior to impact

Photo 1  
Description: Caulking – off white  
Location: Main Room  
**Asbestos:** 15% Chrysotile  
Sample(s): 30014-15

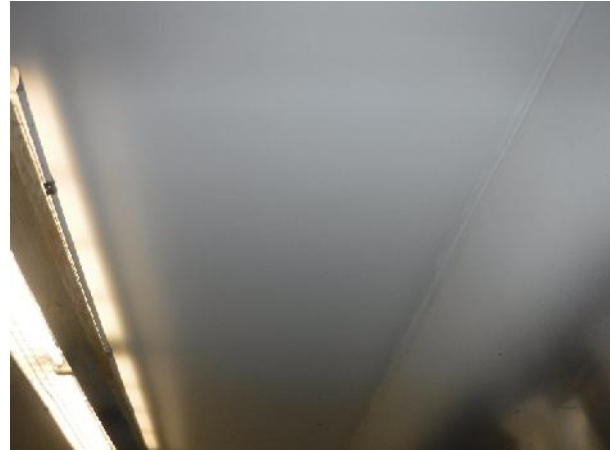
Photo 2  
Description: Drywall joint compound  
Location: Storage Room  
**Asbestos:** Suspect

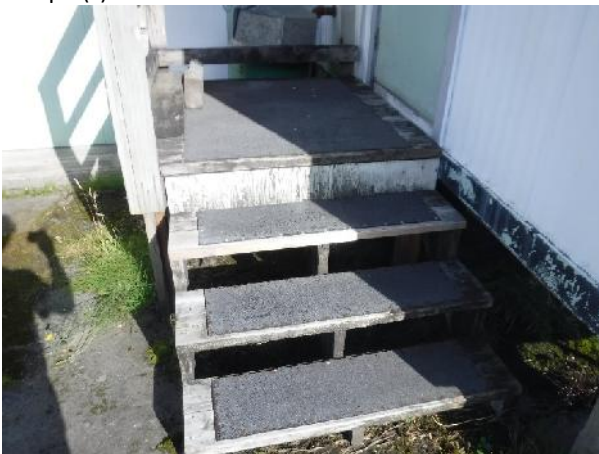
Photo 3  
Description: Asphalt stair tread  
Location: Exterior stairs  
**Asbestos:** Suspect

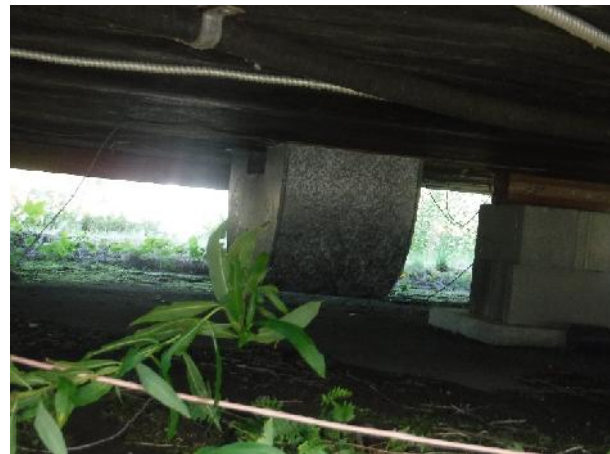
Mastic – grey	Ducting	Beneath Trailer	Suspect	Assume on ducting throughout	Access A – Accessible to all building users	Non friable	Good	Action 5 – Proactive ACM removal / Action 7 – Routinely monitor condition Test prior to impact

Photo 4  
Description: Mastic – grey  
Location: Ductwork Beneath Trailer  
**Asbestos:** Suspect
