Alert Bay Learning Centre 77 Larch Street, Alert Bay, BC Asbestos Management Inventory

NWest File: 39957 AMI1 V1.0
Date Issued: November 10, 2020

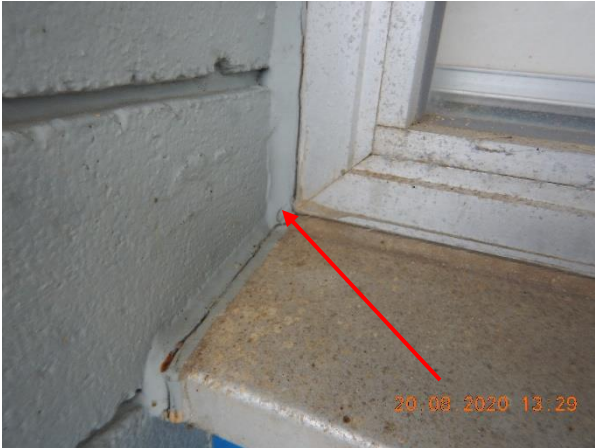
Photo 1
Description: Caulking – Grey
Location: Exterior
Asbestos: Suspect

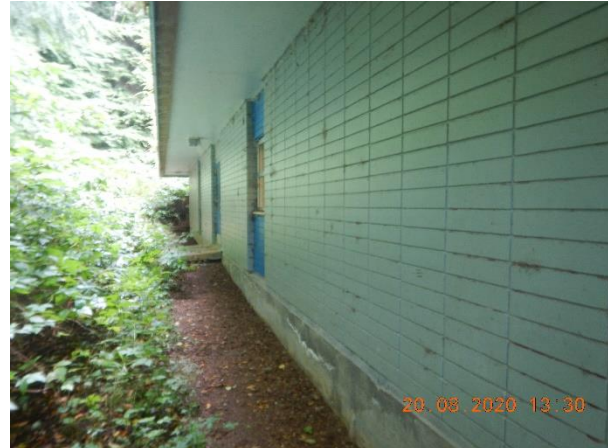
Photo 2
Description: Concrete block
Location: Exterior
Asbestos: Suspect (may contain vermiculite)

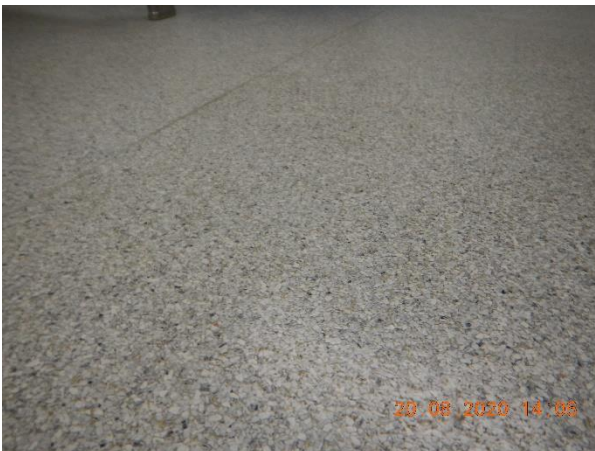
Sheet flooring 1 – Light grey with black specks	Floor	Boys Washroom, Boys Washroom Corridor, Girls Washroom Corridor	Suspect	360 ft ²	Access A – Accessible to all building users	Friable	Good	Action 5 – Proactive ACM removal / Action 7 – Routinely monitor condition Test prior to impact

Photo 3
Description: Sheet flooring 1 – Light grey with black specks
Location: Boys Washroom
Asbestos: Suspect

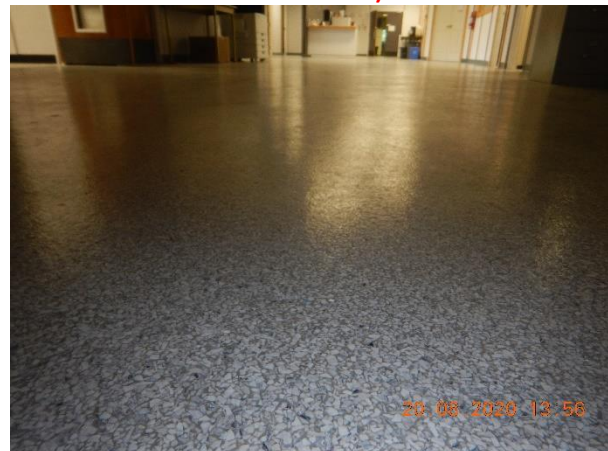
Sheet flooring 2 – Grey and black	Floor	Main Hallway, Entry Foyer	Suspect	2,280 ft ²	Access A – Accessible to all building users	Friable	Good	Action 5 – Proactive ACM removal / Action 7 – Routinely monitor condition Test prior to impact

Photo 4
Description: Sheet flooring 2 – Grey and black
Location: Main Hallway
Asbestos: Suspect

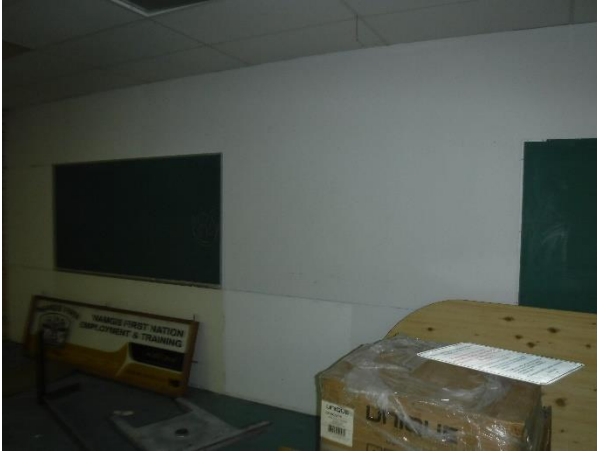
Photo 5
Description: Drywall with joint compound

Location: Storage 2
Asbestos: Suspect

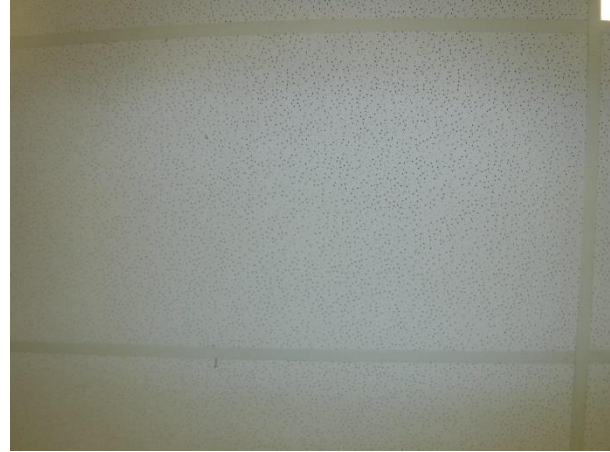
Description	System	Locations	Status	Quantity	Accessibility	Friability	Condition	Mgmt Recommendation
Acoustic ceiling tile type 1 – Small and large pinhole	Ceiling	Office: 1, 2, 3,4, 5 Storage: 1, 2 Meeting Room: 1, 2 Computer Room, Boys Washroom, Boys Washroom Corridor, Janitor Room, Reception, Copy Room, Movie Room, Girls Washroom, Main Hallway, Girls Washroom Corridor, Entry Foyer	Suspect	9,950 ft ²	Access A – Accessible to all building users	Friable	Good	Action 5 – Proactive ACM removal / Action 7 – Routinely monitor condition Test prior to impact
Acoustic ceiling tile type 2 - Patterned fissures small and large pinhole	Ceiling	Office: 2, 3 Storage 2	Suspect	215 ft ²	Access A – Accessible to all building users	Friable	Good	Action 5 – Proactive ACM removal / Action 7 – Routinely monitor condition Test prior to impact
Acoustic ceiling tile type 3 - Lateral fissures with pinholes	Ceiling	Storage 2, Entry Foyer	Suspect	32 ft ²	Access A – Accessible to all building users	Friable	Good	Action 5 – Proactive ACM removal / Action 7 – Routinely monitor condition Test prior to impact

Photo 6
Description: Acoustic ceiling tile type 1 – Small and large pinhole

Location:
Asbestos: Suspect

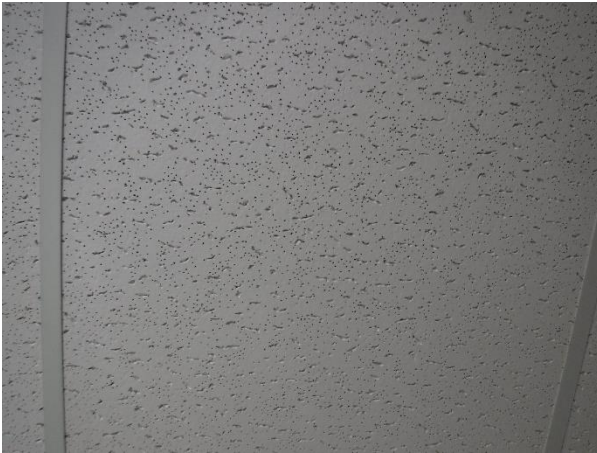
Photo 7
Description: Acoustic ceiling tile type 3 - Lateral fissures with pinholes

Location: Storage 2
Asbestos: Suspect

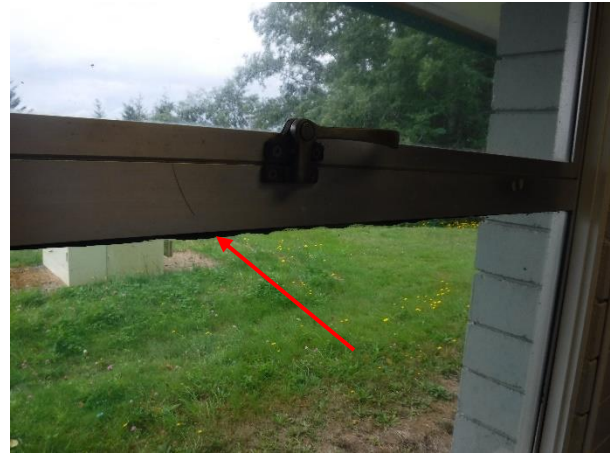
Window mastic – Black	Window	Office: 1, 3, 4, 5 Meeting Room: 1, 2 Computer Room, Reception, Movie Room, Girls Washroom, Storage 2, Girls Washroom Corridor	Confirmed	21 windows	Access A – Accessible to all building users	Non-friable	Good	Action 5 – Proactive ACM removal / Action 7 – Routinely monitor condition Test prior to impact
Caulking – Off white	Window	Meeting Room 1,	Suspect	2 windows	Access A – Accessible to all building users	Non-friable	Good	Action 5 – Proactive ACM removal / Action 7 – Routinely monitor condition Test prior to impact
Baseboard adhesive	Wall	Storage 2	Suspect	Perimeter of room listed	Access A – Accessible to all building users	Non-friable	Fair	Action 5 – Proactive ACM removal / Action 7 – Routinely monitor condition Test prior to impact
Drywall with joint compound	Wall	Storage 2	Suspect	400 ft ²	Access A – Accessible to all building users	Non-friable	Good	Action 5 – Proactive ACM removal / Action 7 – Routinely monitor condition Test prior to impact

Photo 8
Description: Window mastic – Black

Location: Girls Washroom Corridor
Asbestos: 11% Chrysotile

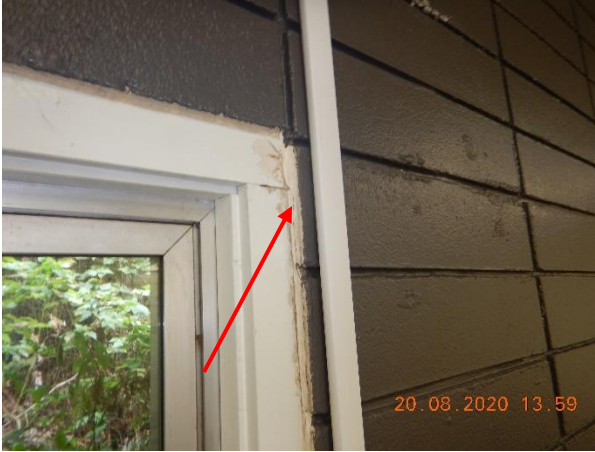
Photo 9
Description: Caulking – Off White
Location: Meeting Room 1
Asbestos: **Suspect**

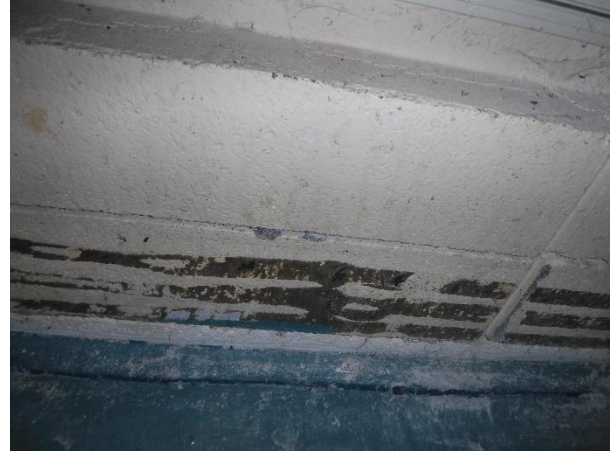
Photo 10
Description: Baseboard adhesive
Location: Storage 2
Asbestos: **Suspect**

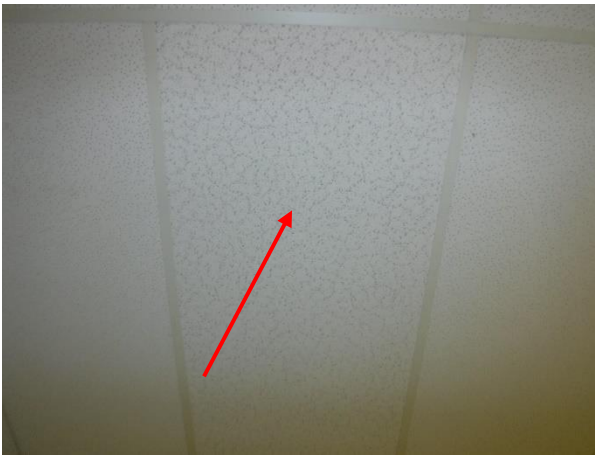
Photo 11
Description: Acoustic ceiling tile type 2 -
Patterned fissures small and large
pinhole
Location: Office 2
Asbestos: **Suspect**
