School District 85

Maintenance Shop Building 1 2071 McNeill Road, Port McNeill, BC Asbestos Management Inventory

NWest File: 39957 AMI1 V1.0

Date Issued: January 4, 2021

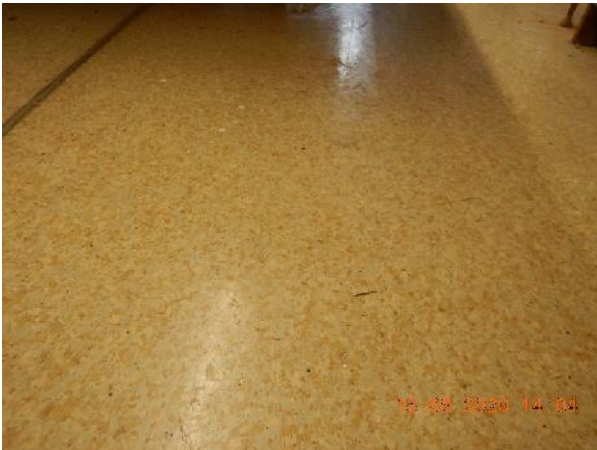
Sheet flooring 11- Yellow/beige square mosaic	Floor	Main Workshop	Confirmed	780 ft ²	Access A – Accessible to all building users	Friable	Good	Action 5 – Proactive ACM removal / Action 7 – Routinely monitor condition Test prior to impact

Photo 1
Description: Sheet flooring 11- Yellow/beige square mosaic
Location: Main Workshop
Asbestos: 20% Chrysotile
Sample(s): 30008-4

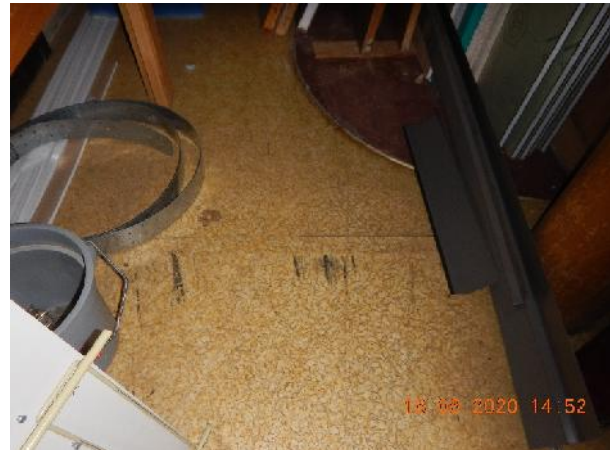
Sheet flooring 13 – Yellow swirl	Floor	Storage Room: I	Confirmed	100 ft ²	Access A – Accessible to all building users	Friable	Good	Action 5 – Proactive ACM removal / Action 7 – Routinely monitor condition Test prior to impact
Floor tile 3 – Beige with red and brown streaks	Floor	Part Supply Entranceway, Party Supply Washroom 1, Party Supply Washroom 2	Suspect	140 ft ²	Access A – Accessible to all building users	Non-friable	Good	Action 5 – Proactive ACM removal / Action 7 – Routinely monitor condition Test prior to impact
Incandescent light gasket	Lighting	Storage Room: D, F, G, H, J Shower D, Bathroom K, Kitchen M, Storage Adjacent Room C	Confirmed	15 lights	Access A – Accessible to all building users	Friable	Good	Action 5 – Proactive ACM removal / Action 7 – Routinely monitor condition Test prior to impact
Drywall with joint compound	Wall	Storage Room: I, L, Kitchen M, Lower Electrical Room O, Mechanical Room, Lower Washroom, Storage Between Main Workshop and Kitchen M	Confirmed	1,780 ft ²	Access A – Accessible to all building users	Non-friable	Good-Fair	Action 5 – Proactive ACM removal / Action 7 – Routinely monitor condition Test prior to impact

Photo 2
Description: Sheet flooring 13 – Yellow swirl
Location: Storage Room I
Asbestos: 20% Chrysotile
Sample(s): 30008-9

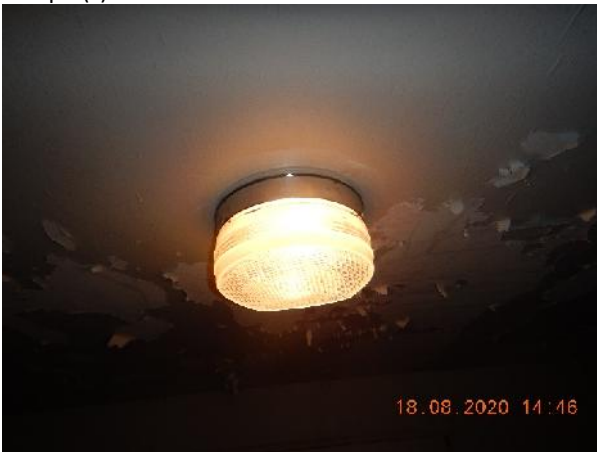
Photo 3
Description: Incandescent light gasket
Location: Storage Room F
Asbestos: 35% Chrysotile
Sample(s): 30008-7

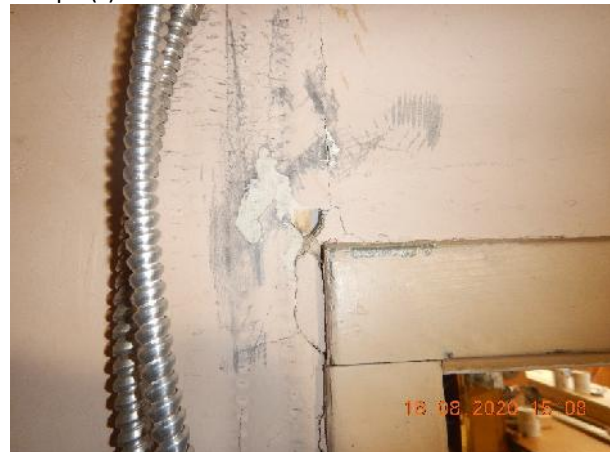
Description	System	Locations	Status	Quantity	Accessibility	Friability	Condition	Mgmt Recommendation
Drywall with joint compound	Ceiling	Lower Storage Room N, Lower Electrical Room O, Lower Washroom	Confirmed	720 ft ²	Access A – Accessible to all building users	Non-friable	Good	Action 5 – Proactive ACM removal / Action 7 – Routinely monitor condition Test prior to impact
Texture coat	Ceiling	Storage Room L	Suspect	280 ft ²	Access A – Accessible to all building users	Non-friable	Good	Action 5 – Proactive ACM removal / Action 7 – Routinely monitor condition Test prior to impact
Mastic type 1 – Gold/silver	Sink	Kitchen M	Suspect	1 sink	Access A – Accessible to all building users	Non-friable	Good	Action 5 – Proactive ACM removal / Action 7 – Routinely monitor condition Test prior to impact
Mastic type 2 – Black	Window	Main Workshop	Suspect	2 windows	Access A – Accessible to all building users	Non-friable	Good	Action 5 – Proactive ACM removal / Action 7 – Routinely monitor condition Test prior to impact

Photo 4
Description: Drywall with joint compound
Location: Mechanical Room
Asbestos: 1.5% Chrysotile
Sample(s): 39957-24b

39957-24b	NISS Maintenance Shop Building 1 Mech Room	Sep 15, 2020	BR	Drywall Joint Compound	Off White	100	Chrysotile	1.5	Non-Fibrous	98.5

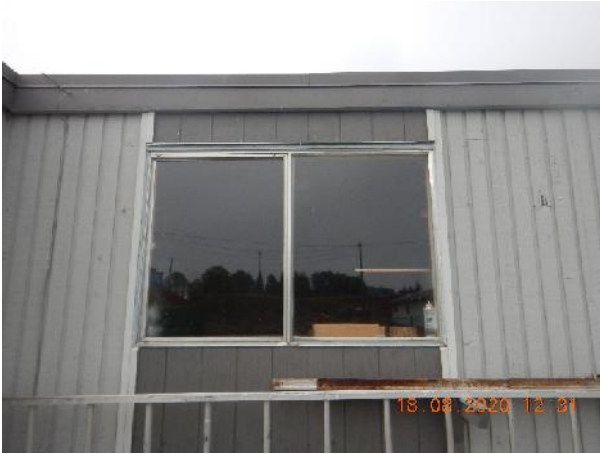
Description	System	Locations	Status	Quantity	Accessibility	Friability	Condition	Mgmt Recommendation
Caulking type 1 – White/grey	Window	Exterior	Suspect	All exterior windows	Access A – Accessible to all building users	Non-friable	Good	Action 5 – Proactive ACM removal / Action 7 – Routinely monitor condition Test prior to impact

Photo 5
Description: Caulking type 1 – White/grey

Location: Exterior
Asbestos: Suspect

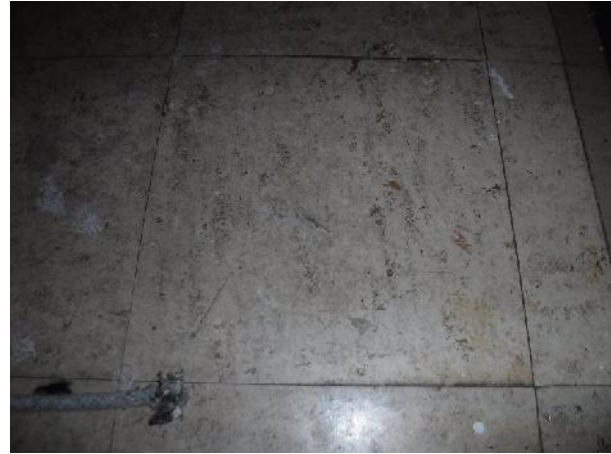
Photo 6
Description: Floor tile 3 – Beige with red and brown streaks

Location:
Asbestos: Suspect

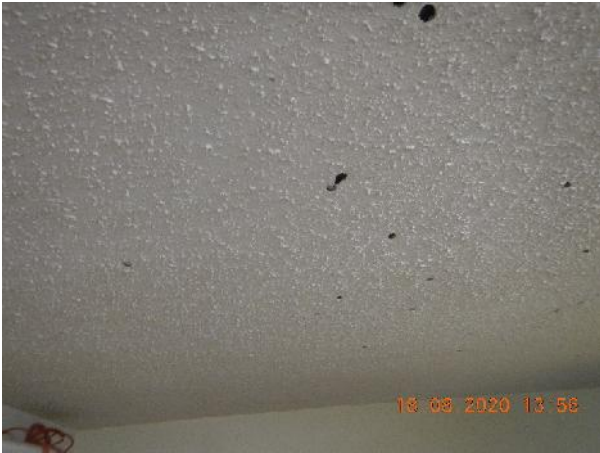
Photo 7
Description: Texture coat
Location: Storage Room L
Asbestos: Suspect

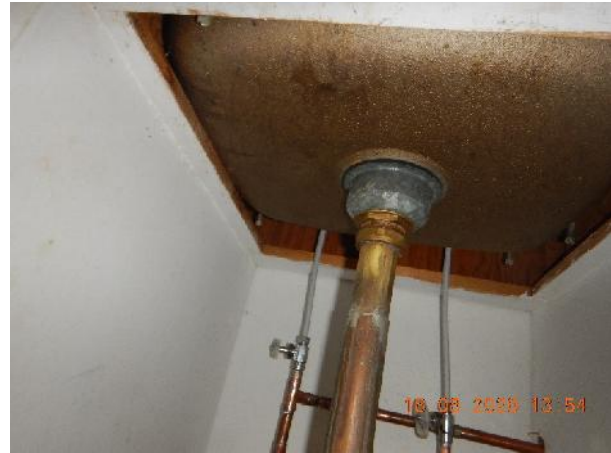
Photo 8
Description: Mastic type 1 – Gold/silver
Location: Kitchen M
Asbestos: Suspect

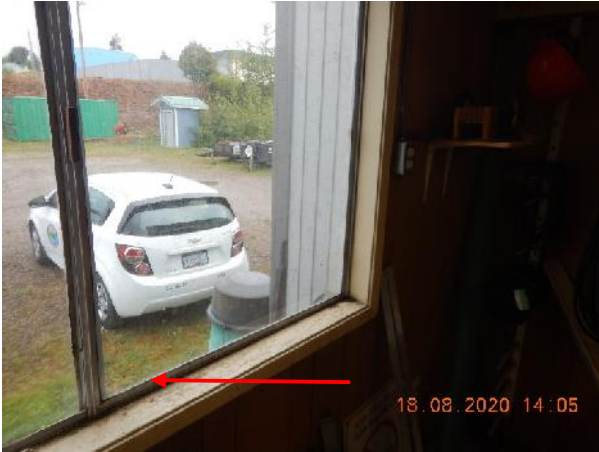
Photo 9
Description: Mastic type 2 – Black
Location: Main Workshop
Asbestos: Suspect

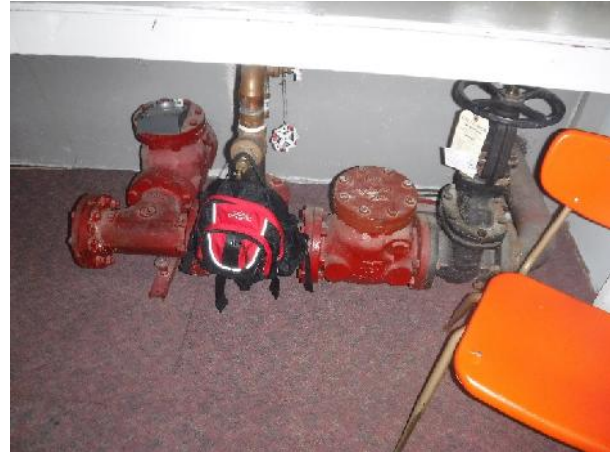
Gaskets	Piping	Lower Storage Room N	Suspect	11 gaskets	Access A – Accessible to all building users	Non-friable	Good	Action 5 – Proactive ACM removal / Action 7 – Routinely monitor condition Test prior to impact

Photo 10
Description: Gaskets
Location: Lower Storage Room N
Asbestos: Suspect
