School District 85

Maintenance Shop Building 2 2071 McNeill Road, Port McNeill, BC Asbestos Management Inventory

NWest File: 39957 AMI1 V1.0

Date Issued: January 4, 2021

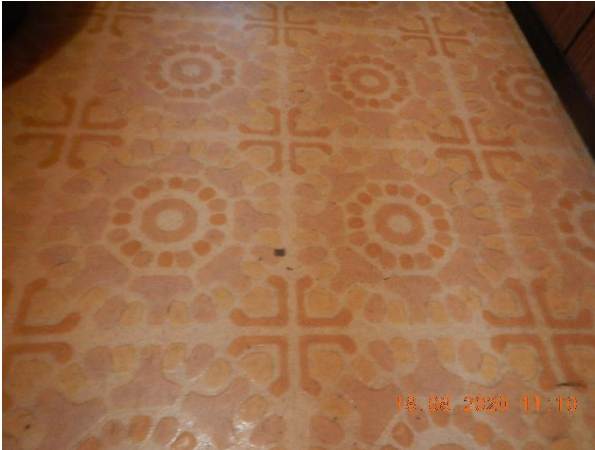
Sheet flooring 9 – Yellow brown flower	Floor	Room: 4, 6	Confirmed	160 ft ²	Access A – Accessible to all building users	Friable	Good	Action 5 – Proactive ACM removal / Action 7 – Routinely monitor condition Test prior to impact
Mastic 1 – Black	Window	Room: 1, 3, 7, 8	Suspect	6 windows	Access A – Accessible to all building users	Non-friable	Good	Action 5 – Proactive ACM removal / Action 7 – Routinely monitor condition Test prior to impact
Mastic 2 – Gold/silver	Sink	Room: 1	Suspect	1 sink	Access A – Accessible to all building users	Non-friable	Good	Action 5 – Proactive ACM removal / Action 7 – Routinely monitor condition Test prior to impact

Photo 1
Description: Sheet flooring 9 – Yellow brown flower
Location: Room 6
Asbestos: 20% Chrysotile
Sample(s): 30008-2

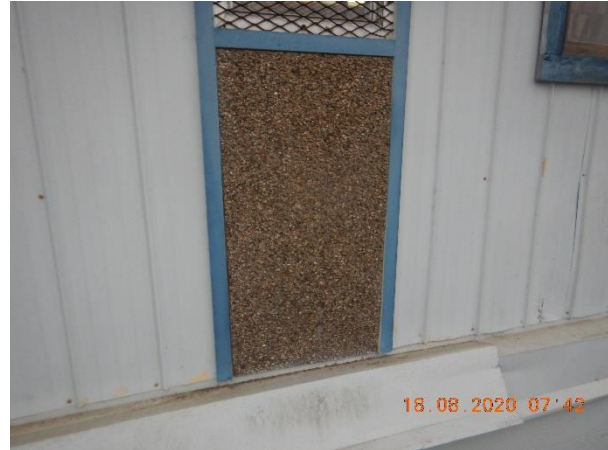
Photo 2
Description: Aggregate panel
Location: Exterior
Asbestos: Suspect

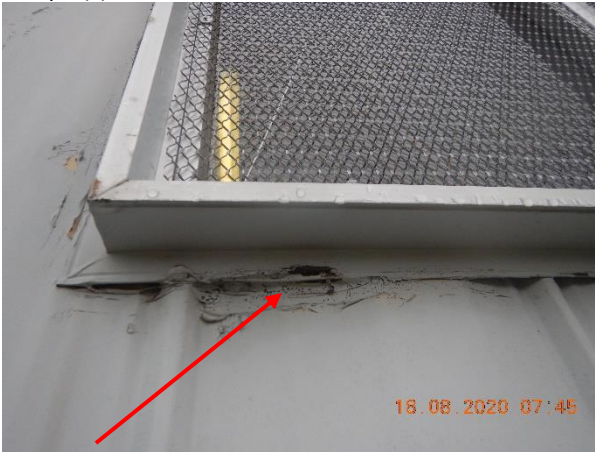
Photo 3
Description: Caulking 1 – Grey
Location: Exterior
Asbestos: Suspect

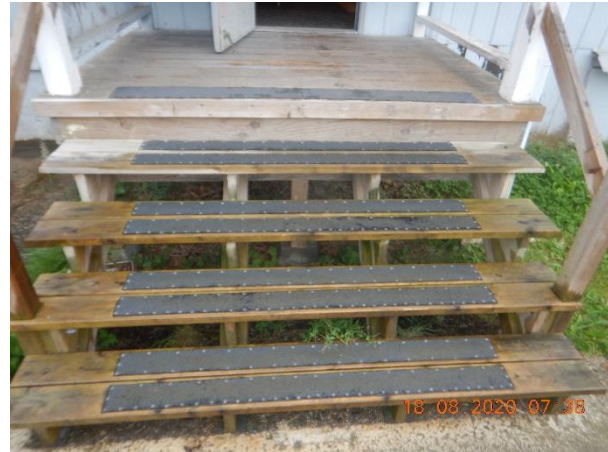
Photo 4
Description: Asphalt stair tread
Location: Exterior
Asbestos: Suspect

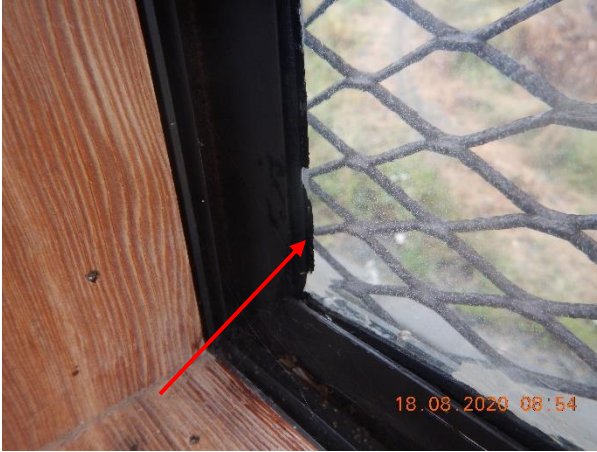
Photo 5
Description: Mastic 1 – Black
Location: Room 1
Asbestos: Suspect

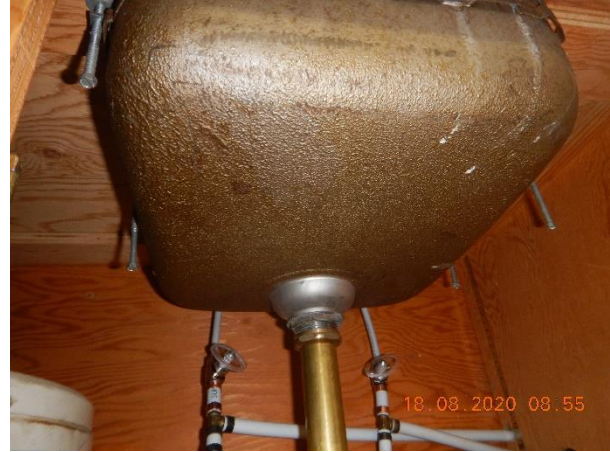
Photo 6
Description: Mastic 2 – Gold/silver
Location: Room 1
Asbestos: Suspect

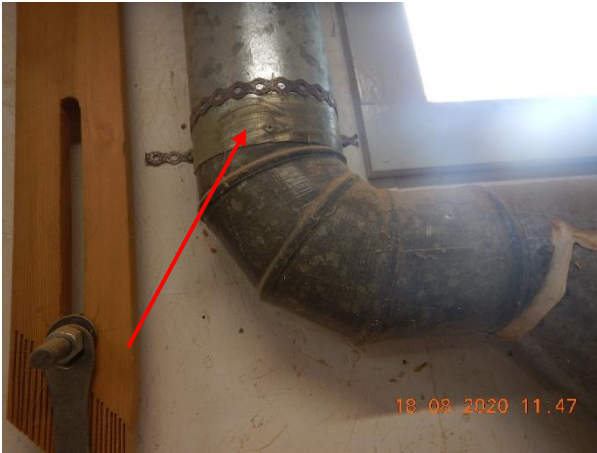
Description	System	Locations	Status	Quantity	Accessibility	Friability	Condition	Mgmt Recommendation
Mastic 3 – Grey	Ducting	Room: 9	Suspect	On all ducting joints in rooms listed	Access A – Accessible to all building users	Non-friable	Good	Action 5 – Proactive ACM removal / Action 7 – Routinely monitor condition Test prior to impact
Incandescent light gasket	Lighting	Room: 5, 6	Suspect	2 light gaskets	Access A – Accessible to all building users	Friable	Good	Action 5 – Proactive ACM removal / Action 7 – Routinely monitor condition Test prior to impact
Radiator (may contain concealed ACM insulation)	Heating	Room: 1, 2, 7	Suspect	3 heaters	Access A – Accessible to all building users	Non-friable	Good	Action 5 – Proactive ACM removal / Action 7 – Routinely monitor condition Test prior to impact
Baseboard adhesive	Wall	Room: 1, 3, 5, 6	Suspect	Perimeter of all listed rooms	Access A – Accessible to all building users	Non-friable	Good	Action 5 – Proactive ACM removal / Action 7 – Routinely monitor condition Test prior to impact

Photo 7
Description: Mastic 3 – Grey
Location: Room 9
Asbestos: Suspect

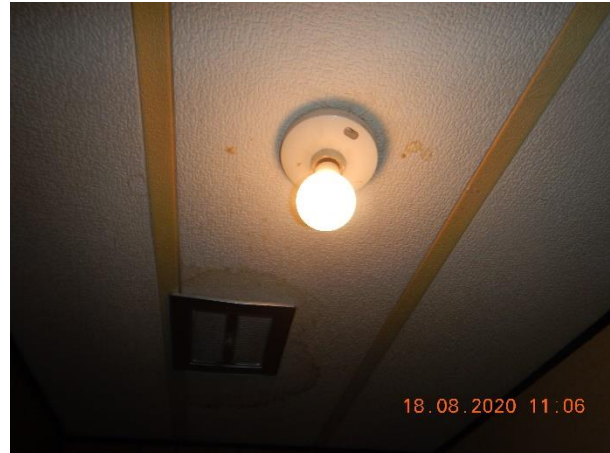
Photo 8
Description: Incandescent light gasket
Location: Room 5
Asbestos: Suspect

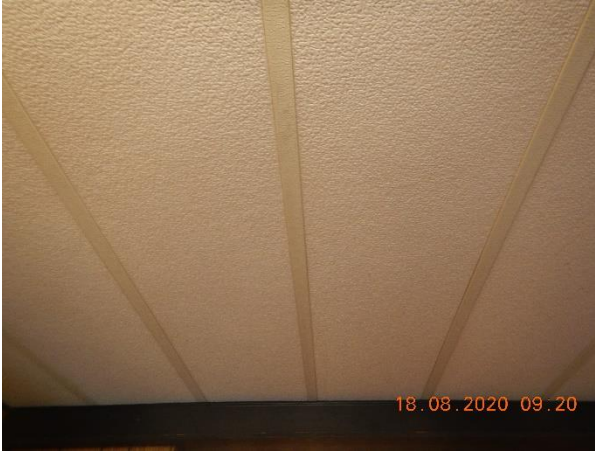
Photo 9
Description: Acoustic ceiling tile 1 – Textured
Location: Room 4
Asbestos: Suspect

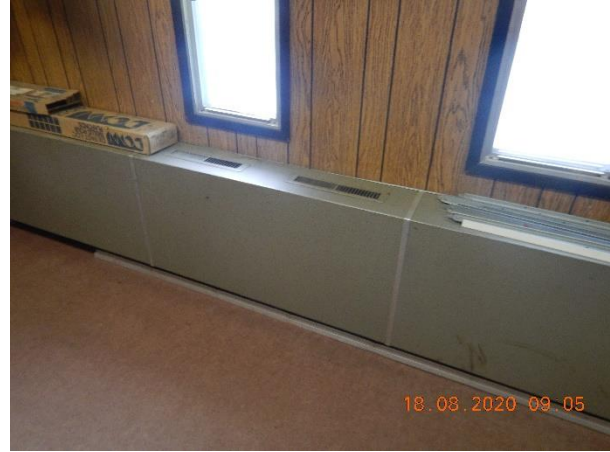
Photo 10
Description: Radiator (may contain concealed ACM insulation)
Location: Room 2
Asbestos: Suspect

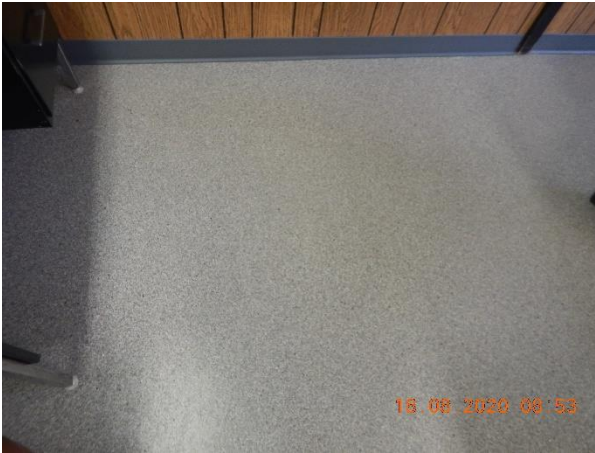
Photo 11
Description: Baseboard Adhesive
Location: Room 1
Asbestos: Suspect
