## School District 85

**North Island Secondary School  
2071 McNeill Road, Port McNeill, BC  
Asbestos Management Inventory**

NWest File: 39957 AMI1 V1.0

Date Issued: January 7, 2021

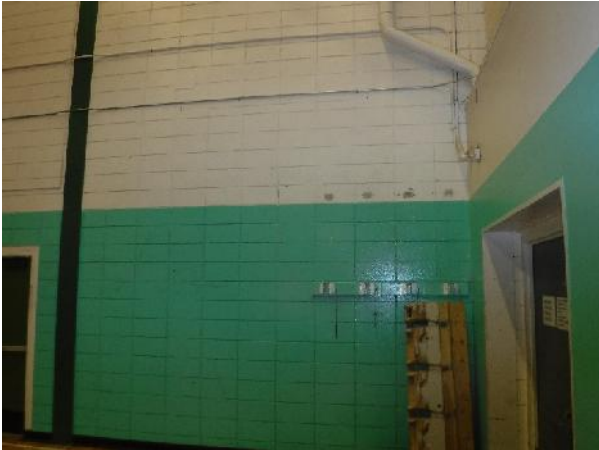
| Description | System | Locations | Status | Quantity | Accessibility | Friability | Condition | Mgmt Recommendation |
|---|---|---|---|---|---|---|---|---|
| Concrete block (contains vermiculite) | Siding | Exterior | Confirmed | 5,700 ft <sup>2</sup> | Access A – Accessible to all building users | Non friable | Good | Action 5 – Proactive ACM removal / Action 7 – Routinely monitor condition<br>Test prior to impact |

Photo 1  
 Description: Concrete block (contains vermiculite)  
 Location: Gym  
**Asbestos: 1% Actinolite**  
 Sample(s): 40391-48b

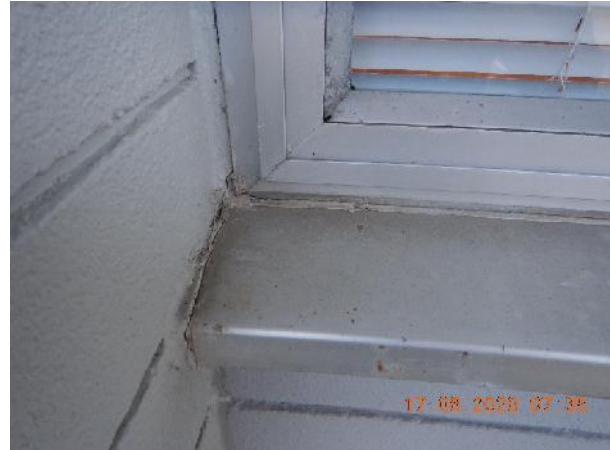
| Description | System | Locations | Status | Quantity | Accessibility | Friability | Condition | Mgmt Recommendation |
|--|---|--|---|---|---|---|---|--|
| Caulking 3 – Grey | Window | Exterior | Confirmed | Exterior windows not stamped for post 1990 production | Access A – Accessible to all building users | Non friable | Good | Action 5 – Proactive ACM removal / Action 7 – Routinely monitor condition Test prior to impact |

Photo 2  
 Description: Caulking 3 – Grey  
 Location: Exterior  
**Asbestos: 1.3% Chrysotile**  
 Sample(s): 30007-27

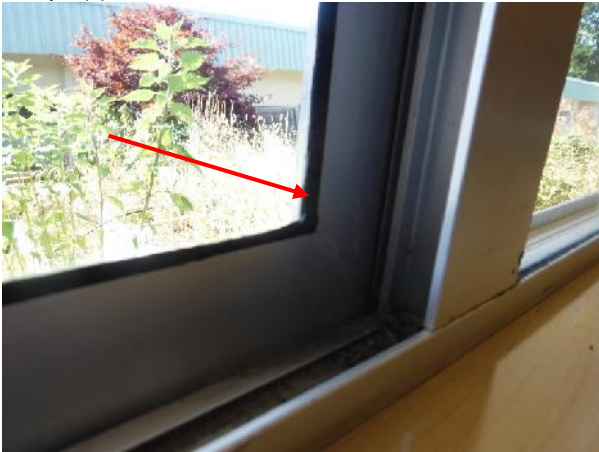
| Description | System | Locations | Status | Quantity | Accessibility | Friability | Condition | Mgmt Recommendation |
|--|---|--|---|---|---|---|---|--|
| Caulking 5 – Black | Window | Room: 102, 105, 107, 109, 201, 227, 229, 230, 231, 318 Entry Foyer, Hallway 2, Staff Room | Confirmed | 27 windows | Access A – Accessible to all building users | Non friable | Good | Action 5 – Proactive ACM removal / Action 7 – Routinely monitor condition Test prior to impact |

Photo 3  
 Description: Caulking 5 – Black  
 Location: Room 227  
**Asbestos: 9% Chrysotile**  
 Sample(s): 40391-17b

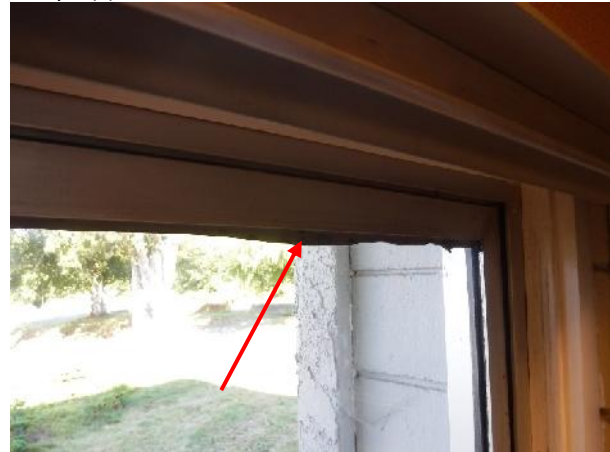
| Description | System | Locations | Status | Quantity | Accessibility | Friability | Condition | Mgmt Recommendation |
|--|---|--|---|---|---|---|---|--|
| Caulking 6 – Grey | Window | First Nations Room, Hallway 4 | Confirmed | 5 windows | Access A – Accessible to all building users | Non friable | Good | Action 5 – Proactive ACM removal / Action 7 – Routinely monitor condition Test prior to impact |

Photo 4  
 Description: Caulking 6 – Grey  
 Location: First Nations Room  
**Asbestos: 12% Chrysotile**  
 Sample(s): 40391-29b

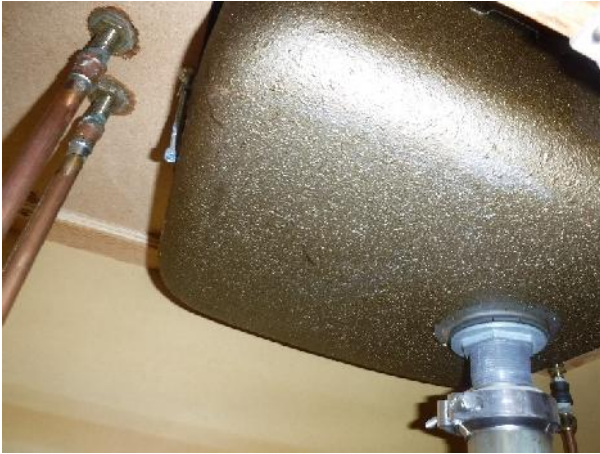
| Description | System | Locations | Status | Quantity | Accessibility | Friability | Condition | Mgmt Recommendation |
|---|---|--|---|--|--|---|---|--|
| Mastic 3 – Black/Silver on sink | Sink | Room: 111 and 231 | Confirmed | 12 sinks | Access A – Accessible to all building users | Non friable | Good | Action 5 – Proactive ACM removal / Action 7 – Routinely monitor condition Test prior to impact |

Photo 7  
Description: Mastic 3 – Black/Silver on sink  
Location: Room 231  
Asbestos: 1.3% Chrysotile  
Sample(s): 30007-21

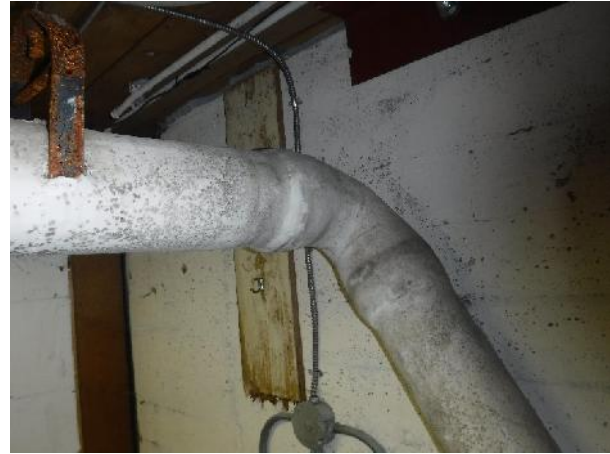
| Description | System | Locations | Status | Quantity | Accessibility | Friability | Condition | Mgmt Recommendation |
|---|---|--|---|---|--|---|---|--|
| Pipe elbow and fitting insulation | Pipe insulation | Basement, Hallway 4 Janitors Room | Confirmed | 8 elbows and fittings | Access B – Accessible to maintenance workers | Friable | Fair | Action 5 – Proactive ACM removal<br>or<br>Action 6 – Repair damaged ACM |

Photo 8  
Description: Pipe elbow and fitting insulation  
Location: Basement  
Asbestos: 26% Chrysotile  
4% Amosite  
Sample(s): 39957-9b,12b,13b

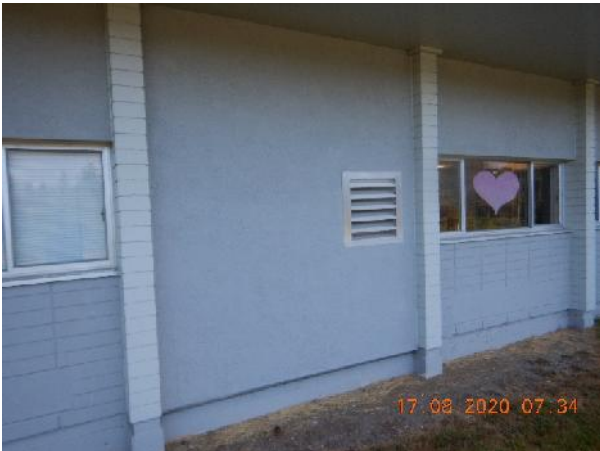
| Description | System | Locations | Status | Quantity | Accessibility | Friability | Condition | Mgmt Recommendation |
|---|---|---|---|---|---|---|---|---|
| Stucco | Siding | Exterior | Suspect | 5,700 ft <sup>2</sup> | Access A – Accessible to all building users | Non friable | Good | Action 5 – Proactive ACM removal / Action 7 – Routinely monitor condition<br>Test prior to impact |

Photo 9  
Description: Stucco  
Location: Exterior  
Asbestos: Suspect

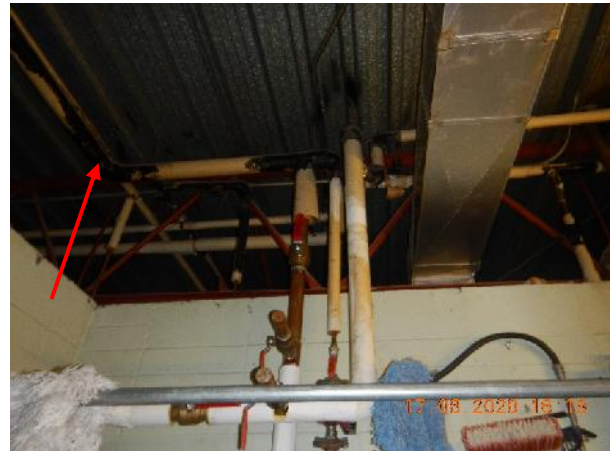
| Description | System | Locations | Status | Quantity | Accessibility | Friability | Condition | Mgmt Recommendation |
|---|---|--|---|--|--|---|---|--|
| Mastic 1 – Black on pipe insulation | Plumbing | Basement, Hallway 8 Janitors Room, Crawl Space | Suspect | Select areas on pipe insulation in rooms mentioned | Access B – Accessible to maintenance workers | Non friable | Good | Action 5 – Proactive ACM removal / Action 7 – Routinely monitor condition Test prior to impact |

Photo 10  
Description: Mastic 1 – Black on pipe insulation  
Location: Hallway 8 Janitors Room  
Asbestos: Suspect

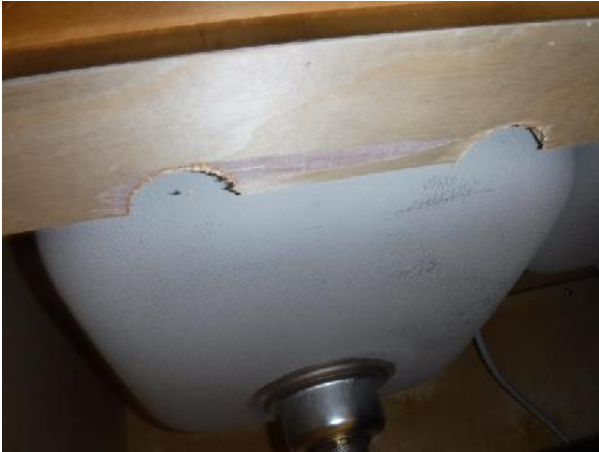
| Description | System | Locations | Status | Quantity | Accessibility | Friability | Condition | Mgmt Recommendation |
|--|---|--|---|---|---|---|---|--|
| Mastic 4 – White on sink | Sink | Room: 108, 109, 112, 227, 229, 319B<br>Main Office First Aid, Staff Room | Suspect | 9 sinks | Access A – Accessible to all building users | Non friable | Good | Action 5 – Proactive ACM removal / Action 7 – Routinely monitor condition Test prior to impact |

Photo 11  
Description: Mastic 4 – White on sink  
Location: Room 227  
Asbestos: Suspect

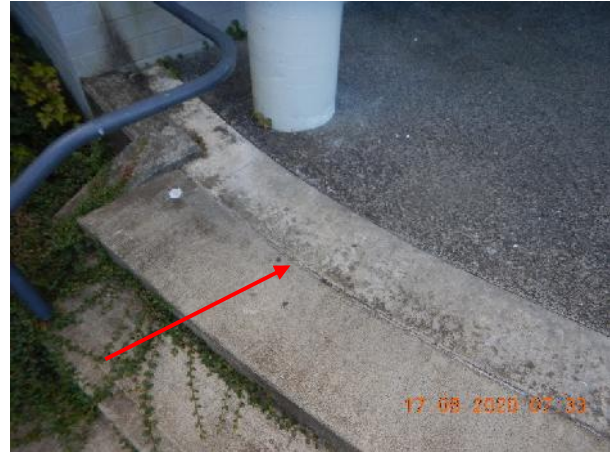
| Description | System | Locations | Status | Quantity | Accessibility | Friability | Condition | Mgmt Recommendation |
|--|---|--|---|---|---|---|---|--|
| Caulking 7 – Light Grey | Stairs | Exterior | Suspect | Various amounts in cracks of front entrance steps | Access A – Accessible to all building users | Non friable | Good | Action 5 – Proactive ACM removal / Action 7 – Routinely monitor condition Test prior to impact |

Photo 12  
Description: Caulking 7 – Light Grey  
Location: Exterior  
Asbestos: Suspect concealed asbestos leveling compound(s)

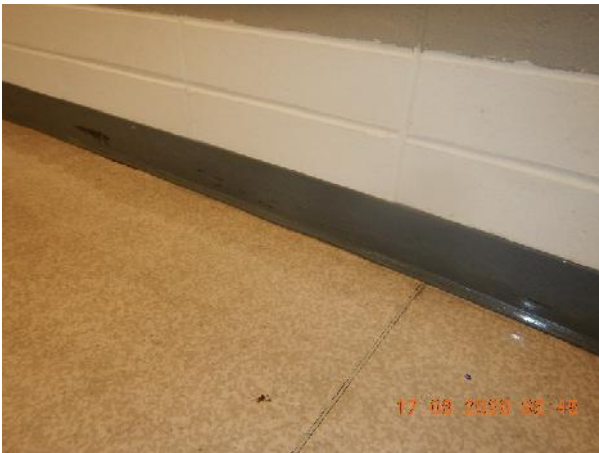
| Description | System | Locations | Status | Quantity | Accessibility | Friability | Condition | Mgmt Recommendation |
|---|---|--|---|---|--|---|---|--|
| Baseboard adhesive | Wall | Throughout building | Suspect | At base of walls throughout building | Access A – Accessible to all building users | Non friable | Good | Action 5 – Proactive ACM removal / Action 7 – Routinely monitor condition Test prior to impact |

Photo 13  
Description: Baseboard adhesive  
Location: Room 101  
Asbestos: Suspect

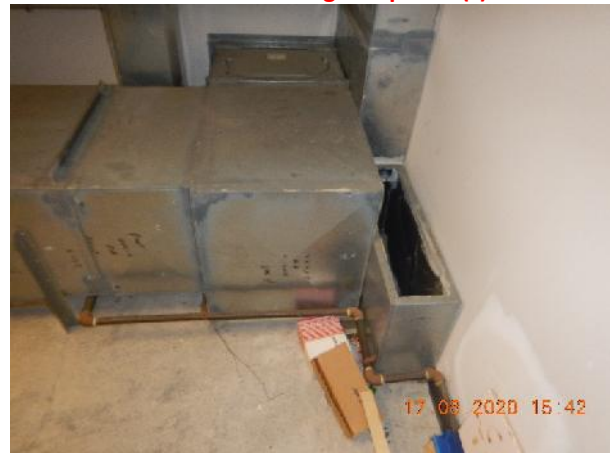
| Description | System | Locations | Status | Quantity | Accessibility | Friability | Condition | Mgmt Recommendation |
|--|---|--|---|---|---|---|---|--|
| Caulking 4 – Grey/white (Likely originally grey but painted white) | Ducting | Room: 100, 101, 102, 103, 104, 105, 107, 108, 109, 110, Mechanical Room Adjacent Drama, Drama Mezzanine Storage, Hallway 8 Janitors Room | Confirmed | Select areas on ducting in rooms mentioned | Access A – Accessible to all building users | Non friable | Good | Action 5 – Proactive ACM removal / Action 7 – Routinely monitor condition Test prior to impact |

Photo 14  
Description: Caulking 4 – Grey/white (Likely originally grey but painted white)  
Location: Mechanical Room Adjacent Drama  
Asbestos: 3.8% Chrysotile  
Sample: 30007-6

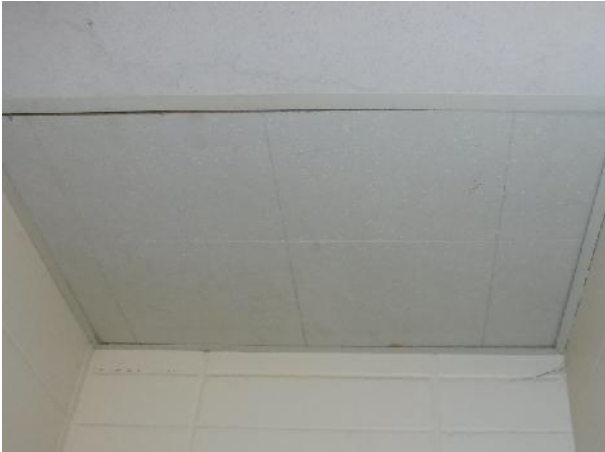
| Description | System | Locations | Status | Quantity | Accessibility | Friability | Condition | Mgmt Recommendation |
|--|---|--|---|---|---|---|---|--|
| Ceiling tile 1 – 12”x12” donnacona textured | Ceiling | Boys Change Room, Boys Change Room Washroom, Girls Change Room, Girls Change Room Entry, Girls Washroom Off Change Room | Suspect | 2,090 ft <sup>2</sup> | Access A – Accessible to all building users | Friable | Good | Action 5 – Proactive ACM removal / Action 7 – Routinely monitor condition Test prior to impact |

Photo 15  
Description: Ceiling tile 1 – 12"x12" donnacona textured  
Location: Boys Change Room  
**Asbestos: Suspect**

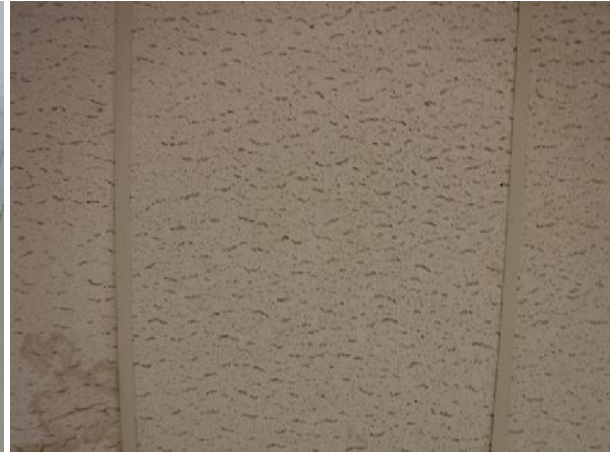
| Description | System | Locations | Status | Quantity | Accessibility | Friability | Condition | Mgmt Recommendation |
|---|---|--|---|---|---|---|---|--|
| Acoustic ceiling tile 3 – Vertical fissure small and large pinholes | Ceiling | Room: 230, 231 Boys Washroom off Hallway 3, Hallway 5, Hallway 4 Janitors Room, Hallway 3 Janitors Room | Suspect | 2,450 ft <sup>2</sup> | Access A – Accessible to all building users | Friable | Good | Action 5 – Proactive ACM removal / Action 7 – Routinely monitor condition Test prior to impact |

Photo 16  
Description: Acoustic ceiling tile 3 – Vertical fissure small and large pinholes  
Location:  
**Asbestos: Suspect**

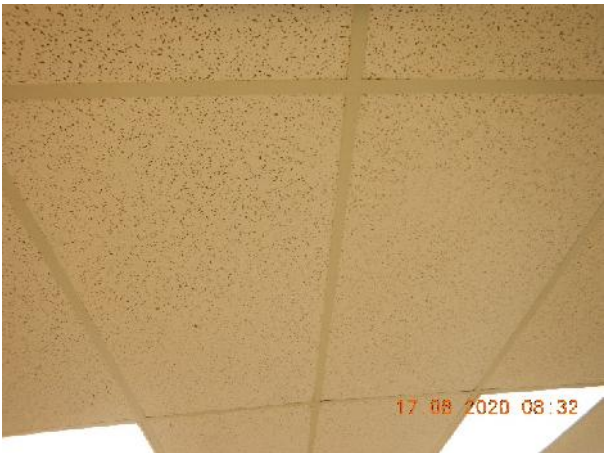
| Description | System | Locations | Status | Quantity | Accessibility | Friability | Condition | Mgmt Recommendation |
|---|---|--|---|---|---|---|---|--|
| Acoustic ceiling tile 4 – Random fissure, large pinholes | Ceiling | Room: 100, 102, 103, 104, 105 | Suspect | 730 ft <sup>2</sup> | Access A – Accessible to all building users | Friable | Good | Action 5 – Proactive ACM removal / Action 7 – Routinely monitor condition Test prior to impact |

Photo 17  
Description: Acoustic ceiling tile 4 – Random fissure, large pinholes  
Location: Room 100  
**Asbestos: Suspect**

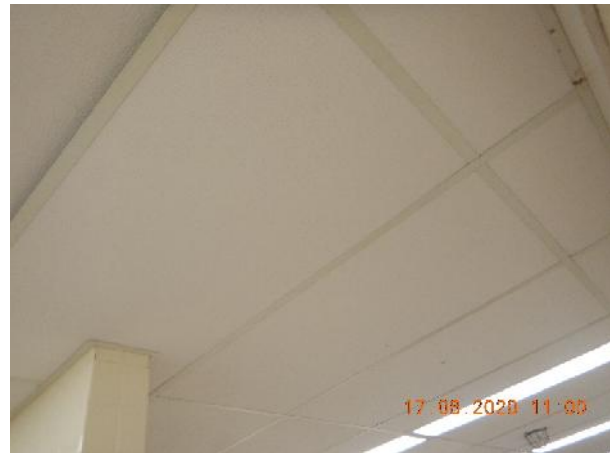
| Description | System | Locations | Status | Quantity | Accessibility | Friability | Condition | Mgmt Recommendation |
|---|---|--|---|---|---|---|---|--|
| Acoustic ceiling tile 5 – Textured fibreglass | Ceiling | Boys Washroom off Hallway 3, Hallway 4 Gentlemen Washroom, Guys Instructor Change Room | Suspect | 515 ft <sup>2</sup> | Access A – Accessible to all building users | Friable | Good | Action 5 – Proactive ACM removal / Action 7 – Routinely monitor condition Test prior to impact |

Photo 18  
Description: Acoustic ceiling tile 5 – Textured fibreglass  
Location: Hallway 4 Gentlemen Washroom  
**Asbestos: Suspect**

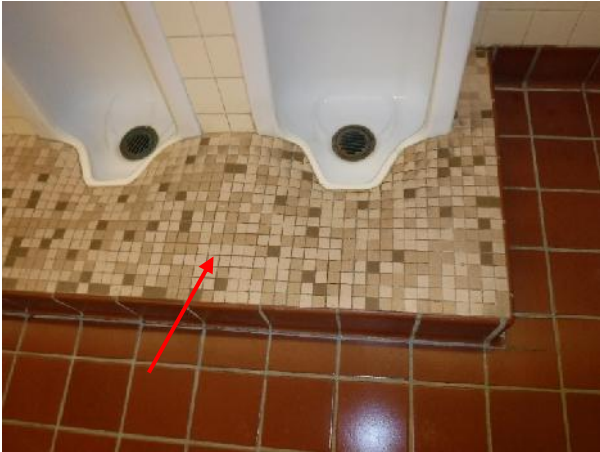
| Description | System | Locations | Status | Quantity | Accessibility | Friability | Condition | Mgmt Recommendation |
|---|---|--|---|---|---|---|---|--|
| 1”x 1” beige and brown ceramic tile grout and mortar | Urinal platform | Boys Washroom off Hallway 3, Hallway 4 Gentlemen Washroom | Suspect | 40 ft <sup>2</sup> | Access A – Accessible to all building users | Non friable | Good | Action 5 – Proactive ACM removal / Action 7 – Routinely monitor condition Test prior to impact |

Photo 19  
Description: 1"x1" beige and brown ceramic tile grout and mortar  
Location: Boys Washroom Off Hallway 3  
**Asbestos: Suspect**

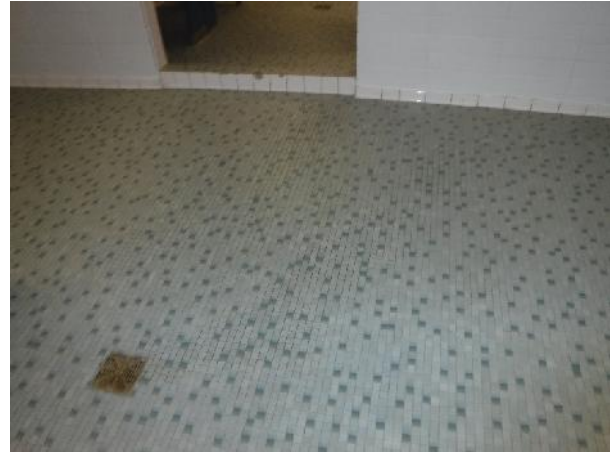
| Description | System | Locations | Status | Quantity | Accessibility | Friability | Condition | Mgmt Recommendation |
|---|---|--|---|---|---|---|---|--|
| 1"x 1" green and grey ceramic tile grout and mortar | Floor | Girls Change Room, Girls Instructor, Guys Instructor Change Room, Girls Instructor Change Room | Suspect | 1, 260 ft <sup>2</sup> | Access A – Accessible to all building users | Non friable | Good | Action 5 – Proactive ACM removal / Action 7 – Routinely monitor condition Test prior to impact |

Photo 20  
Description: 1"x1" green and grey ceramic tile grout and mortar  
Location: Girls Change Room  
**Asbestos: Suspect**

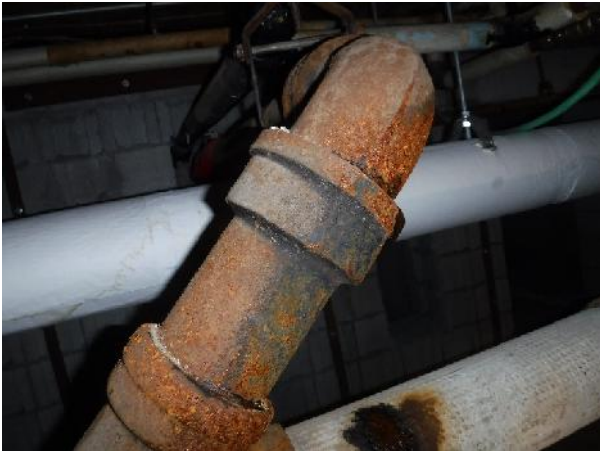
| Description | System | Locations | Status | Quantity | Accessibility | Friability | Condition | Mgmt Recommendation |
|---|---|--|---|---|--|---|---|--|
| Bell and spigot pipe gaskets | Plumbing | Crawl space | Suspect | 25 gaskets | Access B – Accessible to maintenance workers | Non friable | Good | Action 5 – Proactive ACM removal / Action 7 – Routinely monitor condition Test prior to impact |

Photo 21  
Description: Bell and spigot pipe gaskets  
Location: Crawl Space  
**Asbestos: Suspect**

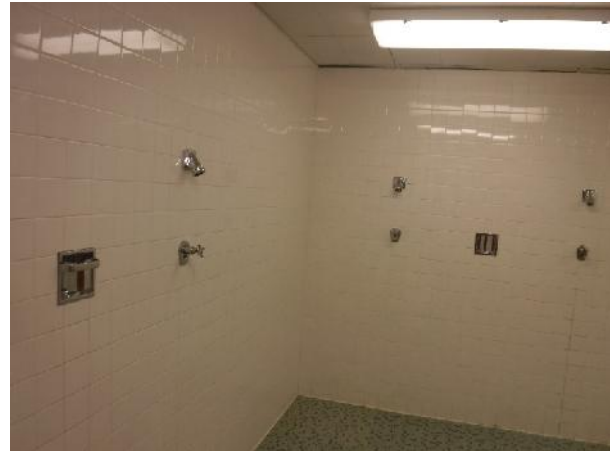
| Description | System | Locations | Status | Quantity | Accessibility | Friability | Condition | Mgmt Recommendation |
|---|---|--|---|---|---|---|---|--|
| 4"x 4" white ceramic tile grout and mortar | Wall | Boys Change Room, Boys Washroom off Hallway 3, Hallway 4 Gentlemen Washroom, Girls Change Room, Girls Instructor, Guys Instructor, Guys Instructor Change Room, Girls Instructor Change Room, Hallway 4 Ladies Washroom, Hallway 3 Ladies Washroom | Suspect | 3,435 ft <sup>2</sup> | Access A – Accessible to all building users | Non friable | Good | Action 5 – Proactive ACM removal / Action 7 – Routinely monitor condition Test prior to impact |

Photo 22  
Description: 4"x4" white ceramic tile grout and mortar  
Location: Boys Change Room  
**Asbestos: Suspect**

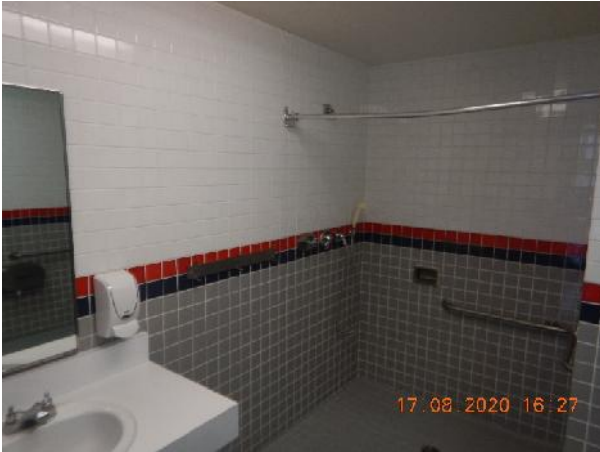
| Description | System | Locations | Status | Quantity | Accessibility | Friability | Condition | Mgmt Recommendation |
|---|---|--|---|---|---|---|---|--|
| 4"x 4" white, grey, red and black ceramic tile grout and mortar | Wall | Handicap Washroom by Main Office | Suspect | 360 ft <sup>2</sup> | Access A – Accessible to all building users | Non friable | Good | Action 5 – Proactive ACM removal / Action 7 – Routinely monitor condition Test prior to impact |

Photo 23  
Description: 4"x4" white, grey, red and black ceramic tile grout and mortar  
Location: Handicap Washroom by Main Office

**Asbestos: Suspect**

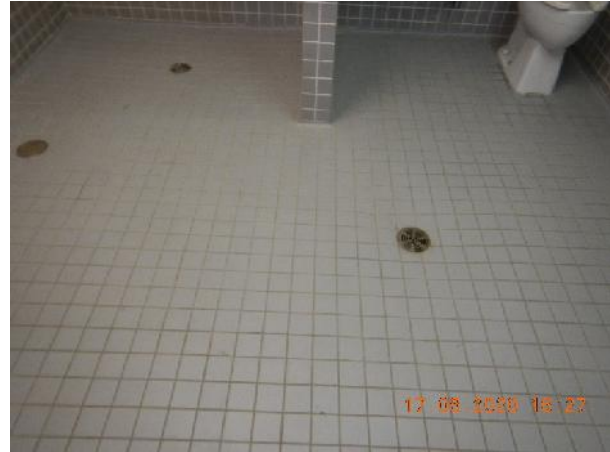
| Description | System | Locations | Status | Quantity | Accessibility | Friability | Condition | Mgmt Recommendation |
|---|---|--|---|---|---|---|---|--|
| 4"x 4" grey ceramic tile grout and mortar | Floor | Handicap Washroom by Main Office | Suspect | 100 ft <sup>2</sup> | Access A – Accessible to all building users | Non friable | Good | Action 5 – Proactive ACM removal / Action 7 – Routinely monitor condition Test prior to impact |

Photo 24  
Description: 4"x4" grey ceramic tile grout and mortar  
Location: Handicap Washroom by Main Office

**Asbestos: Suspect**

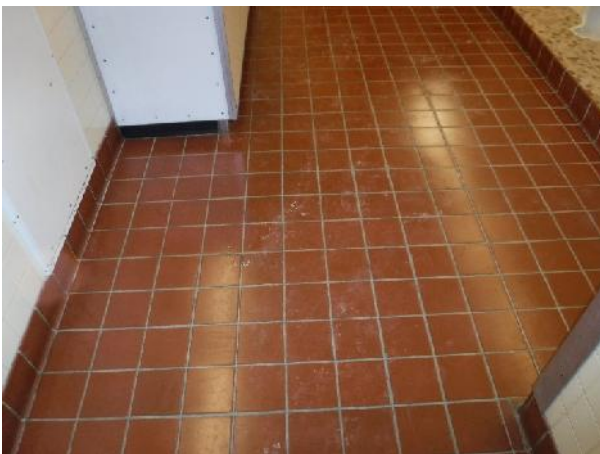
| Description | System | Locations | Status | Quantity | Accessibility | Friability | Condition | Mgmt Recommendation |
|---|---|--|---|---|---|---|---|--|
| 6"x 6" red ceramic tile grout and mortar | Floor | Boys Washroom off Hallway 3, Hallway 4 Gentlemen Washroom, Hallway 4 Ladies Washroom, Hallway 3 Ladies Washroom | Suspect | 1,020 ft <sup>2</sup> | Access A – Accessible to all building users | Non friable | Good | Action 5 – Proactive ACM removal / Action 7 – Routinely monitor condition Test prior to impact |

Photo 25  
Description: 6"x6" red ceramic tile grout and mortar  
Location: Boys Washroom off Hallway 3

**Asbestos: Suspect**

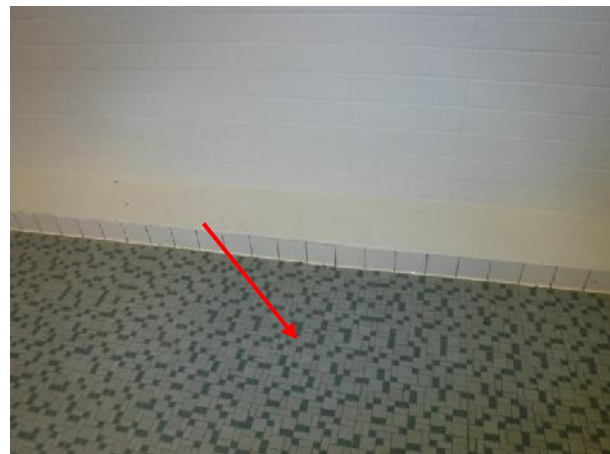
| Description | System | Locations | Status | Quantity | Accessibility | Friability | Condition | Mgmt Recommendation |
|---|---|--|---|---|---|---|---|--|
| Various sized green and grey ceramic tile grout and mortar | Floor | Boys Change Room | Suspect | 900 ft <sup>2</sup> | Access A – Accessible to all building users | Non friable | Good | Action 5 – Proactive ACM removal / Action 7 – Routinely monitor condition Test prior to impact |

Photo 26  
Description: Various sized green and grey ceramic tile grout and mortar  
Location: Boys Change Room

**Asbestos: Suspect**

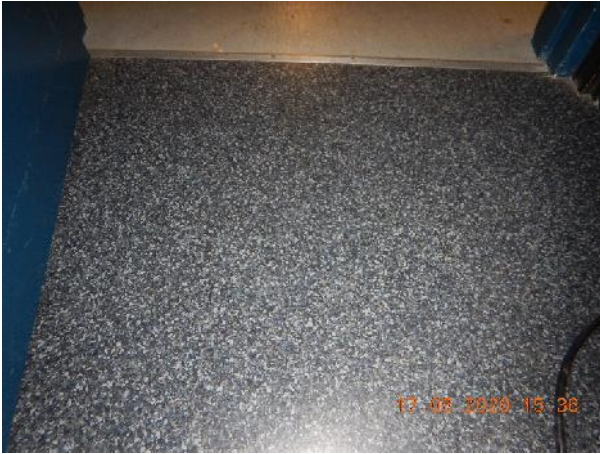
| Description | System | Locations | Status | Quantity | Accessibility | Friability | Condition | Mgmt Recommendation |
|---|---|--|---|---|---|---|---|--|
| Sheet flooring 2 – Grey and speckled pattern | Floor | Drama | Suspect | 1000 ft <sup>2</sup> | Access A – Accessible to all building users | Friable | Good | Action 5 – Proactive ACM removal / Action 7 – Routinely monitor condition Test prior to impact |

Photo 27  
Description: Sheet flooring 2 – Grey and speckled pattern  
Location: Drama  
**Asbestos: Suspect**

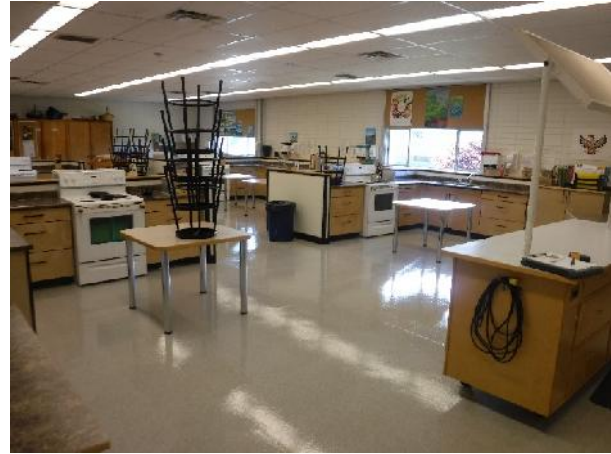
| Description | System | Locations | Status | Quantity | Accessibility | Friability | Condition | Mgmt Recommendation |
|---|---|--|---|---|--|---|---|--|
| Sheet flooring 14 – Grey swirl | Floor | Room: 229 | Suspect | 1400 ft <sup>2</sup> | Access A – Accessible to all building users | Friable | Good | Action 5 – Proactive ACM removal / Action 7 – Routinely monitor condition Test prior to impact |

Photo 28  
Description: Sheet flooring 14 – Grey swirl  
Location: Room 229  
**Asbestos: Suspect**

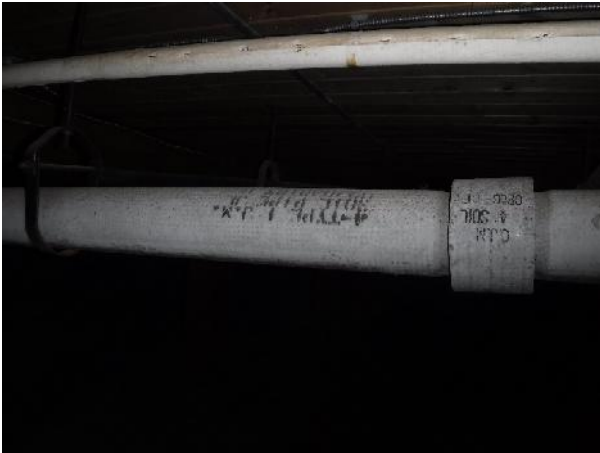
| Description | System | Locations | Status | Quantity | Accessibility | Friability | Condition | Mgmt Recommendation |
|---|---|--|---|---|--|---|---|--|
| Cement pipe | Plumbing | Basement, Hallway 8 Janitors Room, Crawl Space | Suspect | 215 ft <sup>2</sup> | Access B – Accessible to maintenance workers | Non friable | Good | Action 5 – Proactive ACM removal / Action 7 – Routinely monitor condition Test prior to impact |

Photo 29  
Description: Cement pipe  
Location: Crawl Space  
**Asbestos: Suspect**

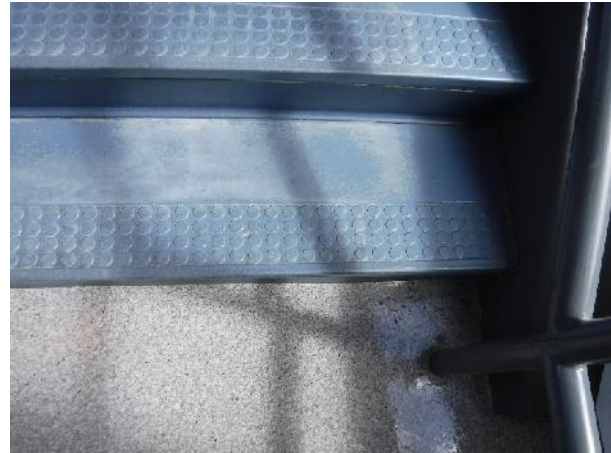
| Description | System | Locations | Status | Quantity | Accessibility | Friability | Condition | Mgmt Recommendation |
|---|---|--|---|---|--|---|---|--|
| Stair tread – Grey/blue | Stair | Hallway 5 | Suspect | 120 ft <sup>2</sup> | Access A – Accessible to all building users | Non friable | Good | Action 5 – Proactive ACM removal / Action 7 – Routinely monitor condition Test prior to impact |

Photo 30  
Description: Stair tread – Grey/blue  
Location: Hallway 5  
**Asbestos: Suspect**

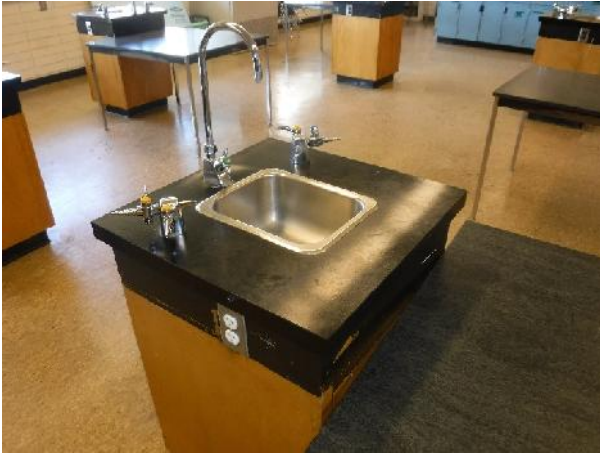
| Description | System | Locations | Status | Quantity | Accessibility | Friability | Condition | Mgmt Recommendation |
|---|---|--|---|---|--|---|---|--|
| Countertops – Black | Counter | Room: 231 | Suspect | 60 ft <sup>2</sup> | Access A – Accessible to all building users | Non friable | Good | Action 5 – Proactive ACM removal / Action 7 – Routinely monitor condition Test prior to impact |

Photo 31  
Description: Countertops – Black  
Location: Room 231  
Asbestos: Suspect

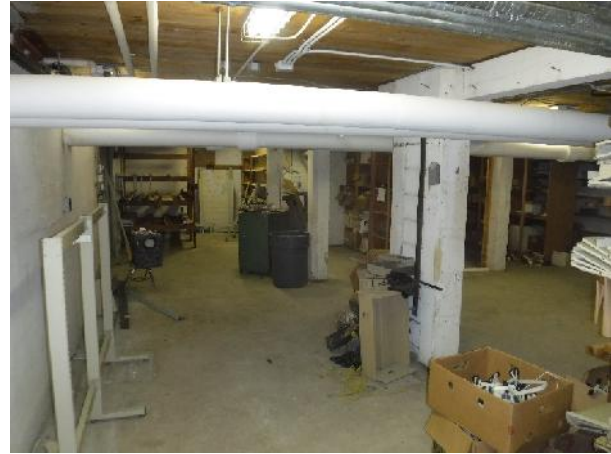
| Description | System | Locations | Status | Quantity | Accessibility | Friability | Condition | Mgmt Recommendation |
|---|---|--|---|---|--|---|---|--|
| Pipe run insulation | Pipe insulation | Basement | Suspect | 45 linear feet | Access B – Accessible to maintenance workers | Friable | Fair | Action 5 – Proactive ACM removal<br>or<br>Action 6 – Repair damaged ACM |

Photo 32  
Description: Pipe run insulation  
Location: Basement  
Asbestos: Suspect

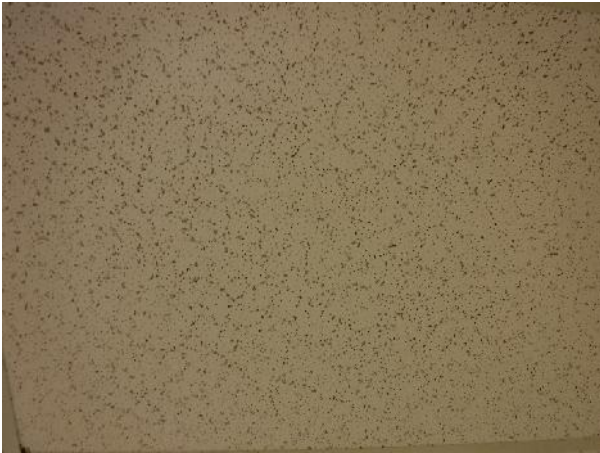
| Description | System | Locations | Status | Quantity | Accessibility | Friability | Condition | Mgmt Recommendation |
|---|---|--|---|---|---|---|---|--|
| Acoustic ceiling tile 1 – Patterned fissure small and large pinhole | Ceiling | Room: 100, 101, 102, 103, 104, 105, 107, 108, 109, 110, 111, 112, 201, 202, 227, 229, 231, 318, 319, 319 Kitchen, 319 Storage, Advising, Advising Office C, Advising Office D, Consulting, First Nations Room, Girls Instructor, Guys Instructor, Hallway 1, Hallway 8, Hallway 2, Hallway 3, Hallway 4, Hallway 5, Hallway 6, Hallway 3 Janitors Room, Hallway 4 Ladies Washroom, Hallway 3 Ladies Washroom, Learning Commons, Library Office, Library Work Room, Main Office, Office A Off Main Office, Office B Off Main Office, Main Office Book Room, Main Office Copier Room, Main Office First Aid, Principal Office, Vice Principal Office, Staff Room, Hallway 5 Copy Room, Storage/Basement Access, Hallway 3 Store Room | Suspect | 26,900 ft <sup>2</sup> | Access A – Accessible to all building users | Friable | Good | Action 5 – Proactive ACM removal / Action 7 – Routinely monitor condition Test prior to impact |

Photo 33  
Description: Acoustic ceiling tile 1 – Patterned  
fissure small and large pinhole  
Location: Guys Instructor  
Asbestos: Suspect
