Port Hardy Secondary School
9350 Granville Street, Port Hardy, BC
Asbestos Management Inventory

North West
Environmental Group Ltd.

NWest File: 39957 AMI1 V1.0

Date Issued: May 4, 2021

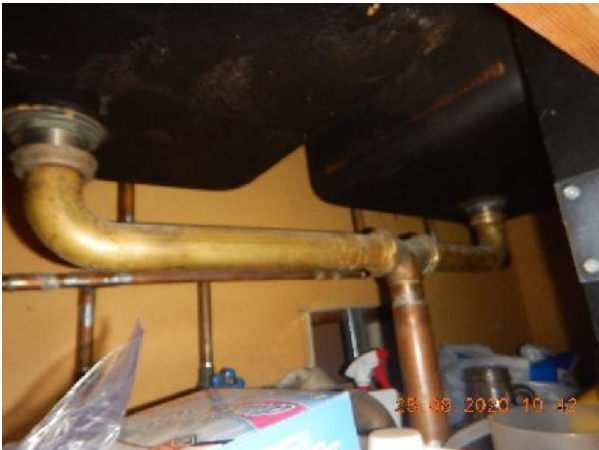
Photo 1
 Description: Sink mastic – black
 Location: Room 507
Asbestos: 6.8%chrysotile
 Sample(s): 30009-20

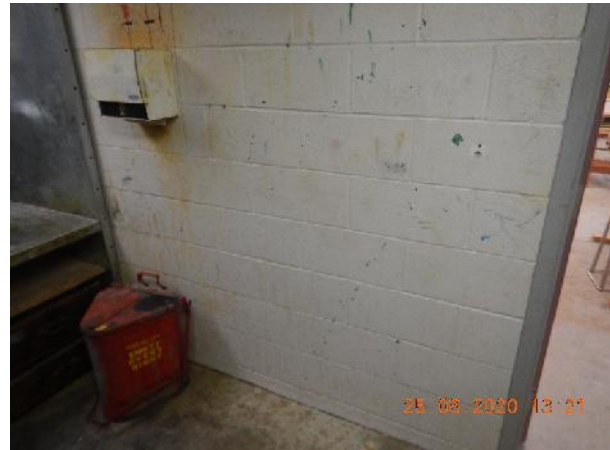
Photo 2
 Description: Concrete block (contains vermiculite)
 Location: Room 607
Asbestos: 0.5%Tremolite
 Sample(s): 31788-22

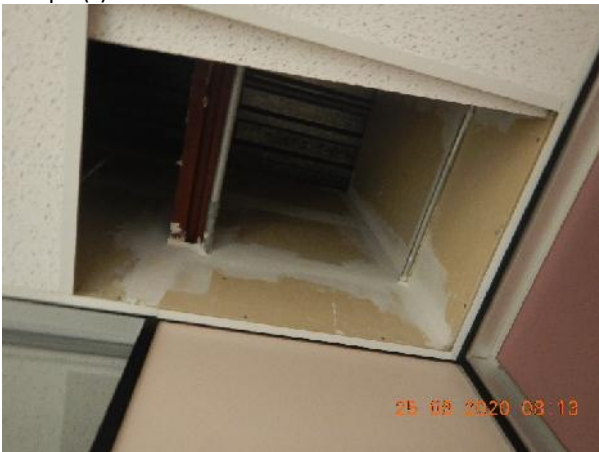
Photo 3
 Description: Drywall joint compound
 Location: Room 310
Asbestos: 1.5%chrysotile
 Sample(s): 31788-6b

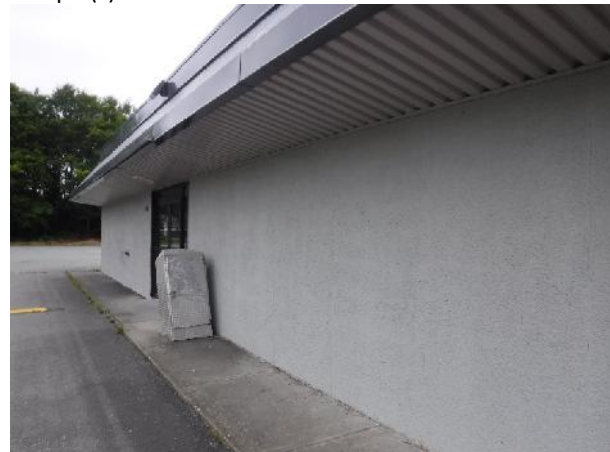
Photo 4
 Description: Stucco
 Location: Exterior
Asbestos: Suspect

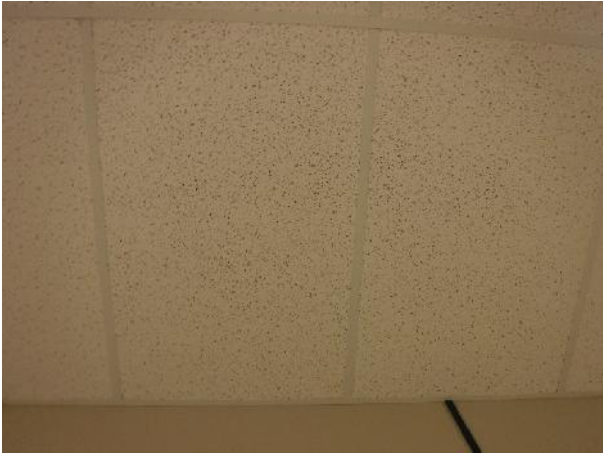
Photo 5
Description: Acoustic ceiling tile 2 – random fissure large pinhole
Location: Room 205
Asbestos: Suspect

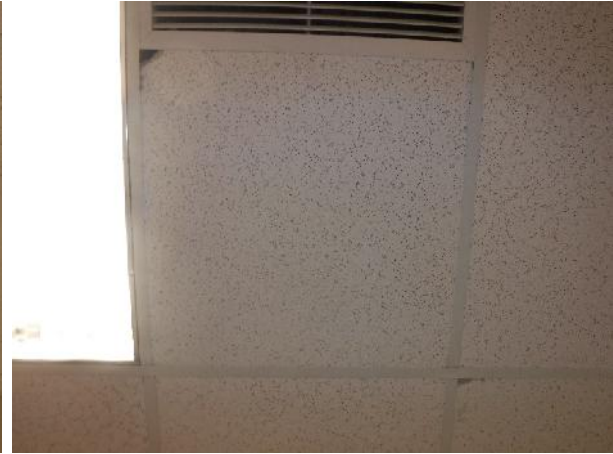
Photo 6
Description: Acoustic ceiling tile 3 – patterned fissure small and large pinhole
Location:
Asbestos: Suspect

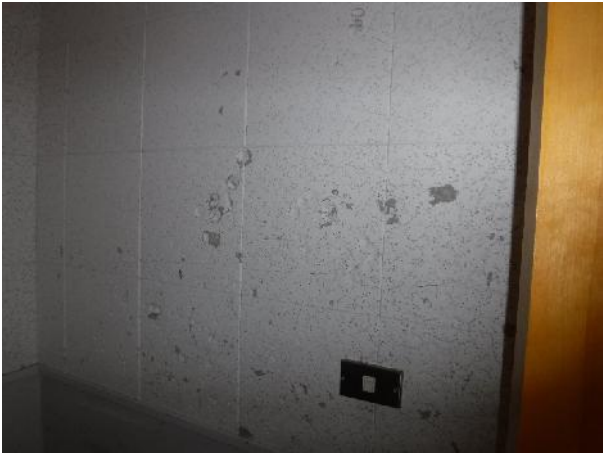
Photo 7
Description: Acoustic ceiling tile 4 – 1'x1' pinhole with random fissure
Location: Room 132
Asbestos: Suspect

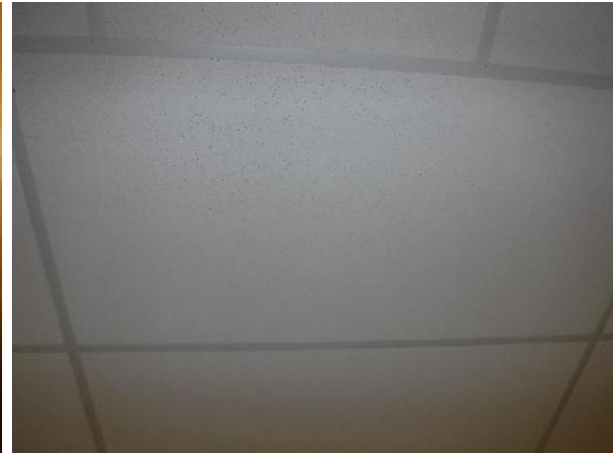
Photo 8
Description: Acoustic ceiling tile 5 – pinhole
Location: Hallway 1
Asbestos: Suspect

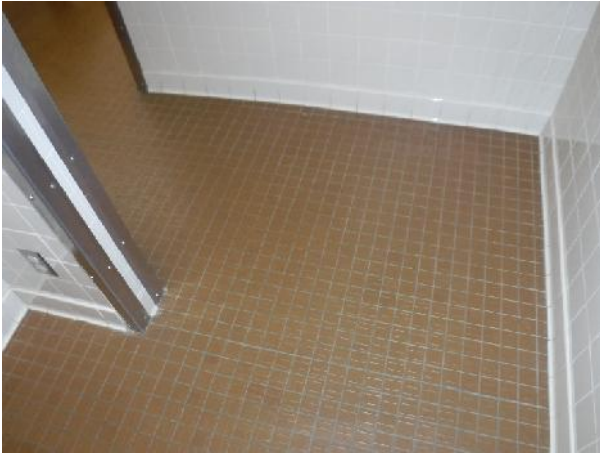
Photo 9
Description: Ceramic tile – 1"x1" brown
Location: Women's Change Room
Asbestos: Suspect

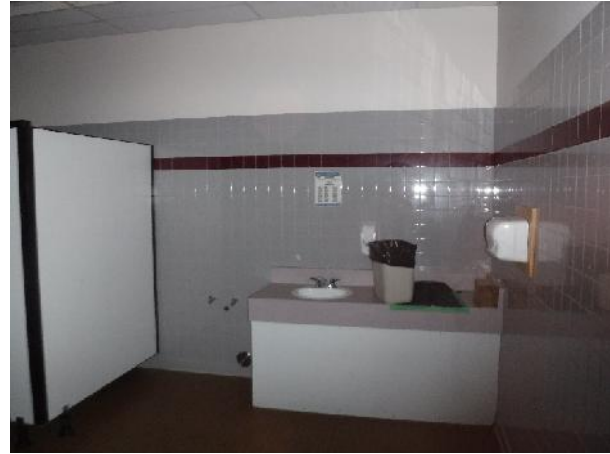
Photo 10
Description: Ceramic tile – 4"x4" grey
Location: Men's Washroom Off Hallway 5
Asbestos: Suspect

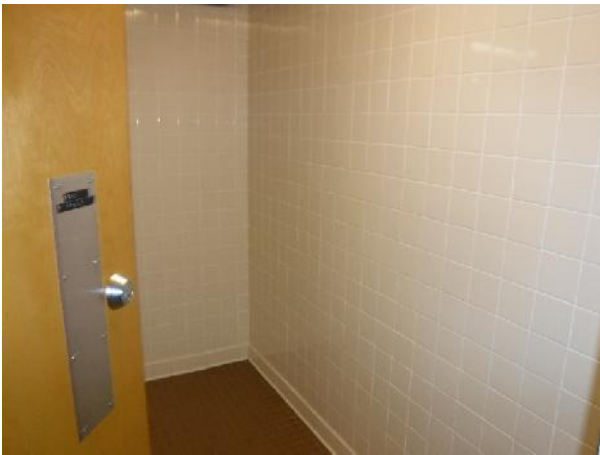
Photo 11
Description: Ceramic tile – 4"x4" white
Location: Women's Change Room
Asbestos: Suspect

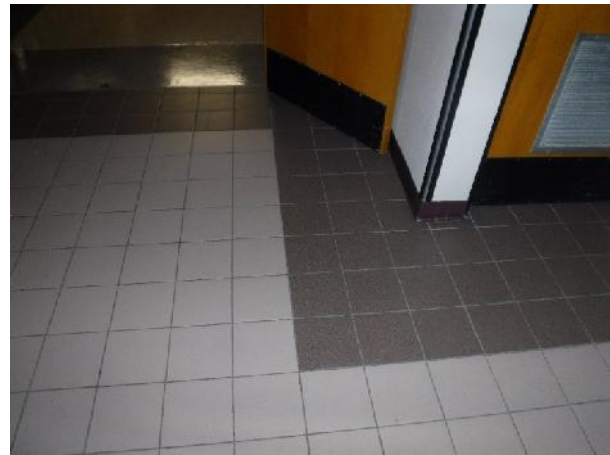
Photo 12
Description: Ceramic tile – 6"x6" white and brown
Location: Hallway 3
Asbestos: Suspect

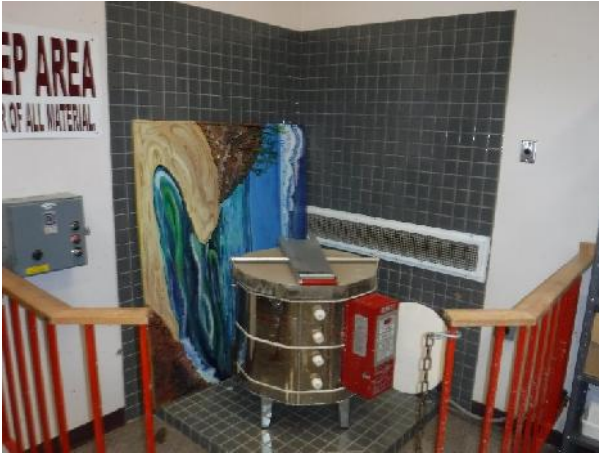
Photo 13
Description: Ceramic tile – 4”x4” dark grey
Location: Room 675
Asbestos: Suspect

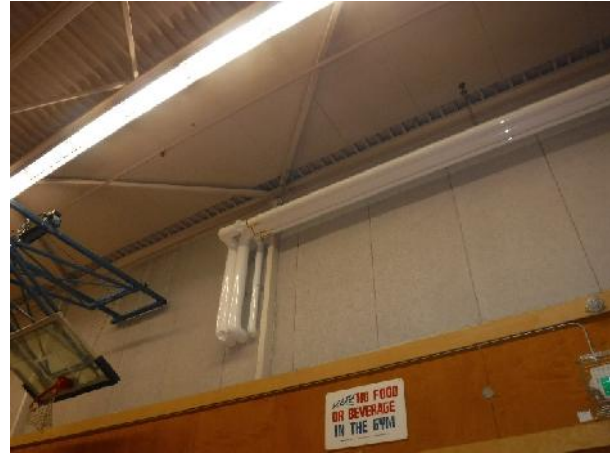
Photo 14
Description: Acoustic wall board
Location: Gym
Asbestos: Suspect

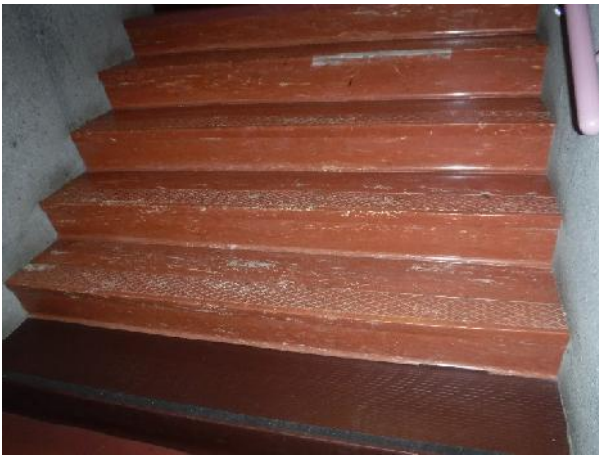
Photo 15
Description: Stair tread – red
Location: Stairwell off Gym to Mezzanine
Asbestos: Suspect

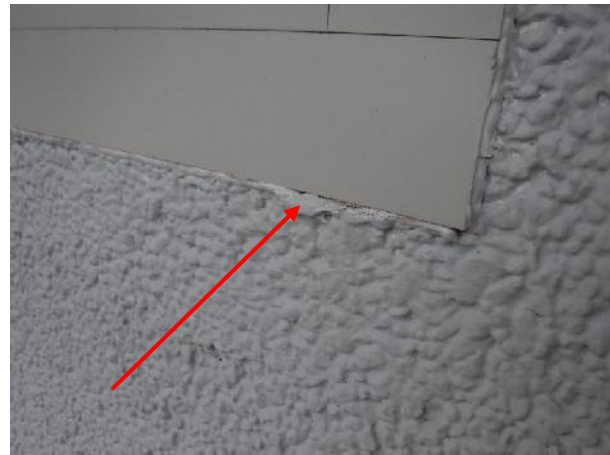
Photo 16
Description: Caulking – grey
Location: Exterior siding
Asbestos: Suspect

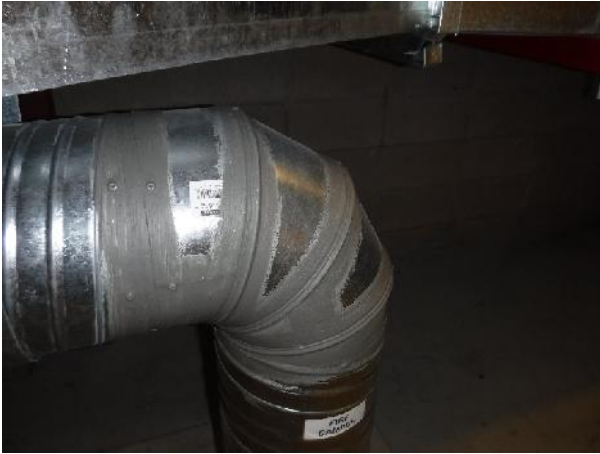
Photo 17
Description: Caulking – grey
Location: Room 209 ducting
Asbestos: Suspect

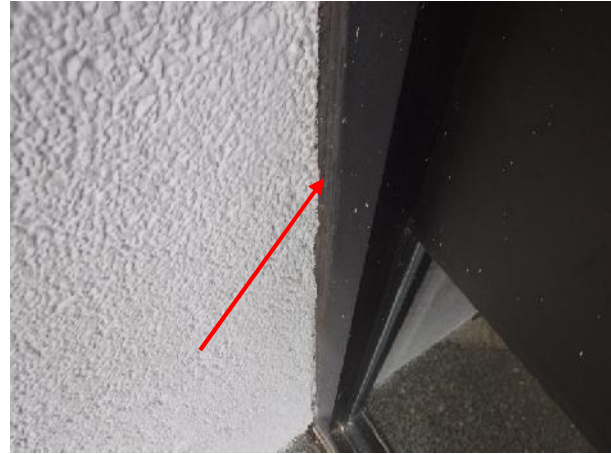
Photo 18
Description: Caulking – brown
Location: Exterior
Asbestos: Suspect

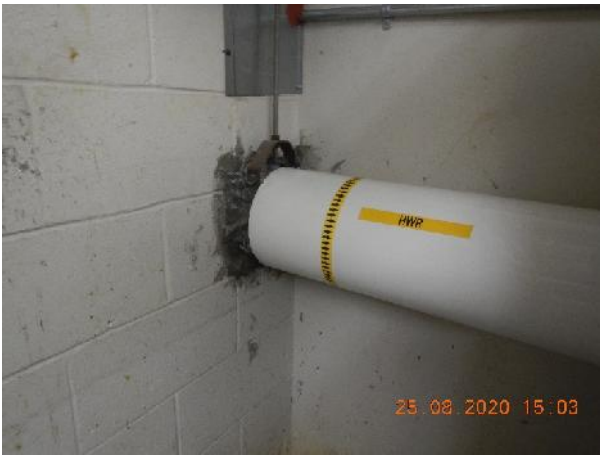
Photo 19
Description: Firestop – grey
Location: 645 Mezzanine Boiler Room
Asbestos: Suspect

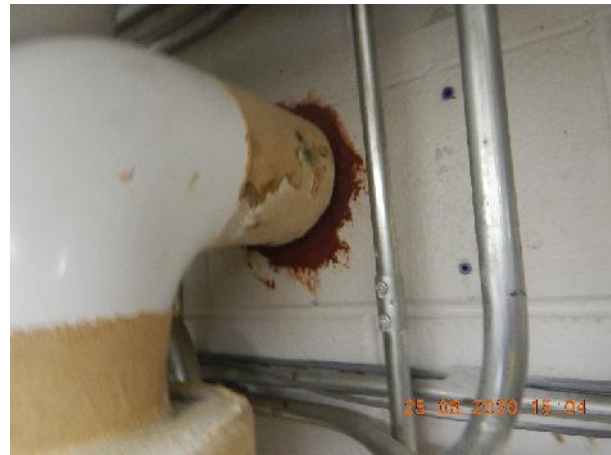
Photo 20
Description: Firestop – red
Location: 645 Mezzanine Boiler Room
Asbestos: Suspect

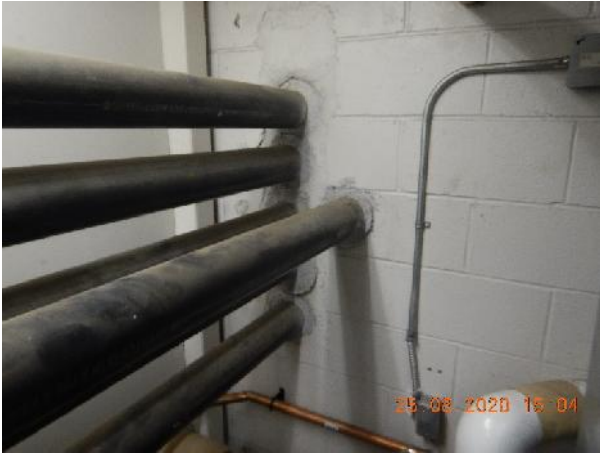
Photo 21
Description: Parging – grey
Location: 645 Mezzanine Boiler Room
Asbestos: Suspect

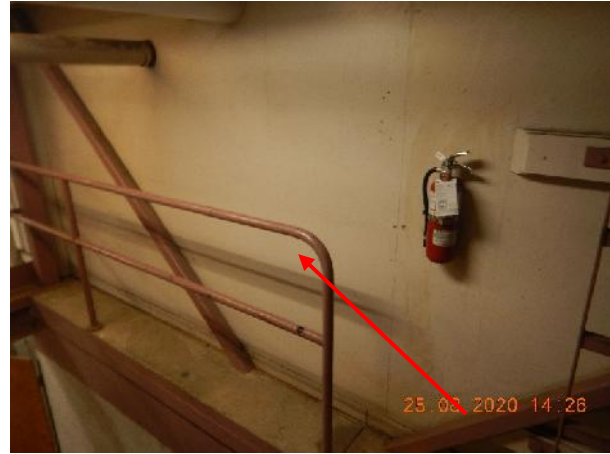
Photo 22
Description: Cement board
Location: Room 645 Stairwell
Asbestos: Suspect

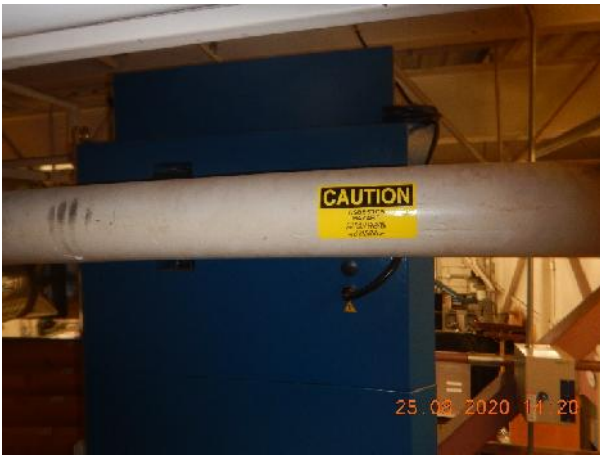
Photo 23
Description: Cement pipe
Location: Room 645 Mezzanine
Asbestos: Confirmed (labelled on site)

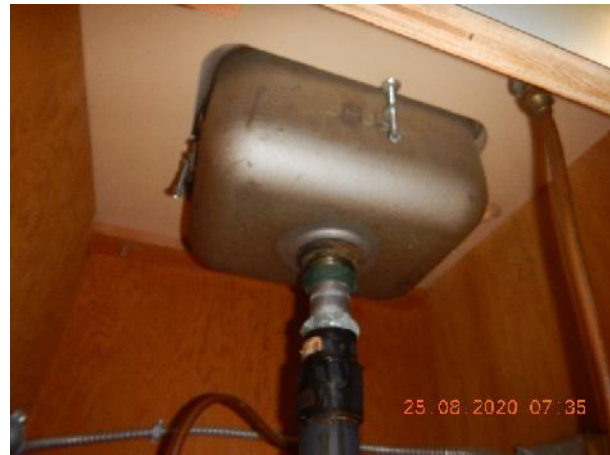
Photo 24
Description: Sink mastic – gold/silver
Location: Room 300
Asbestos: Suspect

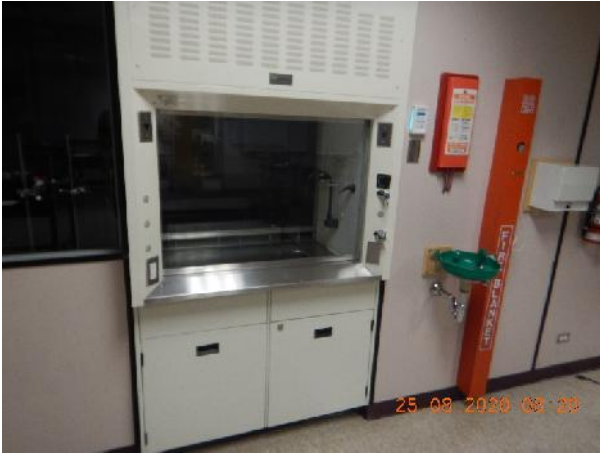
Photo 25
Description: Fume hood cement board
Location: Room 320
Asbestos: Suspect

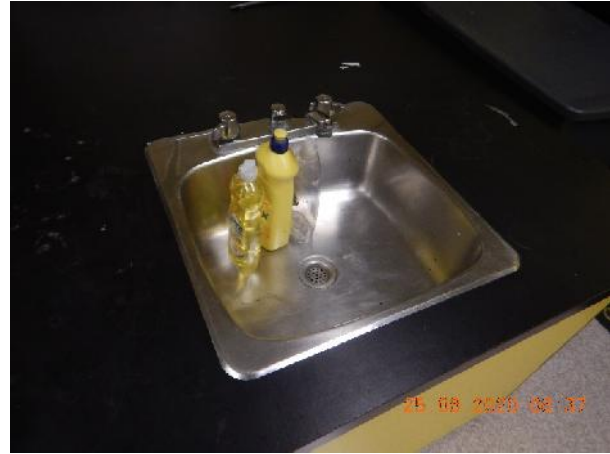
Photo 26
Description: Counter tops
Location: Room 340
Asbestos: Suspect

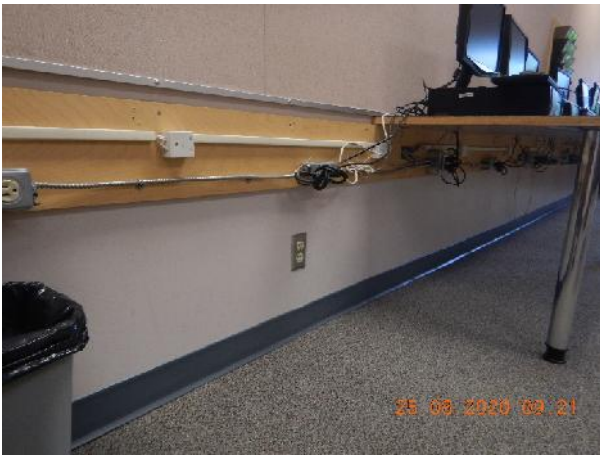
Photo 27
Description: Baseboard adhesive
Location: Room 355
Asbestos: Suspect

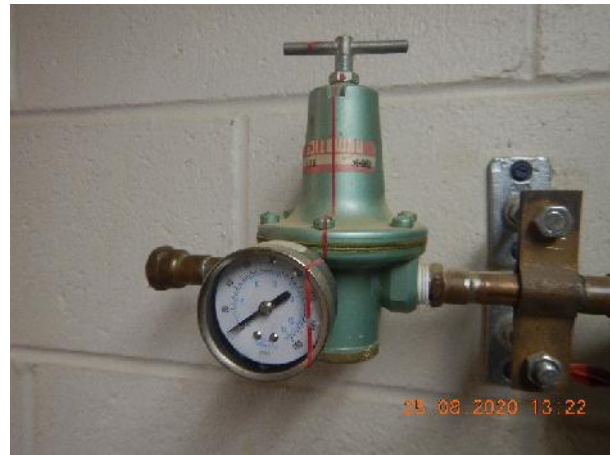
Photo 28
Description: Gasket
Location: Room 607
Asbestos: Suspect
