## School District 85

**School Board Office**  
**6975 Rupert Street, Port Hardy, BC**  
**Asbestos Management Inventory**

NWest File: 39957 AMI1 V1.0

Date Issued: April 13, 2021

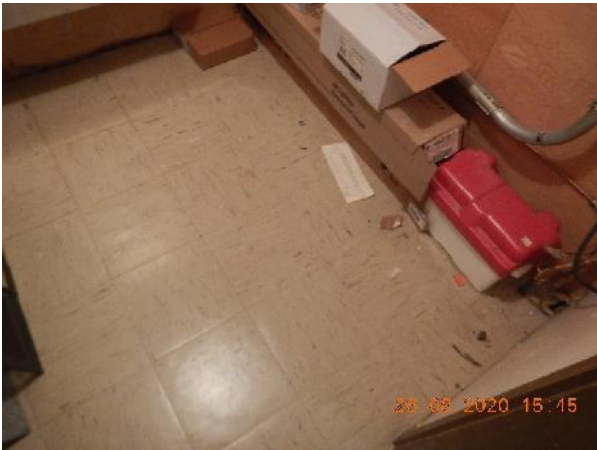
Photo 1  
Description: Floor tile 1 – 12”x12” brown with white streaks  
Location: Lower Level – Electrical Room  
**Asbestos: 2.4% Chrysotile**  
Sample(s): 30011-8

Description	System	Locations	Status	Quantity	Accessibility	Friability	Condition	Mgmt Recommendation
Floor tile 1 – 12"x12" brown with white streaks	Floor	Custodian, Mail/Copy Room, Lower Level – Electrical Room, Lower Level – North Exit, Stairway and Landing, Vault	Confirmed	525 ft <sup>2</sup>	Access A – Accessible to all building users	Non-friable	Good	Action 5 – Proactive ACM removal / Action 7 – Routinely monitor condition Test prior to impact

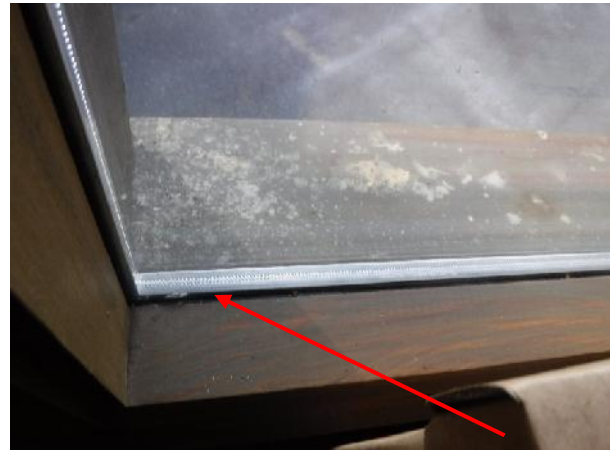
Photo 2  
Description: Window putty – black  
Location: Room 111 – Secretary First Nation  
**Asbestos: 12 % Chrysotile**  
Sample(s): 39957-47b

Description	System	Locations	Status	Quantity	Accessibility	Friability	Condition	Mgmt Recommendation
Window putty – black	Window	Exterior, Room 102 – Secretary Treasurer Office, Room 103 – Admin Assistant, Room 104 – Teacher Payroll, Room 105 – CUPE Payroll, Room 106 – Accounts Payroll, Room 107 – Speech Therapist, Room 108, Room 109 – Director of Instruction, Room 110, Room 111 – Secretary First Nation, Room 112 – Elementary Counsellor, Room 113 – District Principal, Room 114 – Assistant Superintendent, Room 115 – Executive Assistant, Room 116 – Superintendent of Schools, Room 117, Lower Level – Conference Room, Lower Level – Staff Room, Lower Level – North Exit, Lower Level – Main Room, Lower Level – Room C, Lower Level – Room F, Stairway and Landing	Confirmed	100 windows	Access A – Accessible to all building users	Non-friable	Good	Action 5 – Proactive ACM removal / Action 7 – Routinely monitor condition Test prior to impact

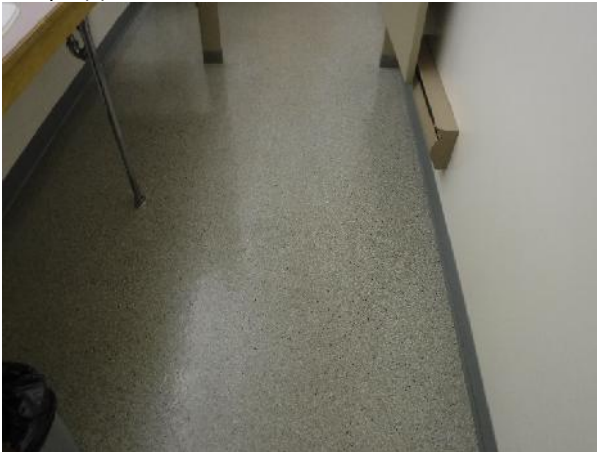
Photo 3  
Description: Sheet flooring 1 – grey white black speckles  
Location: Female Washroom  
**Asbestos: Suspect**

Sheet flooring 1 – grey white black speckles	Floor	Female Washroom, Foyer/Reception, Men's Washroom, Room 117, Lower Level – Male Washroom, Lower Level – Women's Washroom	Suspect	390 ft <sup>2</sup>	Access A – Accessible to all building users	Friable	Good	Action 5 – Proactive ACM removal / Action 7 – Routinely monitor condition Test prior to impact
6"x6" red ceramic tile grout	Floor	Entranceway	Suspect	110 ft <sup>2</sup>	Access A – Accessible to all building users	Non-friable	Good	Action 5 – Proactive ACM removal / Action 7 – Routinely monitor condition Test prior to impact
Acoustic sink insulation – gold/silver	Sink	Room 117	Suspect	1 Sink	Access A – Accessible to all building users	Non-friable	Good	Action 5 – Proactive ACM removal / Action 7 – Routinely monitor condition Test prior to impact

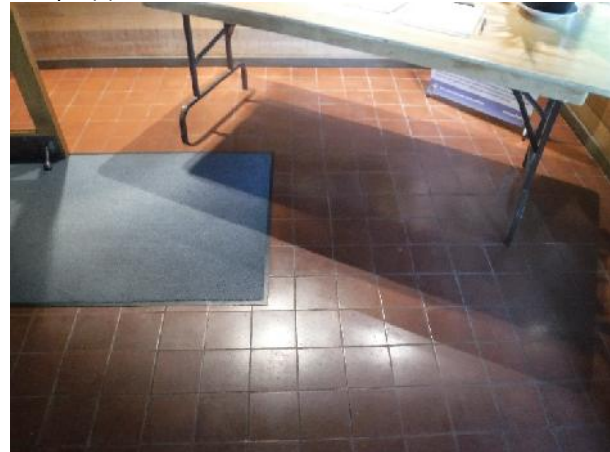
Photo 4  
Description: 6”x6” red ceramic tile grout  
Location: Entranceway  
**Asbestos: Suspect**

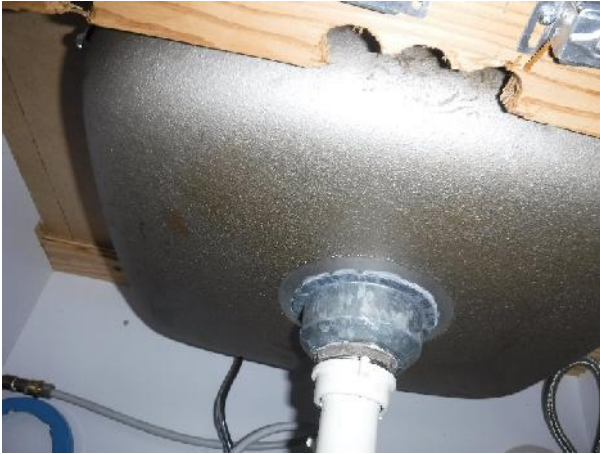
Photo 5  
Description: Acoustic sink insulation – gold/silver  
Location: Room 117  
**Asbestos: Suspect**

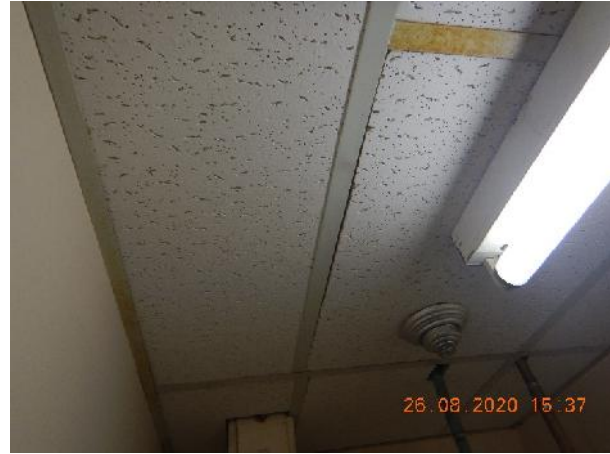
Photo 6  
Description: Acoustic ceiling tile 1 – small and large pinhole  
Location: Lower Level – Custodian Room  
**Asbestos: Suspect**

Acoustic ceiling tile 1 – small and large pinhole	Ceiling	Lower Level – Conference Room, Lower Level – Staff Room, Lower Level – Custodian Room, Lower Level – Main Room, Lower Level – Male Washroom, Lower Level – Room A, Lower Level – Room C, Lower Level – Room D, Lower Level – Room F, Lower Level – Women’s Washroom	Suspect	1,045 ft <sup>2</sup>	Access A – Accessible to all building users	Friable	Good	Action 5 – Proactive ACM removal / Action 7 – Routinely monitor condition Test prior to impact
Acoustic ceiling tile 2 – lateral fissure	Ceiling	Lower Level – Staff Room, Lower Level – West Exit, Lower Level – Main Room, Lower Level – Male Washroom, Lower Level – Room A, Lower Level – Room B, Lower Level – Room D, Lower Level – Room E, Lower Level – Room F	Suspect	1,890 ft <sup>2</sup>	Access A – Accessible to all building users	Friable	Good	Action 5 – Proactive ACM removal / Action 7 – Routinely monitor condition Test prior to impact

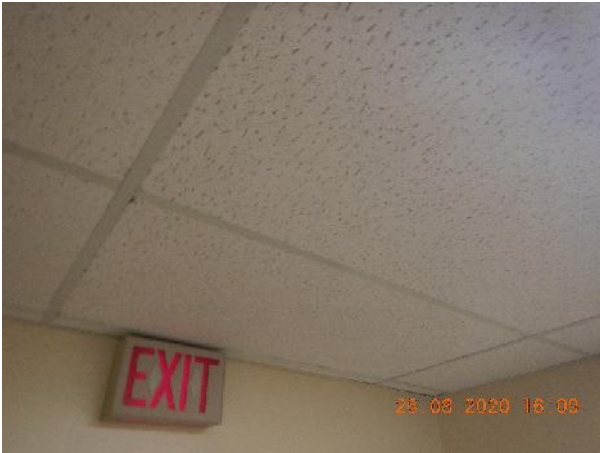
Photo 7  
Description: Acoustic ceiling tile 2 – lateral fissure  
Location: Lower Level – West Exit  
**Asbestos: Suspect**

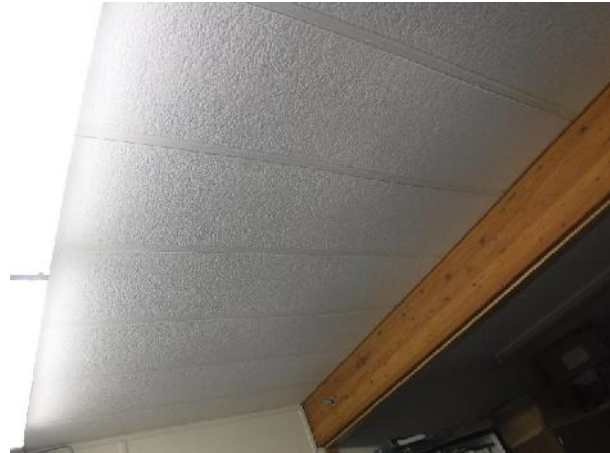
Photo 8  
Description: Trailer type ceiling panel  
Location: Portable Trailer  
**Asbestos: Suspect**

Trailer type ceiling panel	Ceiling	Portable Trailer	Suspect	900 ft <sup>2</sup>	Access A – Accessible to all building users	Friable	Good	Action 5 – Proactive ACM removal / Action 7 – Routinely monitor condition Test prior to impact

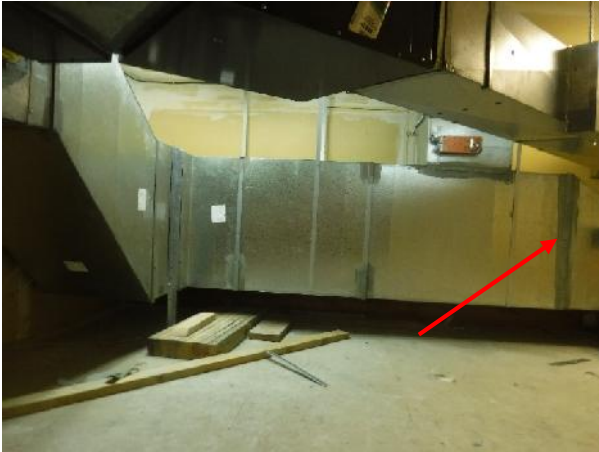
Photo 9  
Description: Caulking type 1 – grey  
Location: Mezzanine Above Copy Room  
Asbestos: Suspect

Description	System	Locations	Status	Quantity	Accessibility	Friability	Condition	Mgmt Recommendation
Caulking type 1 – grey	Ducting	Mezzanine Above Copy and Vault, Lower Level – Room C	Suspect	On ductwork throughout	Access C(e) – Exposed over 8 ft	Non-friable	Good	Action 5 – Proactive ACM removal / Action 7 – Routinely monitor condition Test prior to impact
Caulking type 2 – grey around electrical penetration	Wall	Vault	Suspect	Single penetration area	Access A – Accessible to all building users	Non-friable	Good	Action 5 – Proactive ACM removal / Action 7 – Routinely monitor condition Test prior to impact
Cementitious pipe elbow	Plumbing	Lower Level – Custodian Room	Suspect	1 elbow	Access A – Accessible to all building users	Non-friable	Good	Action 5 – Proactive ACM removal / Action 7 – Routinely monitor condition Test prior to impact
Stair tread – brown/red	Flooring	Stairway and Landing,	Suspect	30 ft²	Access A – Accessible to all building users	Non-friable	Good	Action 5 – Proactive ACM removal / Action 7 – Routinely monitor condition Test prior to impact

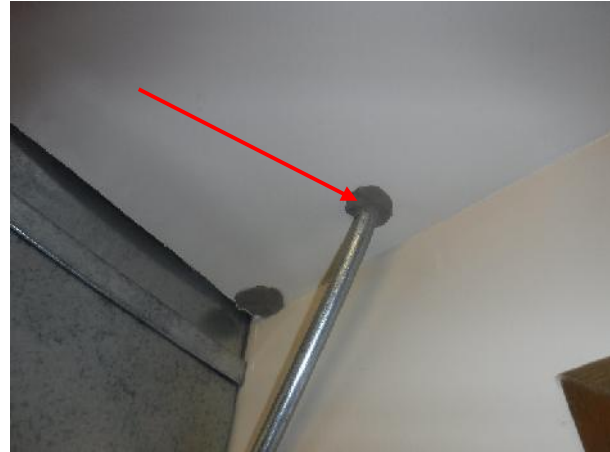
Photo 10  
Description: Caulking type 2 – grey around electrical penetration  
Location: Vault  
Asbestos: Suspect

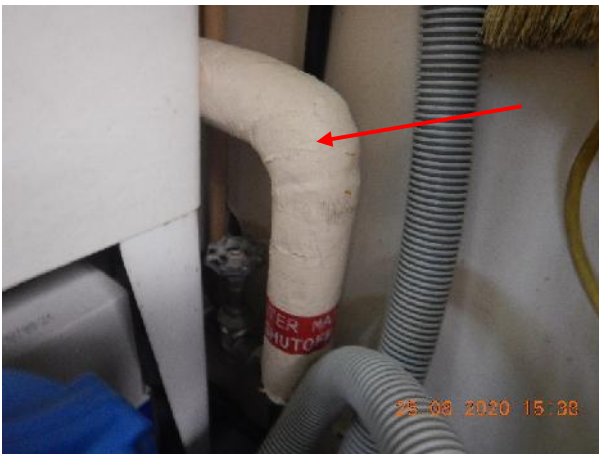
Photo 11  
Description: Cementitious pipe elbow  
Location: Lower Level – Custodian Room  
Asbestos: Suspect

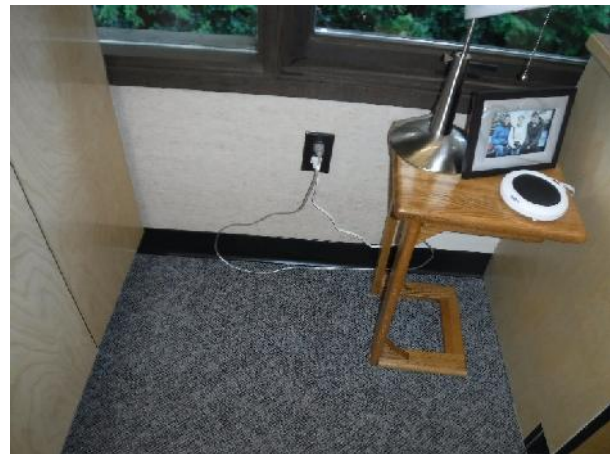
Photo 12  
Description: Baseboard adhesive  
Location: Room 116 – Superintendent of Schools  
Asbestos: Suspect

Baseboard adhesive	Wall	Throughout building	Suspect	Throughout	Access A – Accessible to all building users	Non-friable	Good	Action 5 – Proactive ACM removal / Action 7 – Routinely monitor condition Test prior to impact

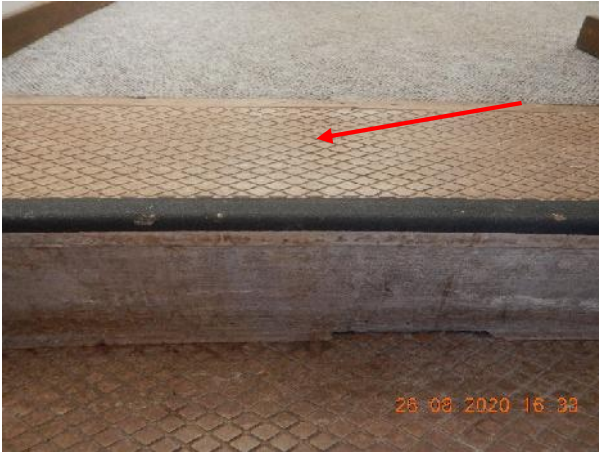
Photo 11

Description: Stair Tread – Brown/Red

Location: Stairway and Landing,

**Asbestos:** **Suspect**
