School District 85

Sunset Elementary
2433 Mountview Crescent, Port McNeill, BC
Asbestos Management Inventory

NWest File: 39957 AMI1 V1.0

Date Issued: April 20, 2021

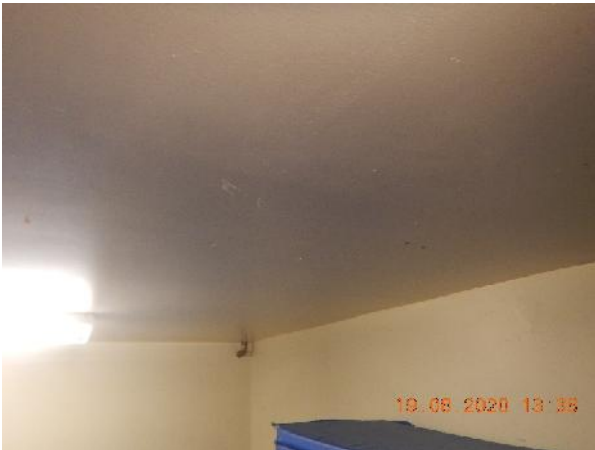
Photo 1
Description: Drywall Joint Compound
Location: Stage Storage Room off Gym
Asbestos: 1.7% chrysotile
Sample(s): 30013-3

Description	System	Locations	Status	Quantity	Accessibility	Friability	Condition	Mgmt Recommendation
Drywall joint compound	Wall	Girls Change Room Off Gym, Boys Change Room Off Gym, Boys Washroom by Gym Foyer, Electrical Room, Focus Room By Room 300, Girls Washroom by Gym Foyer, Hallway by Room 304, Kitchen Off Gym, Storage Off Kitchen, Mezzanine Band Storage Room, Mezzanine Book Room, Mezzanine Boys Dressing Room and Washroom, Mezzanine Girls Dressing Room and Washroom, Mezzanine Hallway, Mezzanine Stairwells, Mezzanine Room 401 (Band Room), Janitor Closet Adjacent Room 401, Room 300, Room 301, Room 302, Room 303, Room 304, Room 305, Room 333 Learning Commons, Librarian Office, Women’s Staff Washroom, Men’s Staff Washroom, Stage Storage Room off Gym, Janitors Closet Adjacent Gym Storage, West Equipment Storage off Gym	Confirmed	17,835 ft ²	Access A – Accessible to all building users	Non-friable	Good	Action 5 – Proactive ACM removal / Action 7 – Routinely monitor condition Test prior to impact

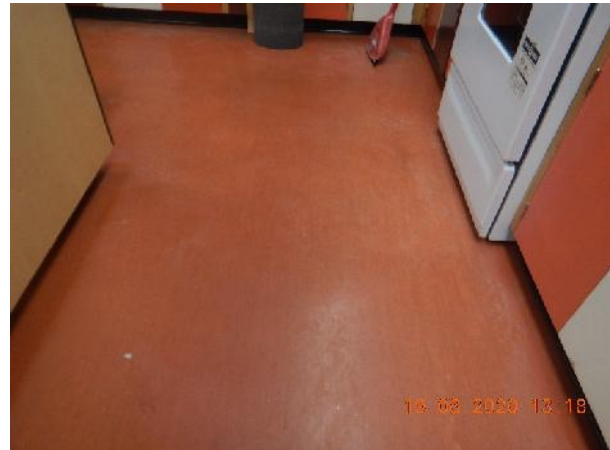
Photo 2
Description: Sheet flooring 3 – red
Location: Kitchen off Gym
Asbestos: 2.4% chrysotile
Sample(s): 30013-2

Sheet flooring 3 – Red	Floor	Boys Washroom Between Classrooms 104 & 101, Girls Washroom Between Classrooms 104 & 101, Janitor by AV Room, Kitchen Off Gym, Storage Off Kitchen, Mezzanine Book Room, Mezzanine Boys Dressing Room and Washroom, Mezzanine Girls Dressing Room and Washroom, Mezzanine Stairwells, Janitor Closet Adjacent Room 401, Foyer Between Room 101 & 104, Room 101, Room 102, Room 104, Photocopy Room, Storage at Back Corner of Gym	Confirmed	2,270 ft ²	Access A – Accessible to all building users	Non-friable	Good	Action 5 – Proactive ACM removal / Action 7 – Routinely monitor condition Test prior to impact
Concrete block (may contain vermiculite)	Wall	Hallway by Room 304, Hallway (Outside 100 Classrooms), Librarian Office	Suspect	450 ft ²	Access A – Accessible to all building users	Non-friable	Good	Action 5 – Proactive ACM removal / Action 7 – Routinely monitor condition Test prior to impact

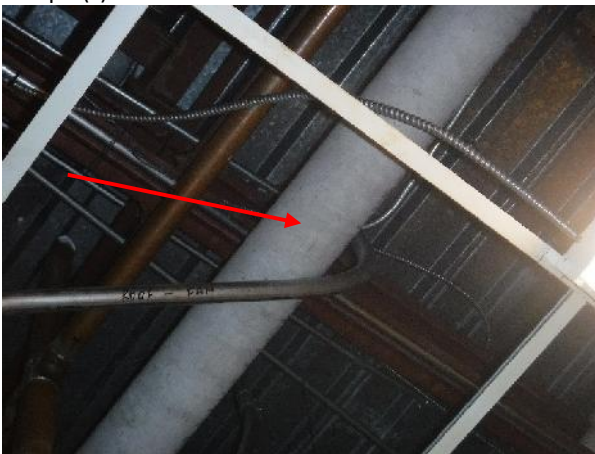
Photo 3
Description: Cement pipe
Location: Janitor by AV Room
Asbestos: 15% chrysotile
Sample(s): 30013-13

Cement pipe	Plumbing	Janitor by AV Room, Mezzanine Boys Dressing Room and Washroom	Confirmed	Concealed quantity in ceiling space	Access A – Accessible to all building users	Non-friable	Good	Action 5 – Proactive ACM removal / Action 7 – Routinely monitor condition Test prior to impact
Pipe fitting insulation	Pipe insulation	Mezzanine Book Room	Suspect	Concealed quantity in ceiling space	Access A – Accessible to all building users	Non-friable	Good	Action 5 – Proactive ACM removal / Action 7 – Routinely monitor condition Test prior to impact
Pipe run insulation	Pipe insulation	Room 304	Suspect	Concealed quantity in ceiling space	Access A – Accessible to all building users	Non-friable	Good	Action 5 – Proactive ACM removal / Action 7 – Routinely monitor condition Test prior to impact
Gasket	Plumbing	Mezzanine Book Room	Suspect	1 gasket	Access A – Accessible to all building users	Non-friable	Good	Action 5 – Proactive ACM removal / Action 7 – Routinely monitor condition Test prior to impact

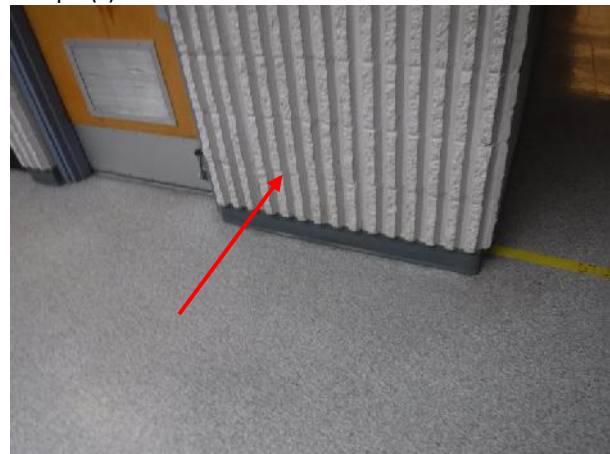
Photo 4
Description: Concrete block (may contain vermiculite)
Location: Hallway by Room 304
Asbestos: Suspect

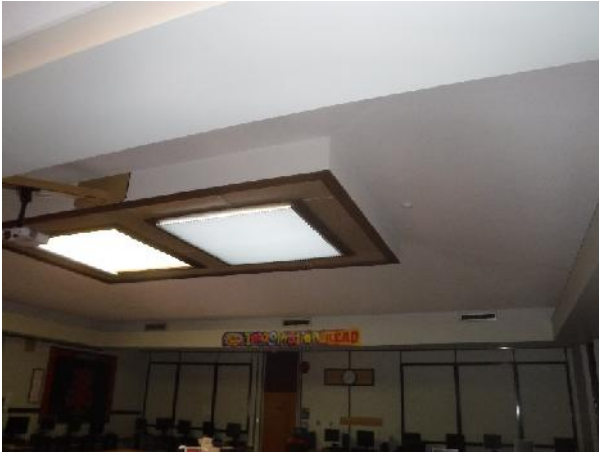
Photo 5
Description: Texture coat
Location: Room 333 Learning Commons
Asbestos: Suspect

Texture coat	Ceiling	Room 333 Learning Commons	Suspect	1300 ft ²	Access A – Accessible to all building users	Non-friable	Good	Action 5 – Proactive ACM removal / Action 7 – Routinely monitor condition Test prior to impact

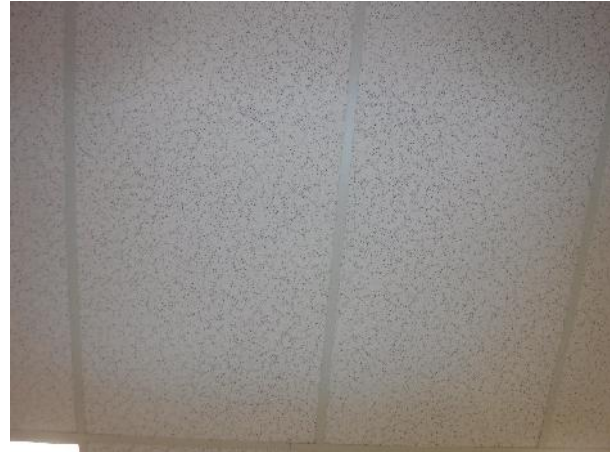
Photo 6
Description: Acoustic ceiling tile 1 – patterned fissures, small and large pinholes
Location: Room 301
Asbestos: Suspect

Description	System	Locations	Status	Quantity	Accessibility	Friability	Condition	Mgmt Recommendation
Acoustic ceiling tile 1 – patterned fissures, small and large pinholes	Ceiling	Boys Washroom Between Classrooms 104 & 101, Boys Washroom by Gym Foyer, AV Room, First Aid Room and Washroom, Focus Room By Room 300, Girls Washroom Between Classrooms 104 & 101, Girls Washroom by Gym Foyer, Gym Foyer, Hallway by Room 304, Mezzanine Girls Dressing Room and Washroom, Mezzanine Hallway, Mezzanine Room 401 (Band Room), Foyer Between Room 101 & 104, Room 100, Room 101, Room 102, Room 103, Room 104, Room 105, Room 200 (General Office), Photocopy Room, Vice Principal’s Office, Room 201, Room 202, Men’s Washroom Adjacent 203, Foyer Between Men’s Washroom & 203, Women’s Washroom Adjacent 202, Foyer Between Women’s Washroom & 202, Room 203, Room 204, Room 205, Room 206, Room 222 Principal’s Office, Room 223, Room 300, Room 301, Room 302, Room 303, Room 304, Room 305, Room 333 Learning Commons, Hallway (Main Entrance to Learning Commons), Hallway (Outside Gym Foyer), Hallway (Outside 100 Classrooms), Women’s Staff Washroom, Men’s Staff Washroom, Staff Washroom Foyer, Storage Room Across from 206	Suspect	20,960 ft ²	Access A – Accessible to all building users	Friable	Good	Action 5 – Proactive ACM removal / Action 7 – Routinely monitor condition Test prior to impact

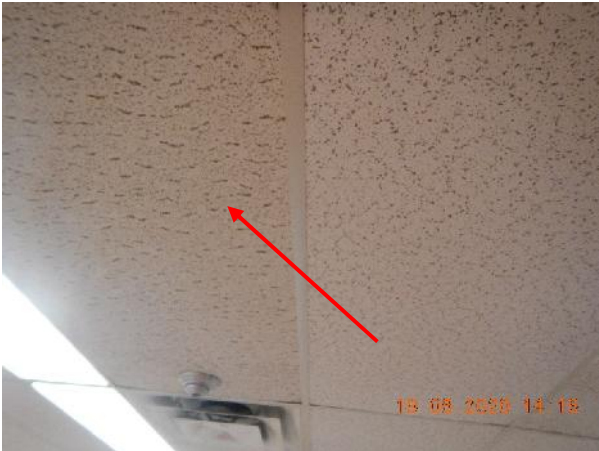
Photo 5
Description: Acoustic ceiling tile 2 – latitudinal fissures, small and large pinholes
Location: Mezzanine Boys Dressing Room and Washroom
Asbestos: Suspect

Acoustic ceiling tile 2 – latitudinal fissures, small and large pinholes	Ceiling	AV Room, First Aid Room and Washroom, Janitor by AV Room, Mezzanine Band Storage Room, Mezzanine Boys Dressing Room and Washroom, Mezzanine Girls Dressing Room and Washroom, Mezzanine Stairwells, Janitor Closet Adjacent Room 401, Room 102, Men’s Washroom Adjacent 203, Storage Room Across from 206	Suspect	1,070 ft ²	Access A – Accessible to all building users	Friable	Good	Action 5 – Proactive ACM removal / Action 7 – Routinely monitor condition Test prior to impact

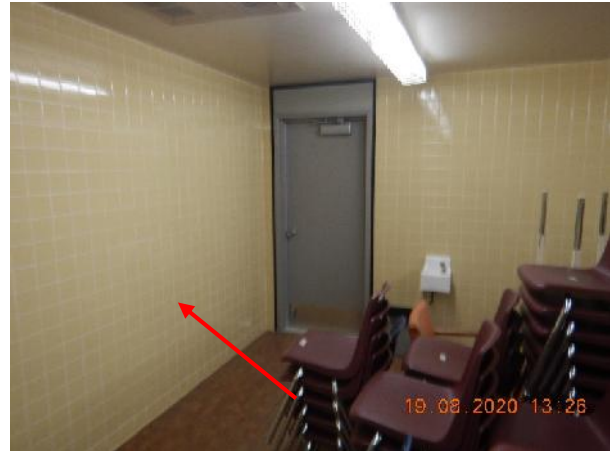
Photo 6
Description: 6"x6" yellow ceramic tile grout
Location: Girls Change Room Off Gym
Asbestos: Suspect

Description	System	Locations	Status	Quantity	Accessibility	Friability	Condition	Mgmt Recommendation
6"x6" yellow ceramic tile grout	Wall	Girls Change Room Off Gym, Boys Change Room Off Gym, Boys Washroom by Gym Foyer, Girls Washroom by Gym Foyer	Suspect	1,910 ft ²	Access A – Accessible to all building users	Non-friable	Good	Action 5 – Proactive ACM removal / Action 7 – Routinely monitor condition Test prior to impact

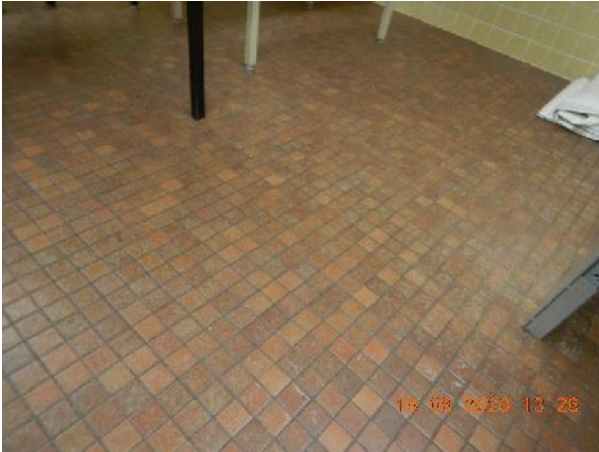
Photo 5
Description: 2"x2" brown ceramic tile grout
Location: Girls Change Room Off Gym
Asbestos: Suspect

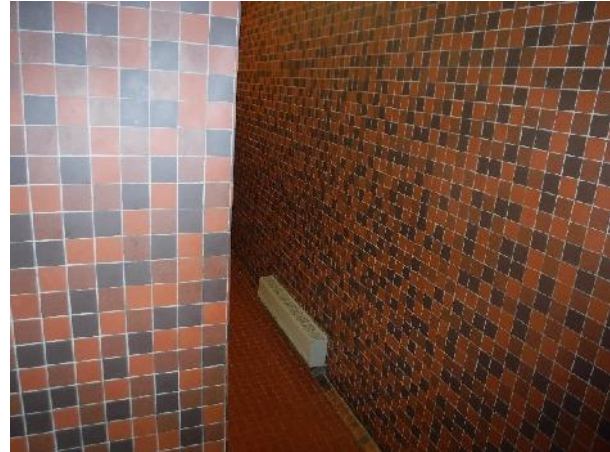
Photo 6
Description: 1.5" red and brown ceramic tile grout
Location: Boys Washroom By Room 302
Asbestos: Suspect

1.5" red and brown ceramic tile grout	Floor	Boys Washroom by Gym Foyer, Boys Washroom By Room 302, Girls Washroom by Gym Foyer, Girls Washroom By Room 302, Janitor's Closet by Room 302	Suspect	635 ft ²	Access A – Accessible to all building users	Non-friable	Good	Action 5 – Proactive ACM removal / Action 7 – Routinely monitor condition Test prior to impact

1.5" red and brown ceramic tile grout	Wall	Boys Washroom By Room 302, Girls Washroom By Room 302, Janitor's Closet by Room 302	Suspect	970 ft ²	Access A – Accessible to all building users	Non-friable	Good	Action 5 – Proactive ACM removal / Action 7 – Routinely monitor condition Test prior to impact
2"x2" brown ceramic tile grout	Floor	Girls Change Room Off Gym, Boys Change Room Off Gym	Suspect	880 ft ²	Access A – Accessible to all building users	Non-friable	Good	Action 5 – Proactive ACM removal / Action 7 – Routinely monitor condition Test prior to impact
Acoustic sink insulation – white	Sink	Focus Room By Room 300, Room 305	Suspect	2 sinks	Access A – Accessible to all building users	Non-friable	Good	Action 5 – Proactive ACM removal / Action 7 – Routinely monitor condition Test prior to impact
Acoustic sink insulation – black/silver	Sink	Kitchen Off Gym, Room 100, Room 101, Room 102, Room 103, Room 104, Room 201, Room 300, Librarian Office, Storage Room Across from 206	Suspect	12 sinks	Access A – Accessible to all building users	Non-friable	Good	Action 5 – Proactive ACM removal / Action 7 – Routinely monitor condition Test prior to impact

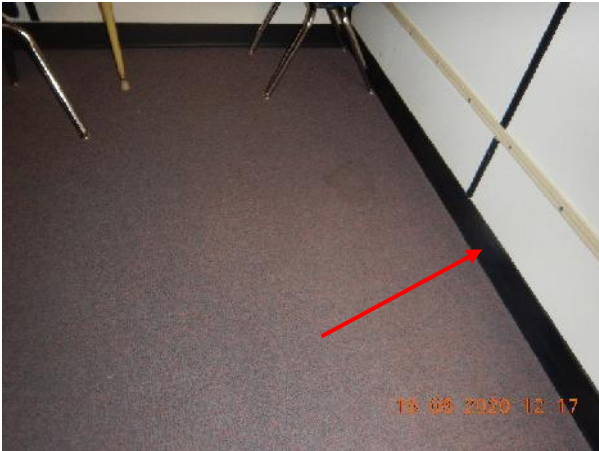
Photo 5
Description: Baseboard adhesive
Location: Throughout
Asbestos: Suspect

Baseboard adhesive	Wall	Throughout	Suspect	Throughout building	Access A – Accessible to all building users	Non-friable	Good	Action 5 – Proactive ACM removal / Action 7 – Routinely monitor condition Test prior to impact

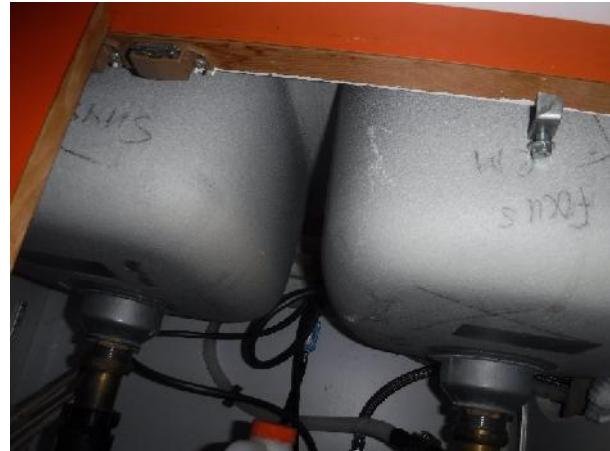
Photo 6
Description: Acoustic sink insulation – white
Location: Room 305
Asbestos: Suspect

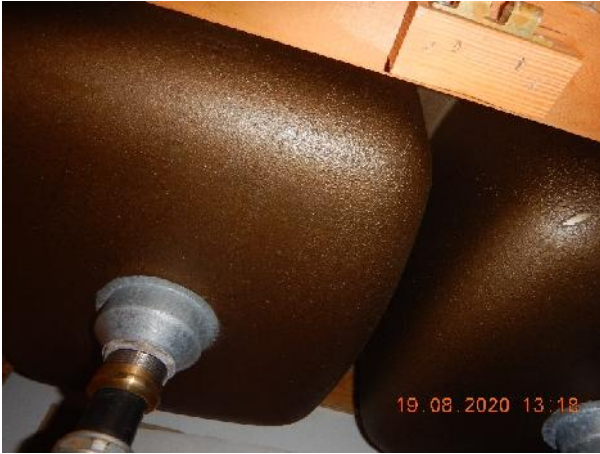
Photo 5
Description: Acoustic sink insulation – black/silver
Location: Kitchen Off Gym
Asbestos: Suspect

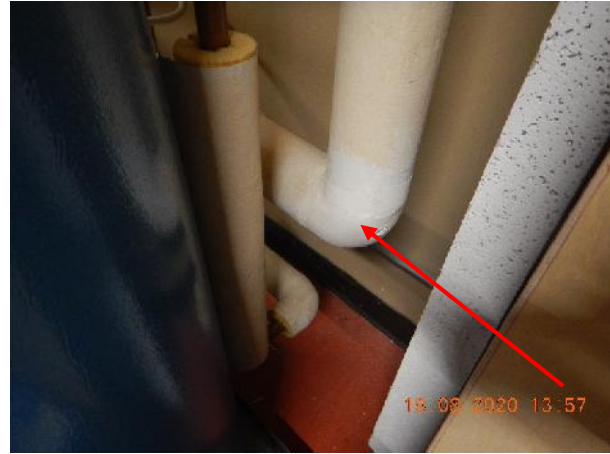
Photo 6
Description: Pipe fitting insulation
Location: Mezzanine Book Room
Asbestos: Suspect

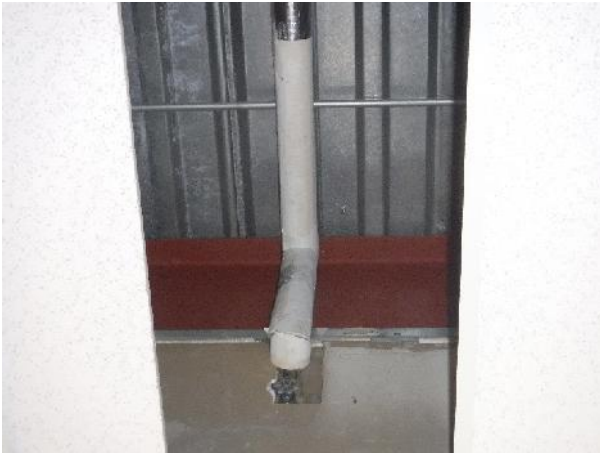
Photo 5
Description: Pipe run insulation
Location: Room 304
Asbestos: Suspect

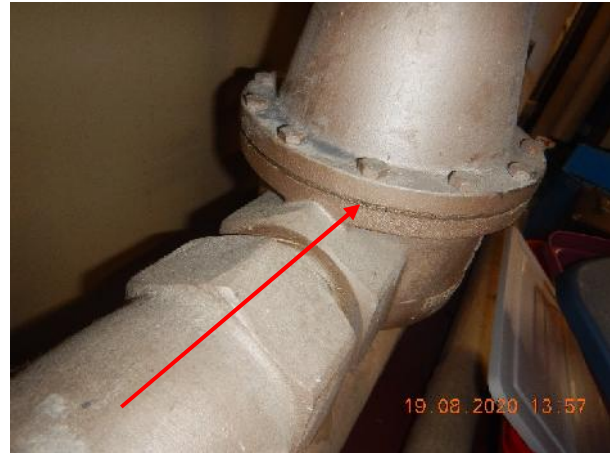
Photo 6
Description: Gasket
Location: Mezzanine Book Room
Asbestos: Suspect

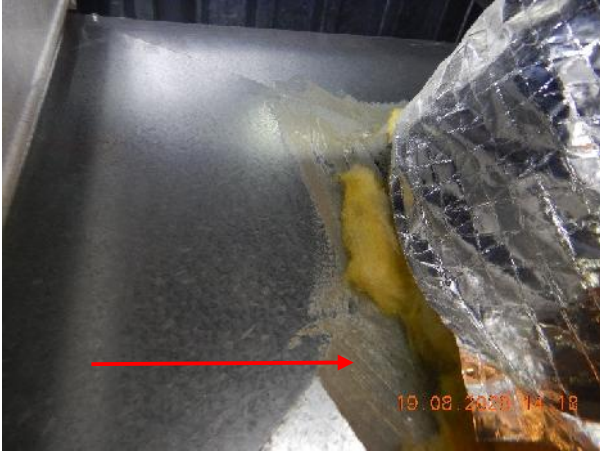
Photo 5

Description: Caulking type 4 – grey
Location: Mezzanine Girls Dressing Room
and Washroom
Asbestos: **Suspect**
