School District 85

Woss Elementary
4500 MacRae Drive, Woss, BC
Asbestos Management Inventory

NWest File: 39957 AMI1 V1.0
Date Issued: April 20, 2021

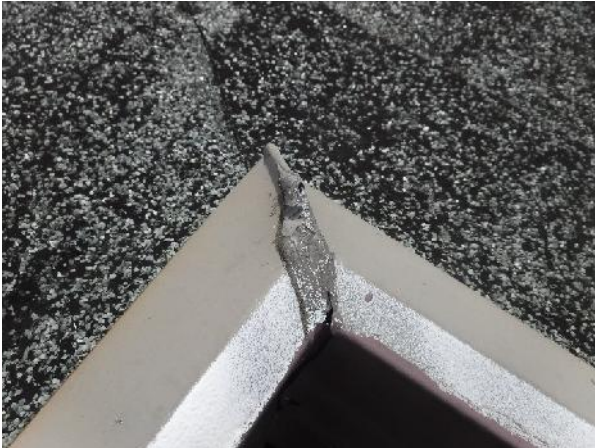
Photo 1
 Description: Mastic (Black/Grey)
 Location: Roof Flashing
Asbestos: 7% chrysotile
 Sample(s): 39956-8b

| Description | System | Locations | Status | Quantity | Accessibility | Friability | Condition | Mgmt Recommendation |
|---|---|---|---|---|--|---|---|--|
| Mastic (Black/Grey) | Roof Flashing | Roof | Confirmed | Unknown – no access at time of assessment | Access B – Accessible to maintenance workers | Non friable | Good | Action 5 – Proactive ACM removal / Action 7 – Routinely monitor condition Test prior to impact |

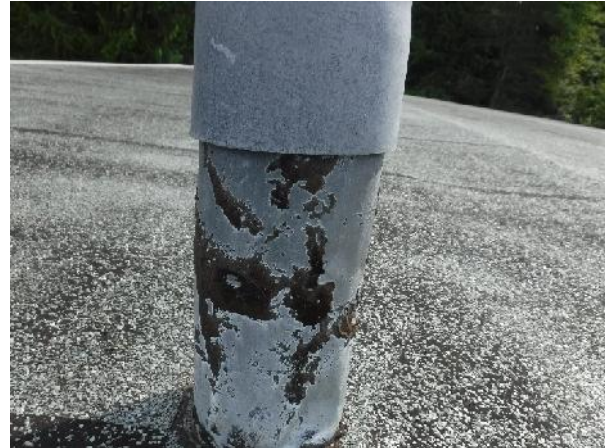
Photo 2
 Description: Mastic (Black)
 Location: Roof
Asbestos: 9% chrysotile
 Sample(s): 39956-11b

| Description | System | Locations | Status | Quantity | Accessibility | Friability | Condition | Mgmt Recommendation |
|---|---|---|---|---|--|---|---|--|
| Mastic (Black) | Roof | Roof | Confirmed | Unknown – no access at time of assessment | Access B – Accessible to maintenance workers | Non friable | Good | Action 5 – Proactive ACM removal / Action 7 – Routinely monitor condition Test prior to impact |

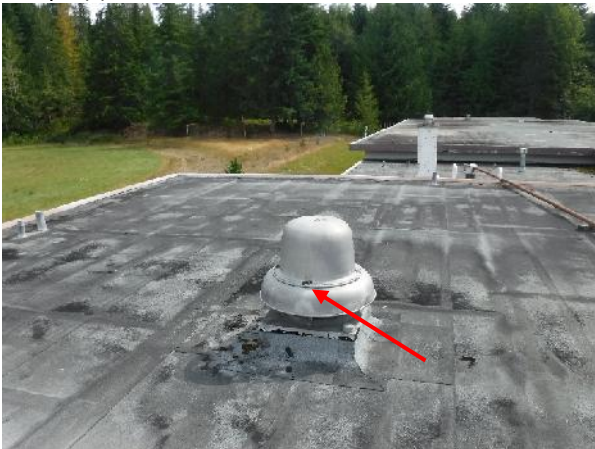
Photo 3
 Description: Mastic (Black with white specks)
 Location: Roof
Asbestos: 9% chrysotile
 Sample(s): 39956-14b

| Description | System | Locations | Status | Quantity | Accessibility | Friability | Condition | Mgmt Recommendation |
|---|---|---|---|---|--|---|---|--|
| Mastic (Black with white specks) | Roof | Roof | Confirmed | Unknown – no access at time of assessment | Access B – Accessible to maintenance workers | Non friable | Good | Action 5 – Proactive ACM removal / Action 7 – Routinely monitor condition Test prior to impact |

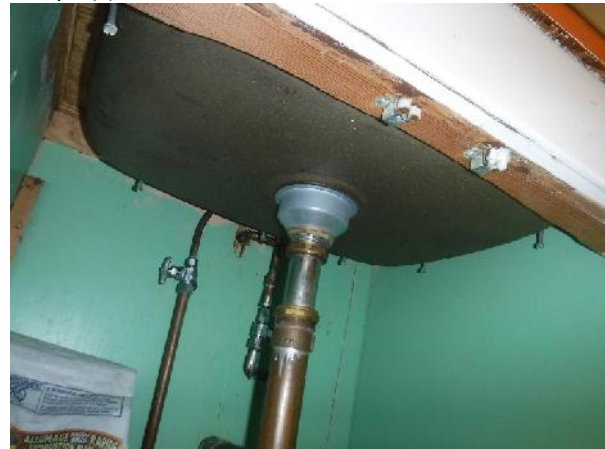
Photo 4
 Description: Acoustic sink insulation – black/gold
 Location: Classroom 6
Asbestos: 20% chrysotile
 Sample(s): 30015-10

| Description | System | Locations | Status | Quantity | Accessibility | Friability | Condition | Mgmt Recommendation |
|---|---|---|---|---|--|---|---|--|
| Acoustic sink insulation – black/gold | Sink | Classroom 5, Classroom 6, Office | Confirmed | 2 sinks | Access A – Accessible to all building users | Non friable | Good | Action 5 – Proactive ACM removal / Action 7 – Routinely monitor condition Test prior to impact |

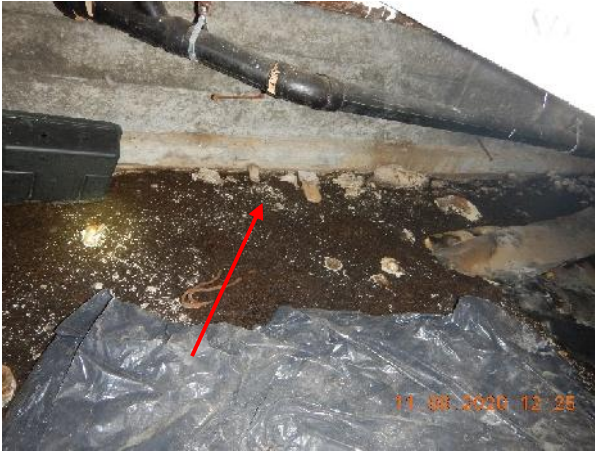
Photo 5
Description: Pipe insulation debris remnants

Location: Crawlspace
Asbestos: 60% chrysotile
Sample(s): 30015-15

| Description | System | Locations | Status | Quantity | Accessibility | Friability | Condition | Mgmt Recommendation |
|---|---|---|---|---|--|---|---|--|
| Pipe insulation debris remnants | Debris | Crawlspace | Confirmed | Suspect to be present throughout crawlspace | Access B – Accessible to maintenance workers | Friable | Poor | Action 1 – Immediate clean-up of debris and Action 3 –ACM removal required for compliance |

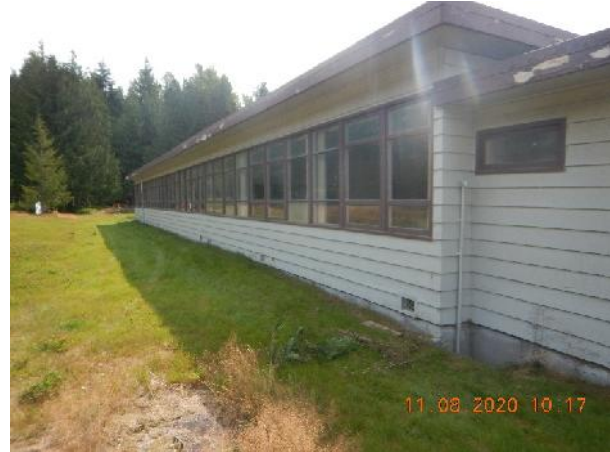
Photo 6
Description: Window putty/caulking - off-white

Location: Exterior
Asbestos: 0.5% chrysotile
Sample(s): 30015-26

| Description | System | Locations | Status | Quantity | Accessibility | Friability | Condition | Mgmt Recommendation |
|---|---|--|---|---|--|---|---|---|
| Window putty/caulking - off-white | Windows | Exterior | Confirmed | All exterior windows | Access A – Accessible to all building users | Non friable | Good | Action 5 – Proactive ACM removal / Action 7 – Routinely monitor condition Test prior to impact |

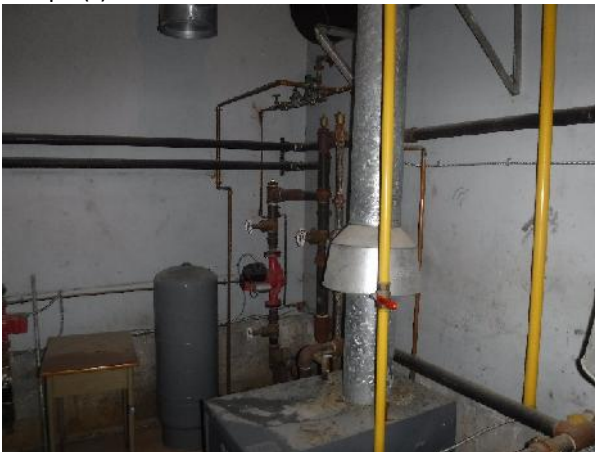
Photo 5
Description: Drywall Joint Compound

Location: Boiler Room
Asbestos: 1.5% chrysotile
Sample(s): 30015-24

| Description | System | Locations | Status | Quantity | Accessibility | Friability | Condition | Mgmt Recommendation |
|---|---|--|---|---|--|---|---|---|
| Drywall Joint Compound | Wall | Boiler Room, Chair Storage Under Stare | Confirmed | 710 ft ² | Access A – Accessible to all building users | Non friable | Fair | Action 5 – Proactive ACM removal / Action 6 – ACM Repair Test prior to impact |

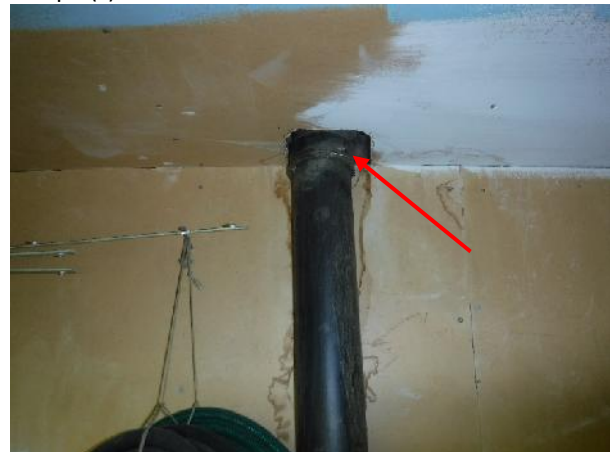
Photo 6
Description: Bell and spigot pipe gaskets

Location: Maintenance Shop
Asbestos: Suspect

| Description | System | Locations | Status | Quantity | Accessibility | Friability | Condition | Mgmt Recommendation |
|---|---|--|---|---|--|---|---|---|
| Bell and spigot pipe gaskets | Plumbing | Maintenance Shop, Gym Stage | Suspect | 6 gaskets | Access A – Accessible to all building users | Non friable | Good | Action 5 – Proactive ACM removal / Action 7 – Routinely monitor condition Test prior to impact |

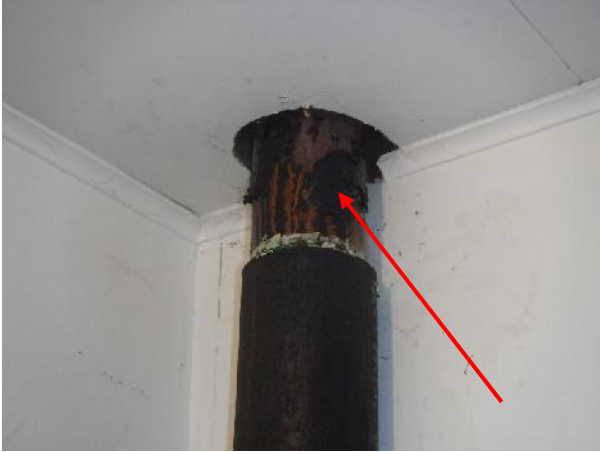
Photo 5
Description: Pipe mastic – black
Location: Janitors Closet
Asbestos: Suspect

| Description | System | Locations | Status | Quantity | Accessibility | Friability | Condition | Mgmt Recommendation |
|---|---|---|---|---|--|---|---|--|
| Pipe mastic – black | Plumbing | Janitors Closet | Suspect | Patches on piping in areas listed | Access B – Accessible to maintenance workers | Non friable | Good | Action 5 – Proactive ACM removal / Action 7 – Routinely monitor condition Test prior to impact |

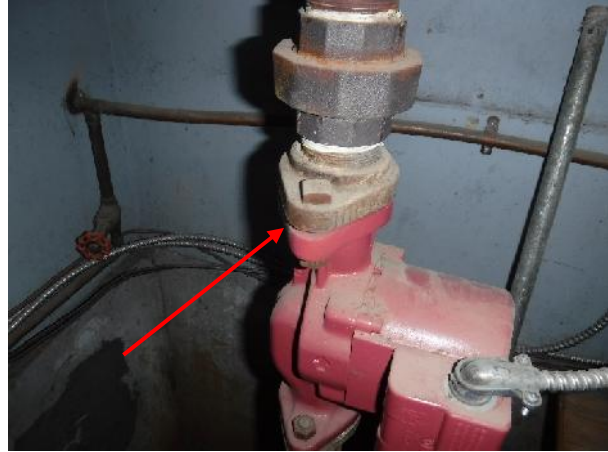
Photo 6
Description: Gasket
Location: Boiler Room
Asbestos: Suspect

| Description | System | Locations | Status | Quantity | Accessibility | Friability | Condition | Mgmt Recommendation |
|---|---|--|---|---|--|---|---|---|
| Gasket | Plumbing | Boiler Room | Suspect | 4 gaskets | Access B – Accessible to maintenance workers | Non friable | Good | Action 5 – Proactive ACM removal / Action 7 – Routinely monitor condition Test prior to impact |

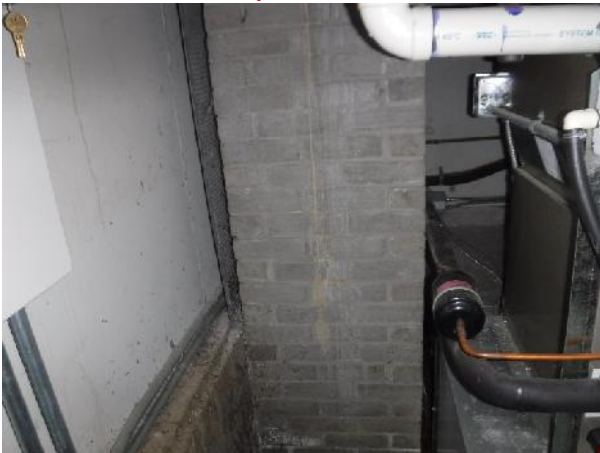
Photo 5
Description: Brick and mortar
Location: Furnace Room
Asbestos: Suspect

| Description | System | Locations | Status | Quantity | Accessibility | Friability | Condition | Mgmt Recommendation |
|---|---|--|---|---|--|---|---|---|
| Brick and mortar | Chimney | Furnace Room | Suspect | 55 ft ² | Access B – Accessible to maintenance workers | Non friable | Good | Action 5 – Proactive ACM removal / Action 7 – Routinely monitor condition Test prior to impact |

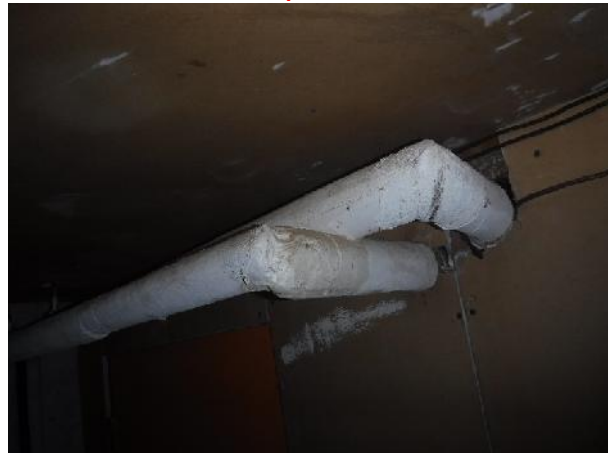
Photo 6
Description: Textile wrapped fibreglass insulation
Location: Maintenance Shop
Asbestos: Suspect

| Description | System | Locations | Status | Quantity | Accessibility | Friability | Condition | Mgmt Recommendation |
|---|---|--|---|---|--|---|---|---|
| Textile wrapped fibreglass insulation | Pipe insulation | Maintenance Shop | Suspect | 50 linear feet | Access B – Accessible to maintenance workers | Non friable | Good | Action 5 – Proactive ACM removal / Action 7 – Routinely monitor condition Test prior to impact |

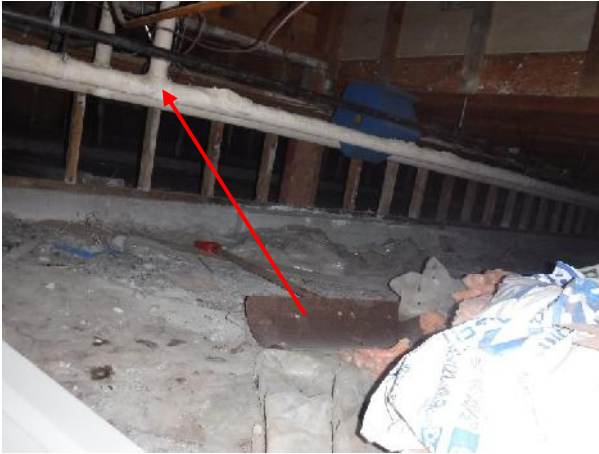
Photo 5

Description: Pipe elbow insulation
Location: Crawlspace
Asbestos: 65% chrysotile
Sample: Furnace Room

| Description | System | Locations | Status | Quantity | Accessibility | Friability | Condition | Mgmt Recommendation |
|---|---|--|---|---|--|---|---|---|
| Pipe elbow insulation | Plumbing | Crawlspace | Confirmed | Suspect to be present throughout crawlspace | Access B – Accessible to maintenance workers | Non friable | Fair | Action 5 – Proactive ACM removal / Action 6 – ACM Repair Test prior to impact |
