Woss Teacherage
83 MacRae Drive, Woss, BC
Asbestos Management Inventory

North West
Environmental Group Ltd.

NWest File: 39957 AMI1 V1.0

Date Issued: May 4, 2021

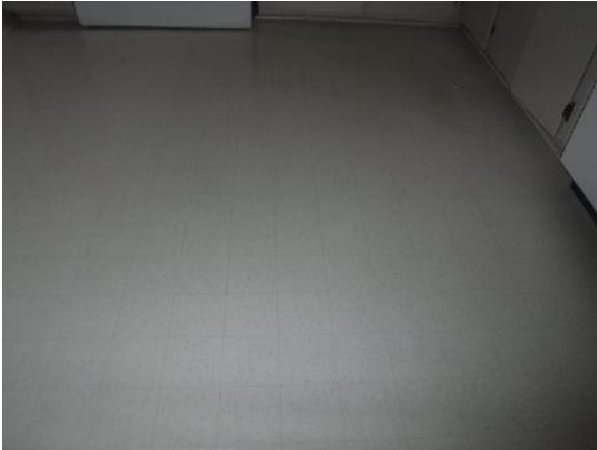
Description	System	Locations	Status	Quantity	Accessibility	Friability	Condition	Mgmt Recommendation
Sheet flooring 1 – 4”x4” off white squares	Floor	Kitchen	Suspect	155 ft ²	Access A – Accessible to all building users	Friable	Good	Action 5 – Proactive ACM removal / Action 7 – Routinely monitor condition Test prior to impact

Photo 1
Description: Sheet flooring 1 – 4”x4” off white squares
Location: Kitchen
Asbestos: Suspect

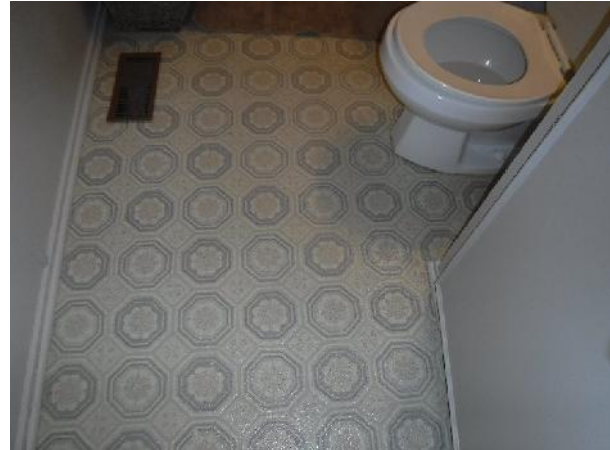
Photo 2
Description: Sheet flooring 3 – octagon and square pattern
Location: Laundry Room
Asbestos: Suspect

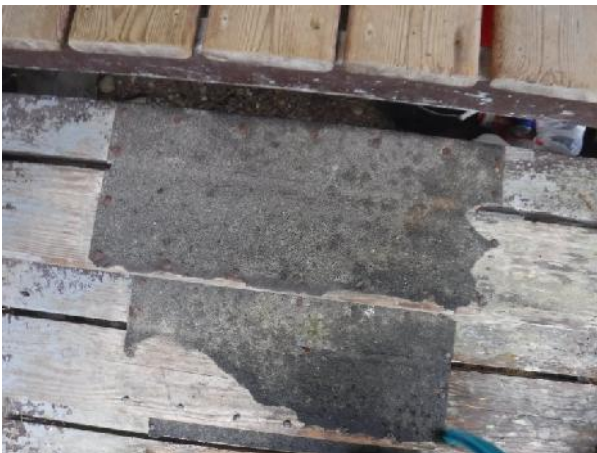
Photo 3
Description: Asphalt stair tread
Location: Exterior
Asbestos: Suspect

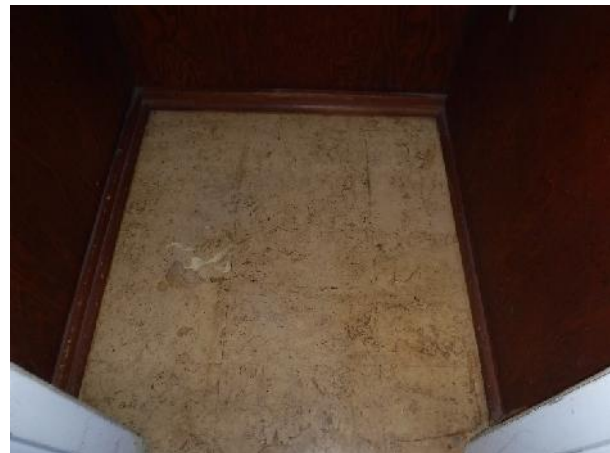
Photo 4
Description: Floor tile 1 – 9”x9” yellow with brown
Location: Hallway Closet
Asbestos: Suspect

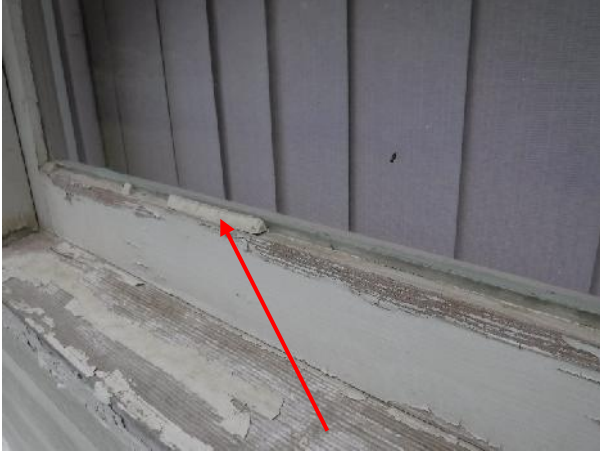
Photo 5
Description: Window putty – white
Location: Exterior
Asbestos: Suspect

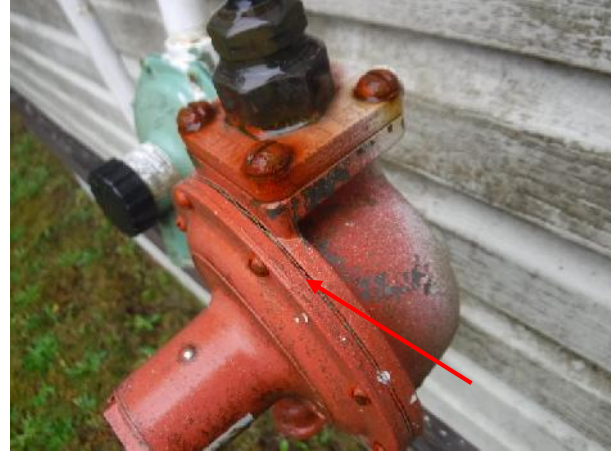
Photo 6
Description: Gasket
Location: Exterior old gas hookup location
Asbestos: Suspect

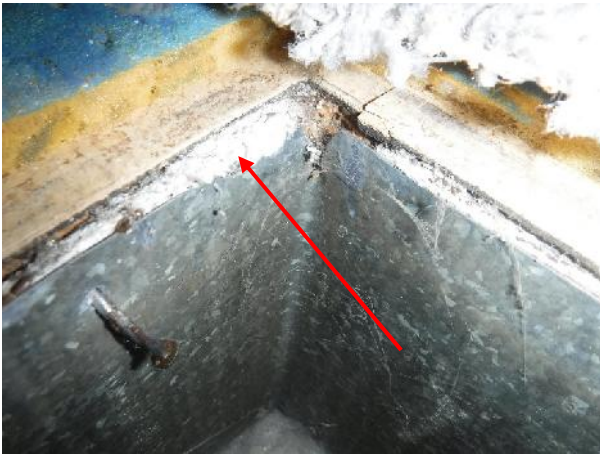
Description	System	Locations	Status	Quantity	Accessibility	Friability	Condition	Mgmt Recommendation
Heat register vibration dampener	HVAC	Throughout	Suspect	All building heat registers	Access A – Accessible to all building users	Friable	Good	Action 5 – Proactive ACM removal / Action 7 – Routinely monitor condition Test prior to impact
Asphalt stair tread	Stair	Exterior	Suspect	25 ft ²	Access A – Accessible to all building users	Non-friable	Good	Action 5 – Proactive ACM removal / Action 7 – Routinely monitor condition Test prior to impact

Photo 5
Description: Heat register vibration dampener
Location: Living Room
Asbestos: Suspect

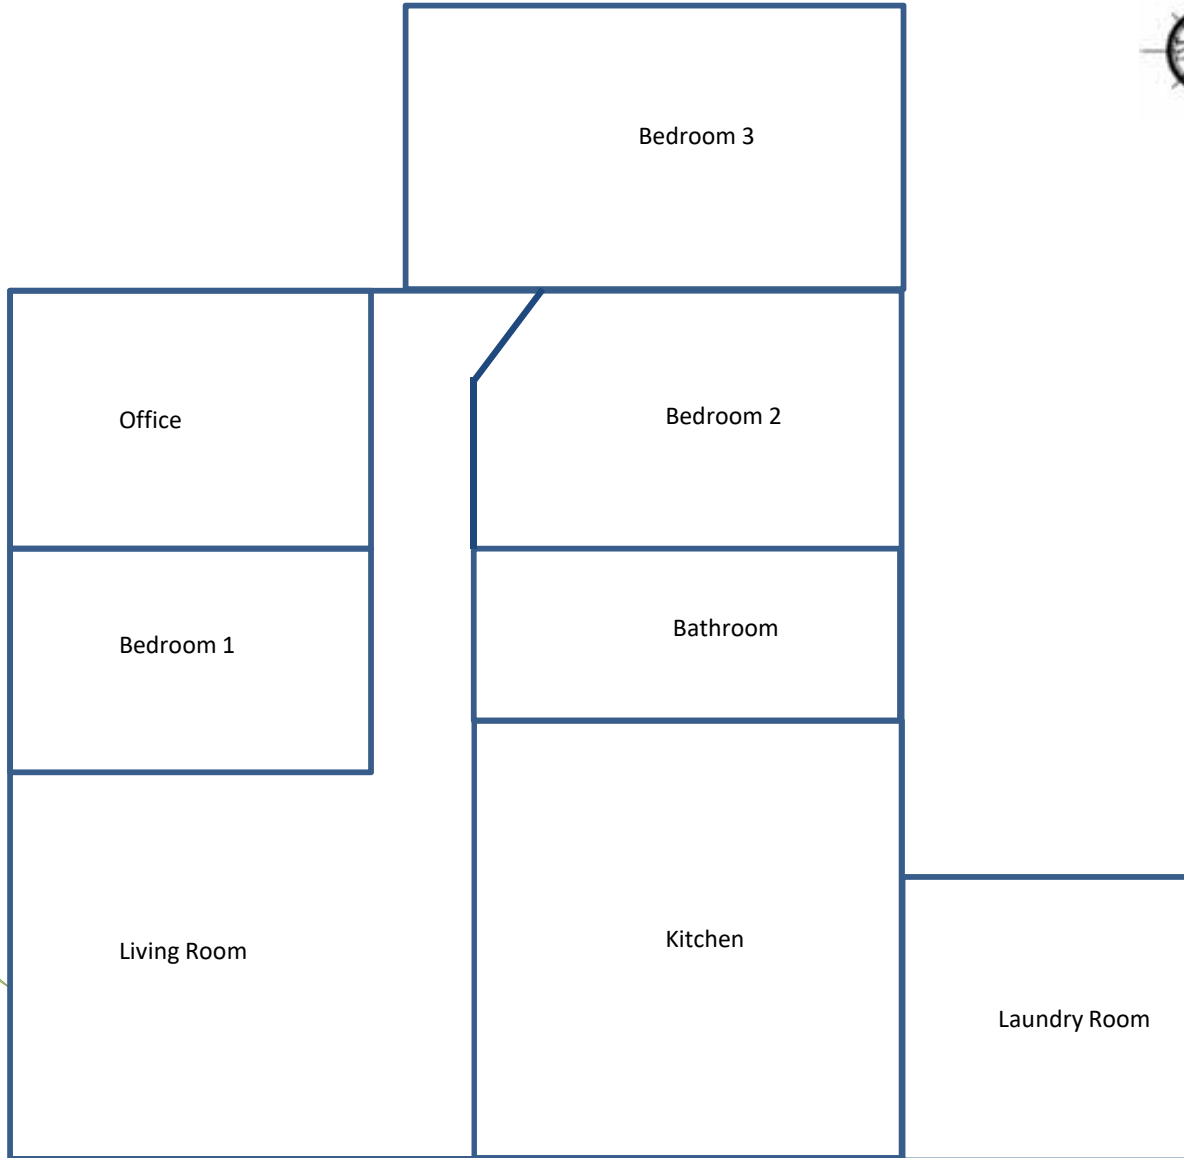
Location: 83 MacRae Drive, Woss, BC
Drawing Title: Sample Locations
Project No: 39957
Drawing No: 001
Surveyed By: PG
Survey Date: August 21, 2020

37b Window Putty (Black)
