SCHOOL DISTRICT 85
VANCOUVER ISLAND NORTH

SEA VIEW ELEMENTARY
ASBESTOS SURVEY AND ASSESSMENT

Date: July 2009
NWEST File: 10565

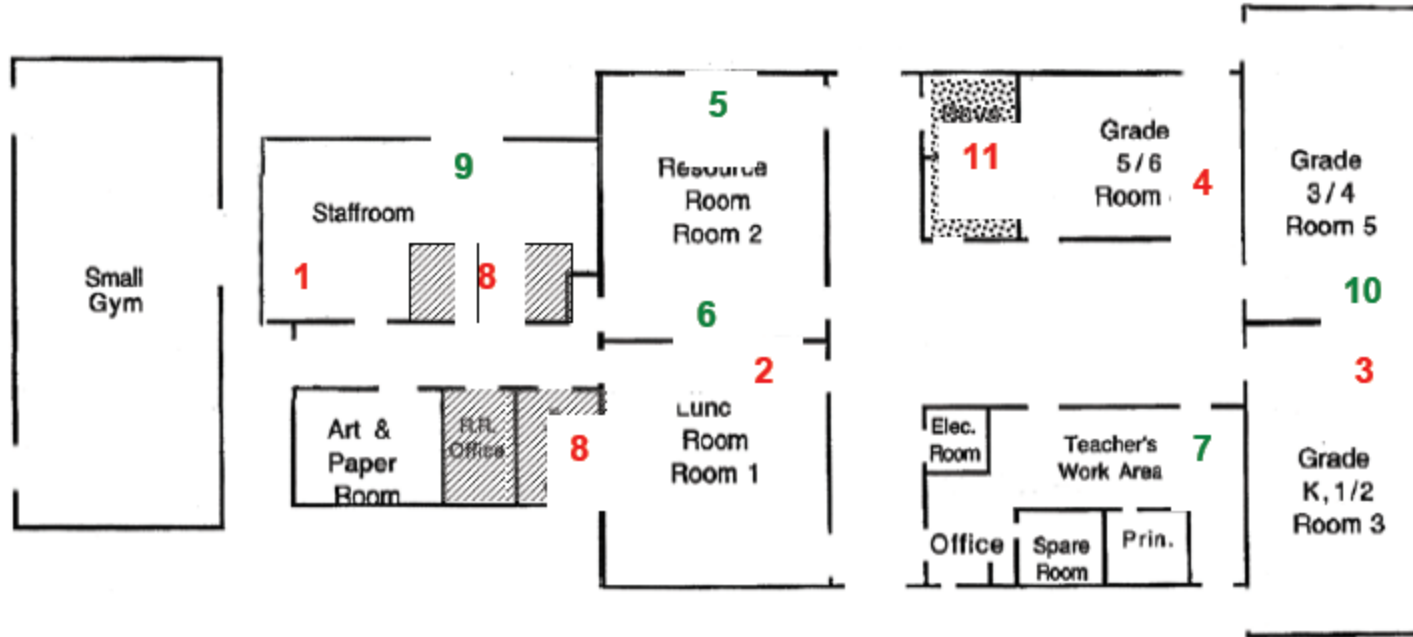
APPENDIX 6: SAMPLE LOCATION DRAWING

Asbestos containing drywall filler compounds are present throughout the building. These are in generally good condition and are unlikely to be damaged during routine building activities.

Asbestos containing floor tiles have been identified in the building. These are in the Janitor Room, but are likely present in other locations (under carpets or other flooring materials). Floor tiles are considered non-friable and are unlikely to be damaged during routine building activities.

Asbestos containing drywall filler compounds and floor tiles are in generally good condition and are unlikely to be damaged during routine building activities. These products can be included in the Asbestos Management Plan and managed in place.
