School District 85 - Vancouver Island North

Asbestos Inventory and Condition Assessment

Seaview Secondary School - 1120 Nigei St, Port Alice, BC V0N 2N0

NWest Project Number: 30012 V.1.0

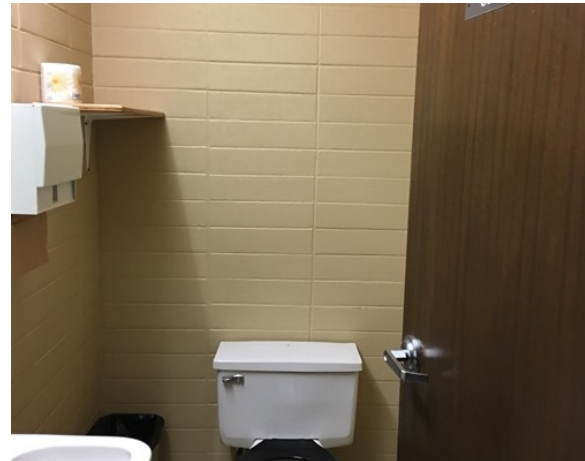
- Ceiling: Ceiling Tile (Acoustic) Type1 - Patterned Fissure, Ceiling Tile (Acoustic) Type3 - Vertical Fissure Small and Large Pinholes
- Wall: Concrete Block Walls May Contain Vermiculite
- Floor: Floor Tile Type1 - 12" x 12" Beige with White/Black Smears

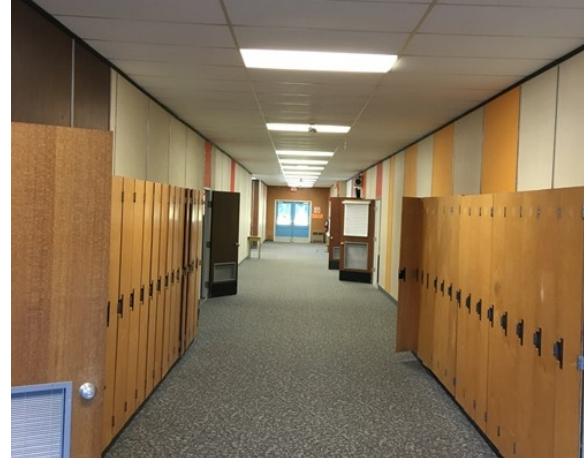
Ceiling: Ceiling Tile (Acoustic) Type1 - Patterned Fissure, Ceiling Tile (Acoustic) Type3 - Vertical Fissure Small and Large Pinholes
 Wall: Concrete Block Walls May Contain Vermiculite, Drywall Type1 - No Drywall Joint Compound Observed
 Floor: Carpet
 Other: Door Panels may contain asbestos

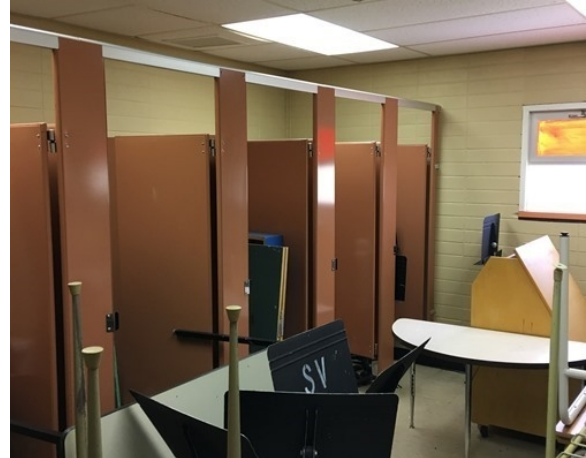
Ceiling: Ceiling Tile (Acoustic) Type1 - Patterned Fissure
 Wall: Concrete Block Walls May Contain Vermiculite
 Floor: Floor Tile Type1 - 12" x 12" Beige with White/Black Smears

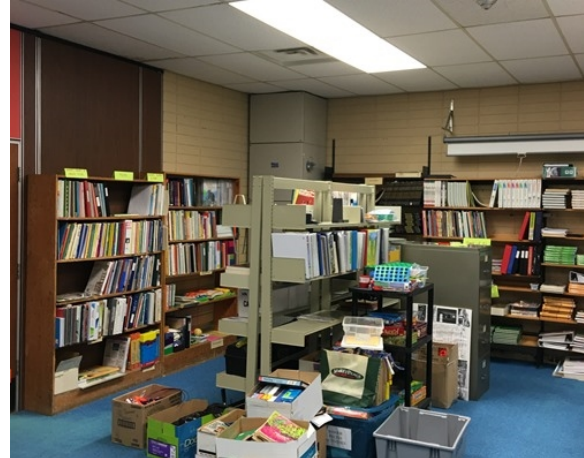
Ceiling: Ceiling Tile (Acoustic) Type1 - Patterned Fissure, Ceiling Tile (Acoustic) Type3 - Vertical Fissure Small and Large Pinholes
 Wall: Concrete Block Walls May Contain Vermiculite, Drywall Type1 - No Drywall Joint Compound Observed
 Floor: Carpet

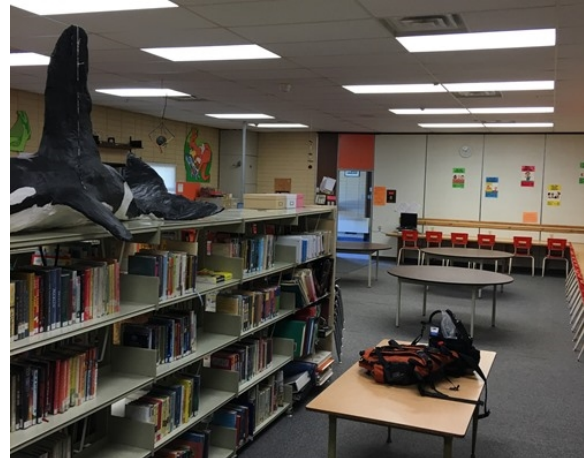
Wall: Concrete Block Walls May Contain Vermiculite, Drywall Type1 - No Drywall Joint Compound Observed

Floor: Carpet

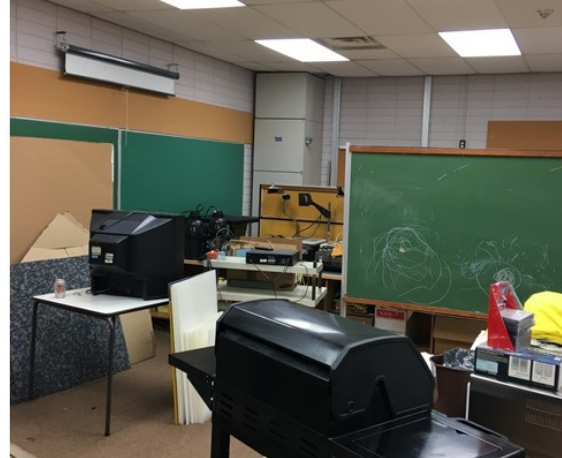
Ceiling: Ceiling Tile (Acoustic) Type1 - Patterned Fissure, Ceiling Tile (Acoustic) Type3 - Vertical Fissure Small and Large Pinholes
 Wall: Concrete Block Walls May Contain Vermiculite, Drywall Type1 - No Drywall Joint Compound Observed
 Floor: Carpet
